Yukon Flood Study

May, 1974

YUKON FLOOD STUDY

NORTHERN NATURAL RESOURCES
AND ENVIRONMENT BRANCH
INDIAN AND NORTHERN AFFAIRS
WHITEHORSE, YUKON TERRITORY

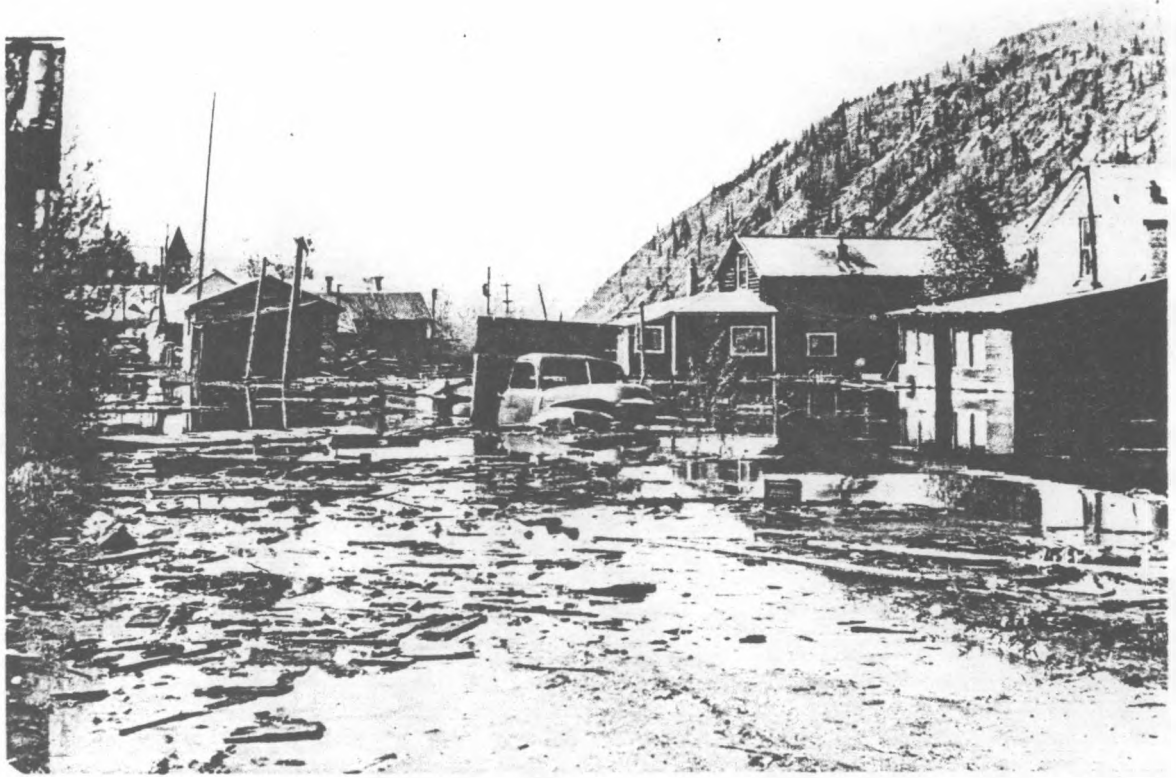
Fig. 1 - Flood, 1964 - Between 2nd and 1st Avenue looking south.

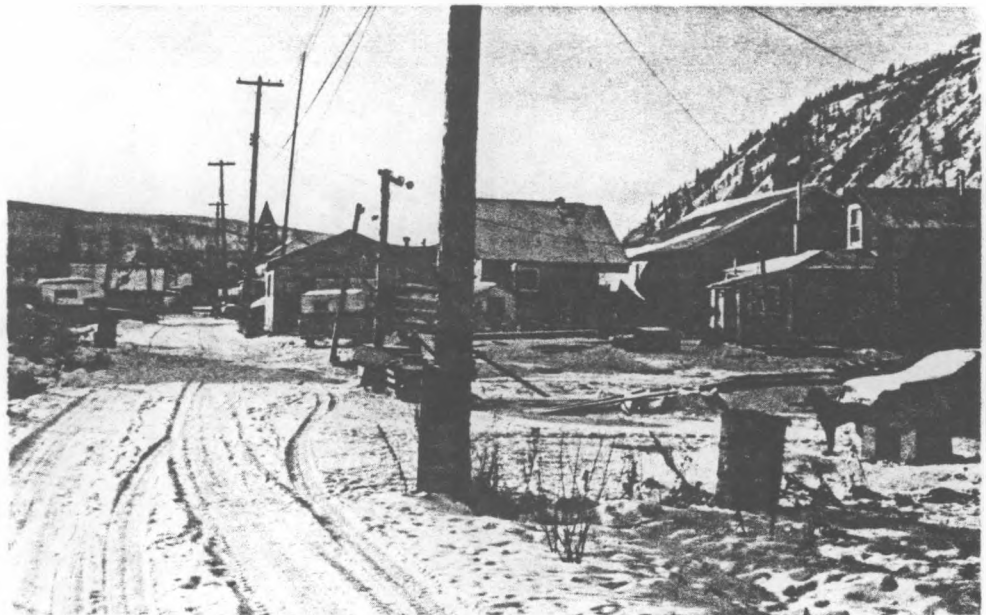
Fig. 2 - Same view - November, 1973.

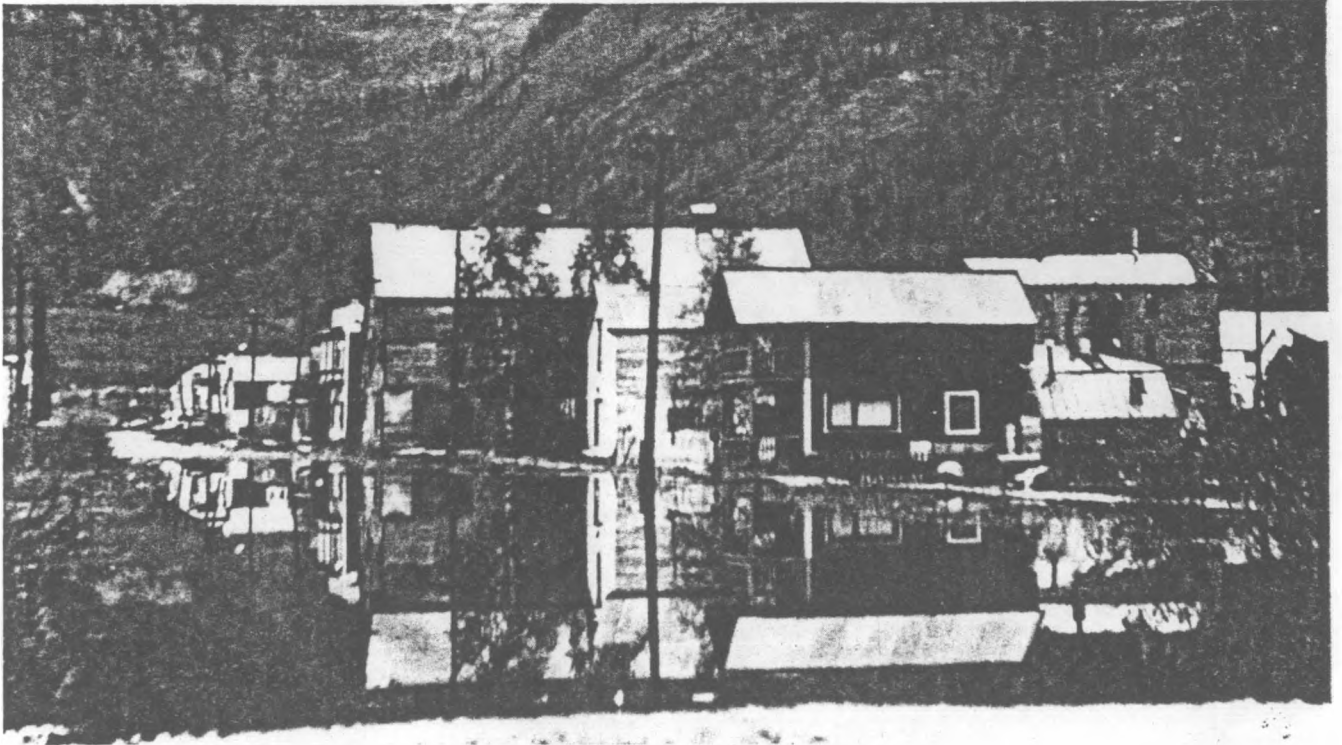
Fig. 3 - 1964 Flood - 2nd Avenue looking north.

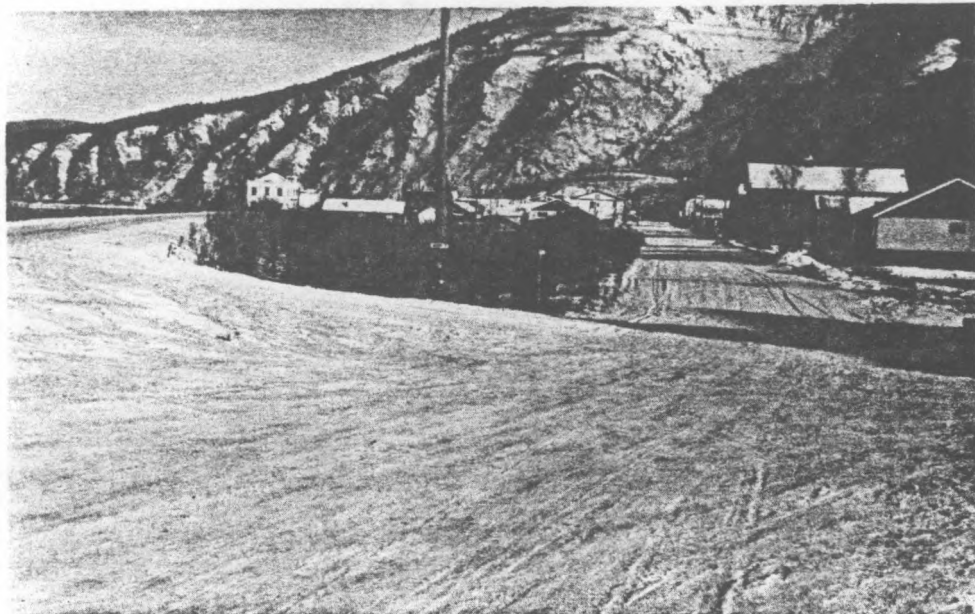
Fig. 4 - November 1973 view - 2nd Avenue with dike on the left.

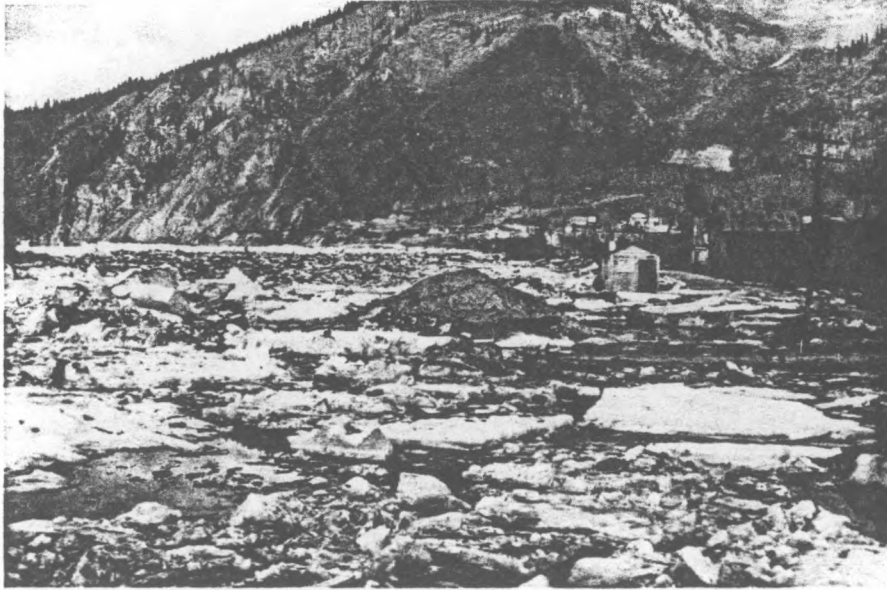
Fig. 5 - Ice floes left after the 1966 Flood.

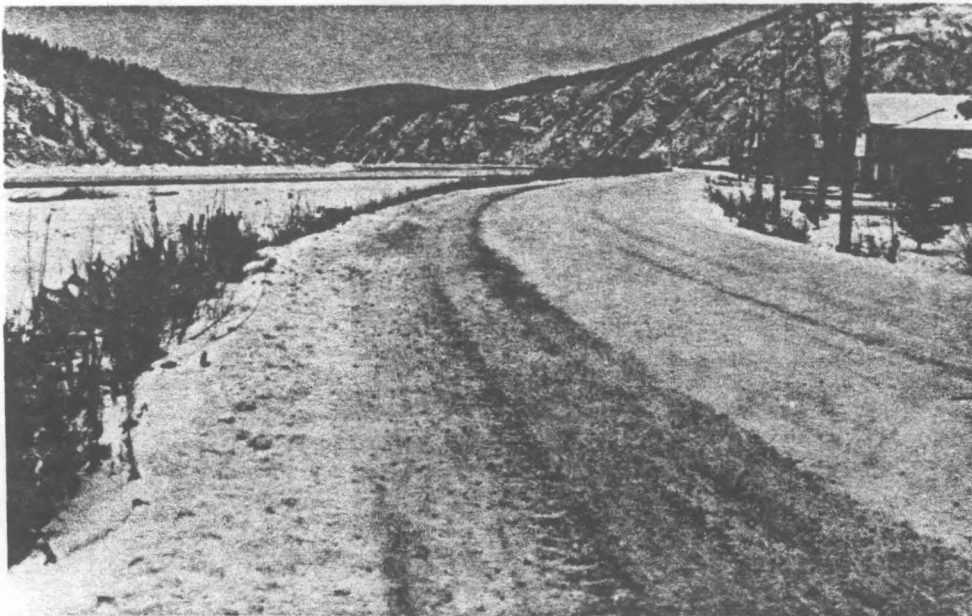
The dike around Dawson was found in good condition. Drainage should be improved and sewers updated.

Fig. 6 - 1973 view of the dike at Dawson.

In the light of the results of the frequency analysis and cost estimate study we recommend that the dike be raised by a minimum of 3 feet. This will offer a 150 year return period flood protection and allow for 0.6 feet of freeboard. That will put the dike at Harper Street at an elevation of 1056 G.S.C. In order to keep the grade of the dike of the same order as the slope of the Yukon River during high water, the elevation at the lower end of the dike should be 1055.5 G.S.C. and the elevation at the N.C.P.C. power station at 1056.6. For the stretch along the Klondike River, the present grade of the dike

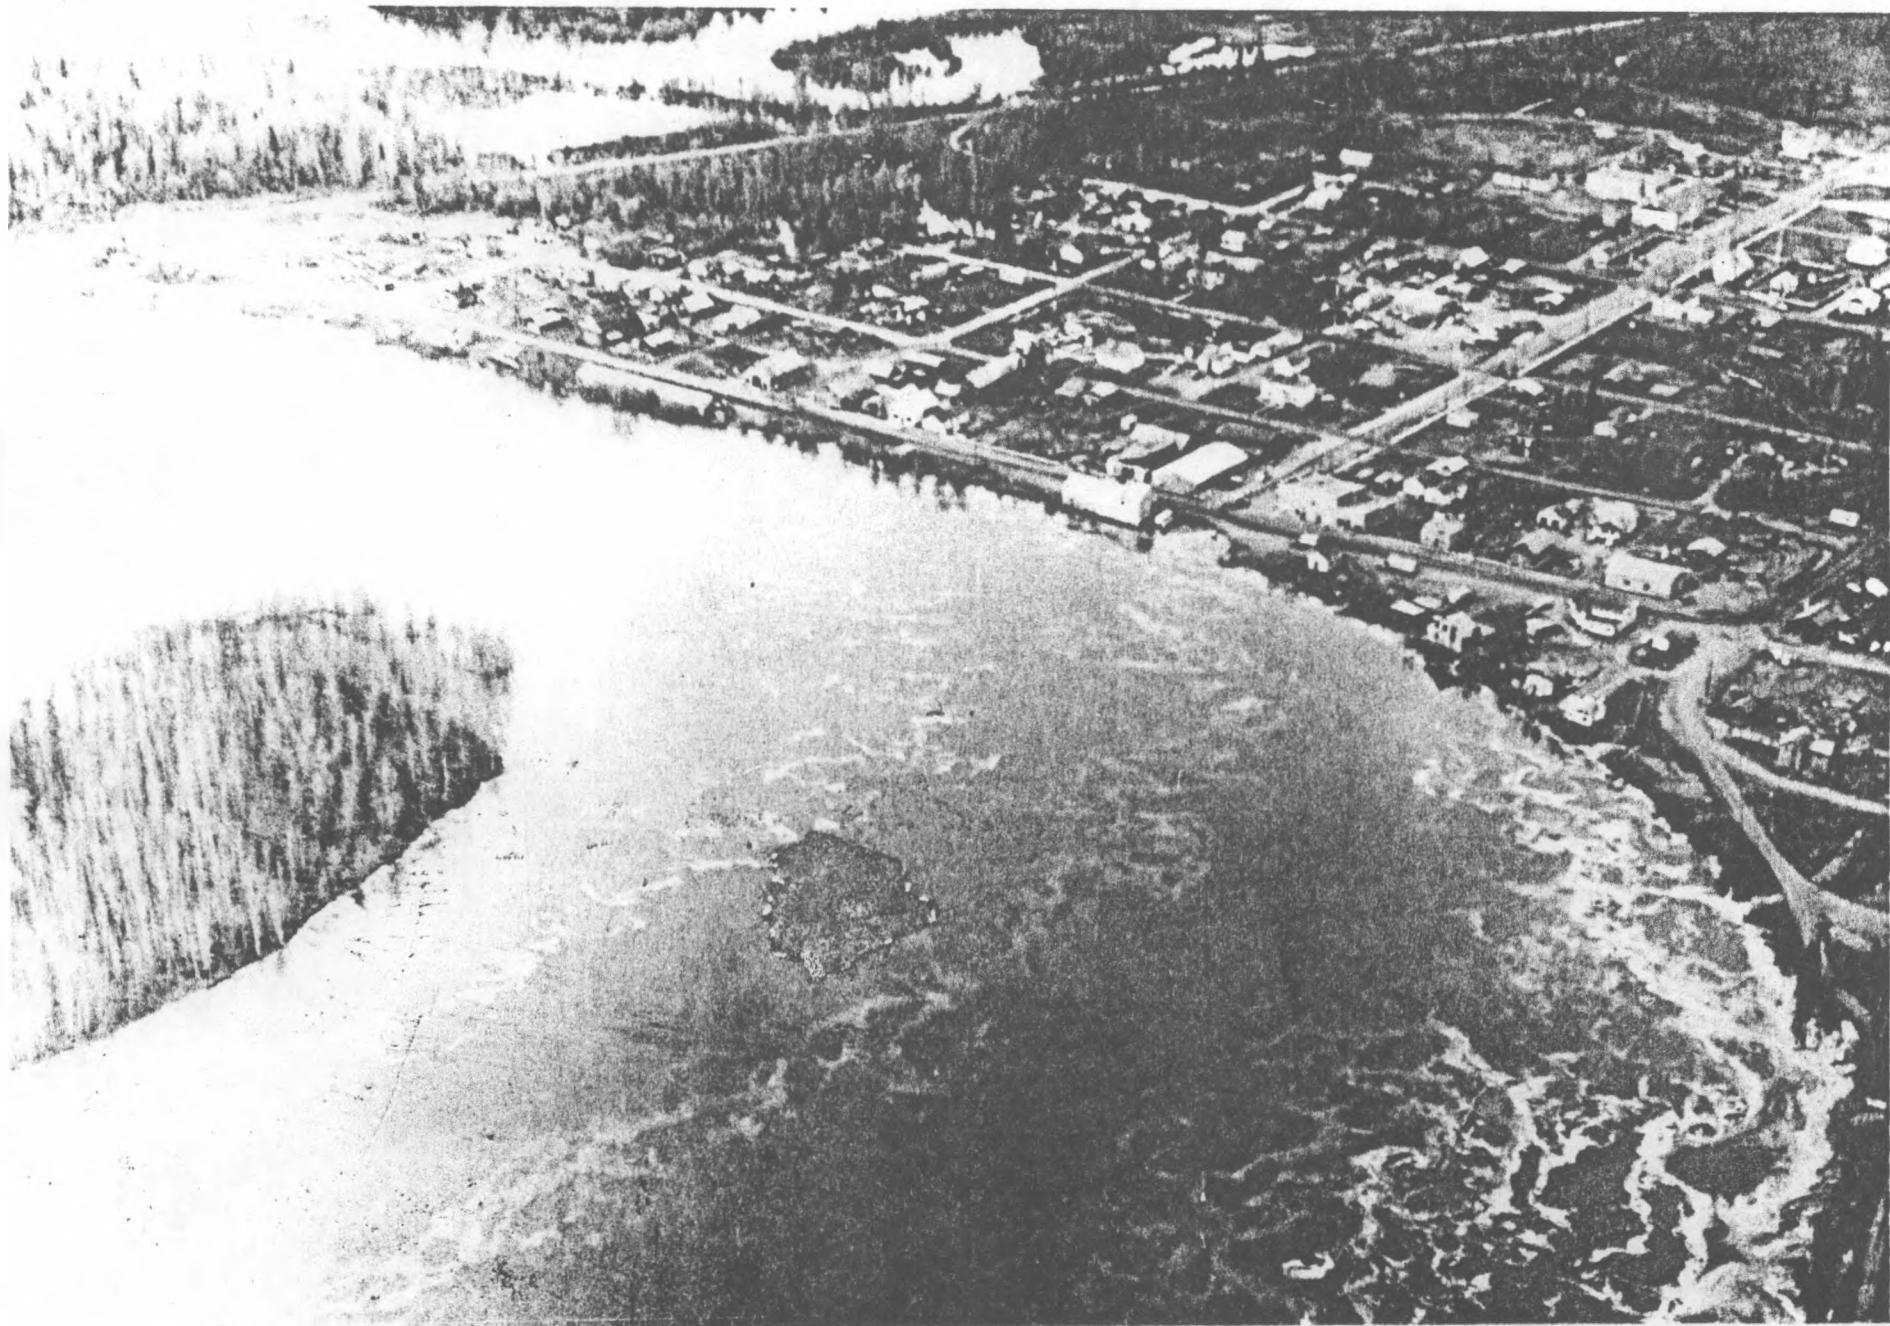
Fig. 7 - 1964 Flood - Aerial view of Mayo

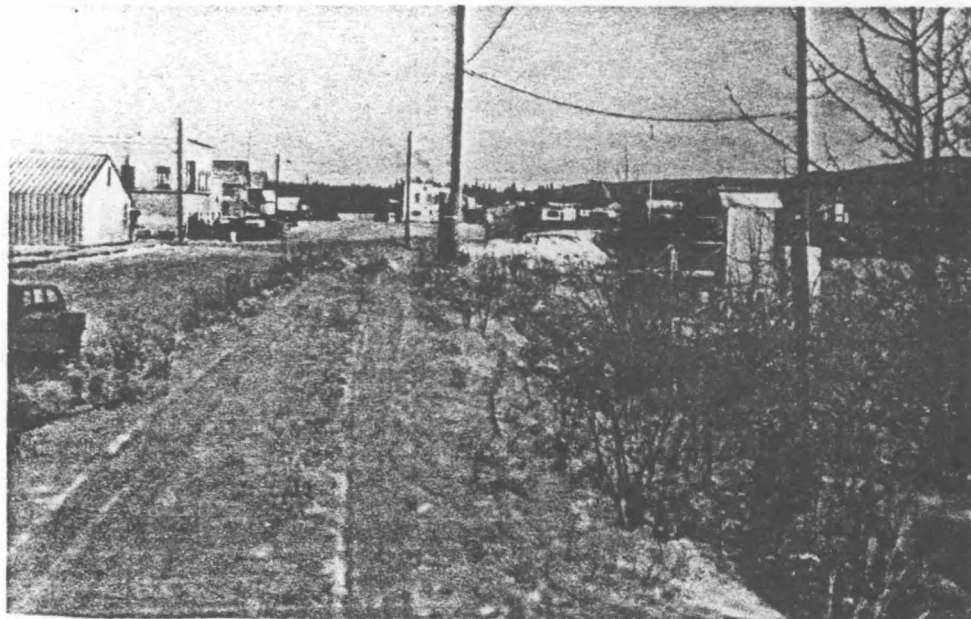
Fig. 10 - Same view
1973

Note that bldgs on
right have been
removed.

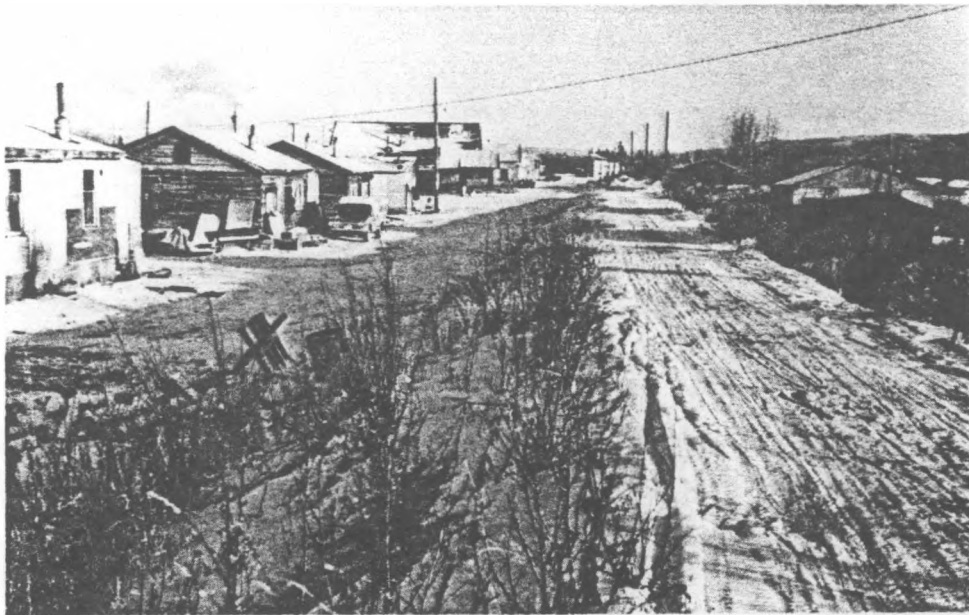
Fig. 12 - Dike and Native Village - November 1973.

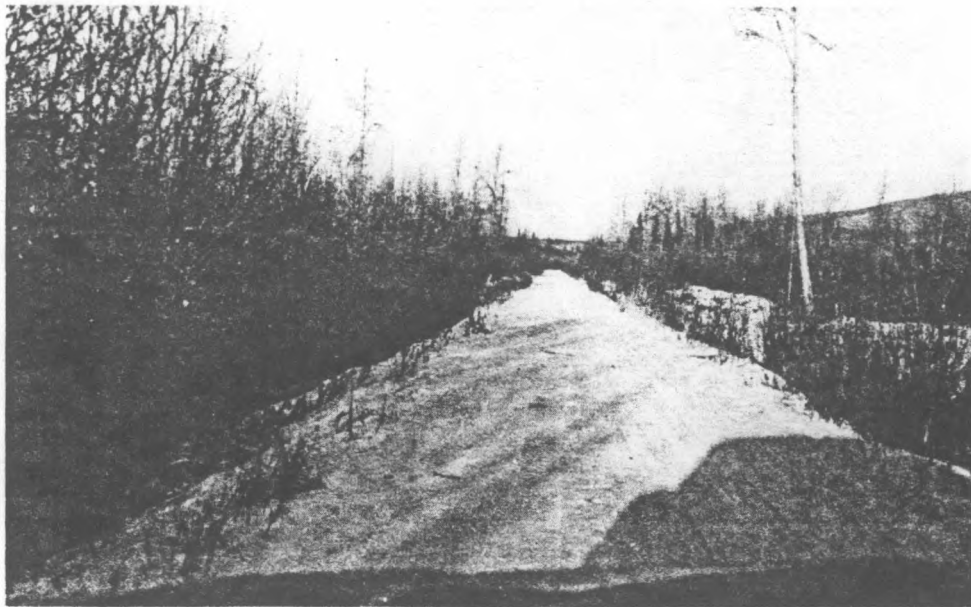
Floods at Mayo have always come from heavy runoff. As an emergency measure, during the most recent floods, a dike has been built and then raised along the endangered part of town. The dike was found to be in fair condition, part of it is used as a road to facilitate dike maintenance. Very little protection is allowed against erosion along the dike, although weed growth should give some natural protection.

Fig. 14 - 1973 view of the dike.

Knowing that for the 100 year flood elevation of 1607.8 almost all the community will be flooded, special care should be taken to ensure that the dike can hold against the flood. Therefore, we recommend that a survey of the dike elevation and grade be undertaken, and that the dike be raised approximately 1.5 feet, to elevation 1608.

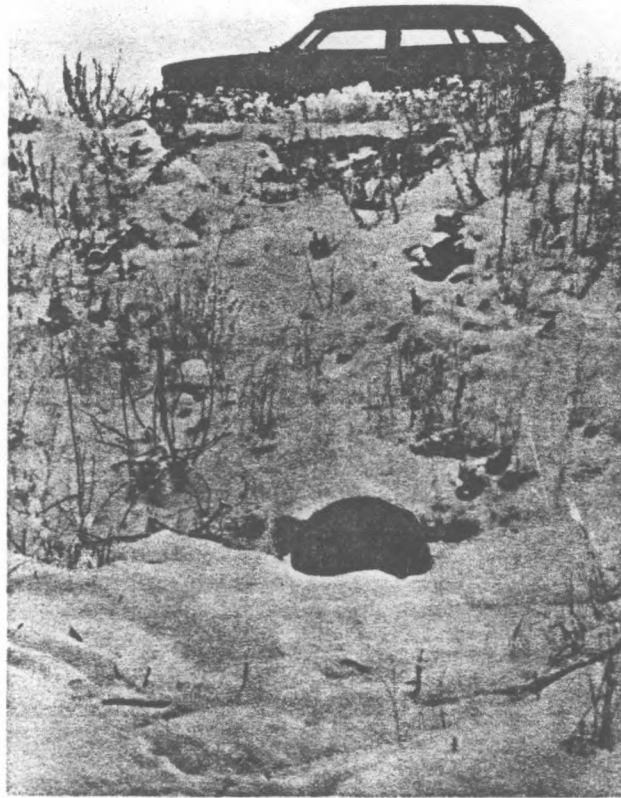
Because of the type of soil and the lack of permafrost in the southwest part of the community, seepage through the ground tends to be more serious in the native village. Moreover, the only culvert draining the water out of the village is located in the western part of town, toward the Mayo River. (Picture of the culvert on Fig. 15.) Therefore, the water is prevented from draining out of the community except through that culvert. The culvert, about 3 feet in diameter can carry a maximum of 60 C.F.S. flowing full with a

Fig. 15 - Drainage culvert through dike.

through one culvert located in the west part of the village. The culvert at the present time is inadequate and we recommend that a survey of the elevation at the base of the culvert be undertaken in order to determine the maximum headwater that can be allowed without endangering houses in the native village. The result of this survey will help to select a proper size for the culvert.

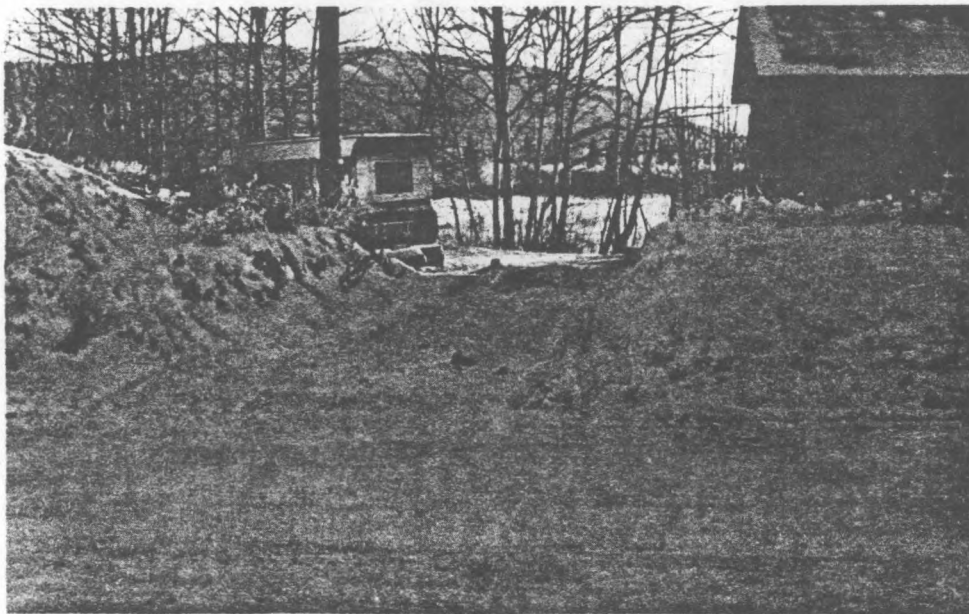
Fig. 16 - Opening through dike - November, 1973.

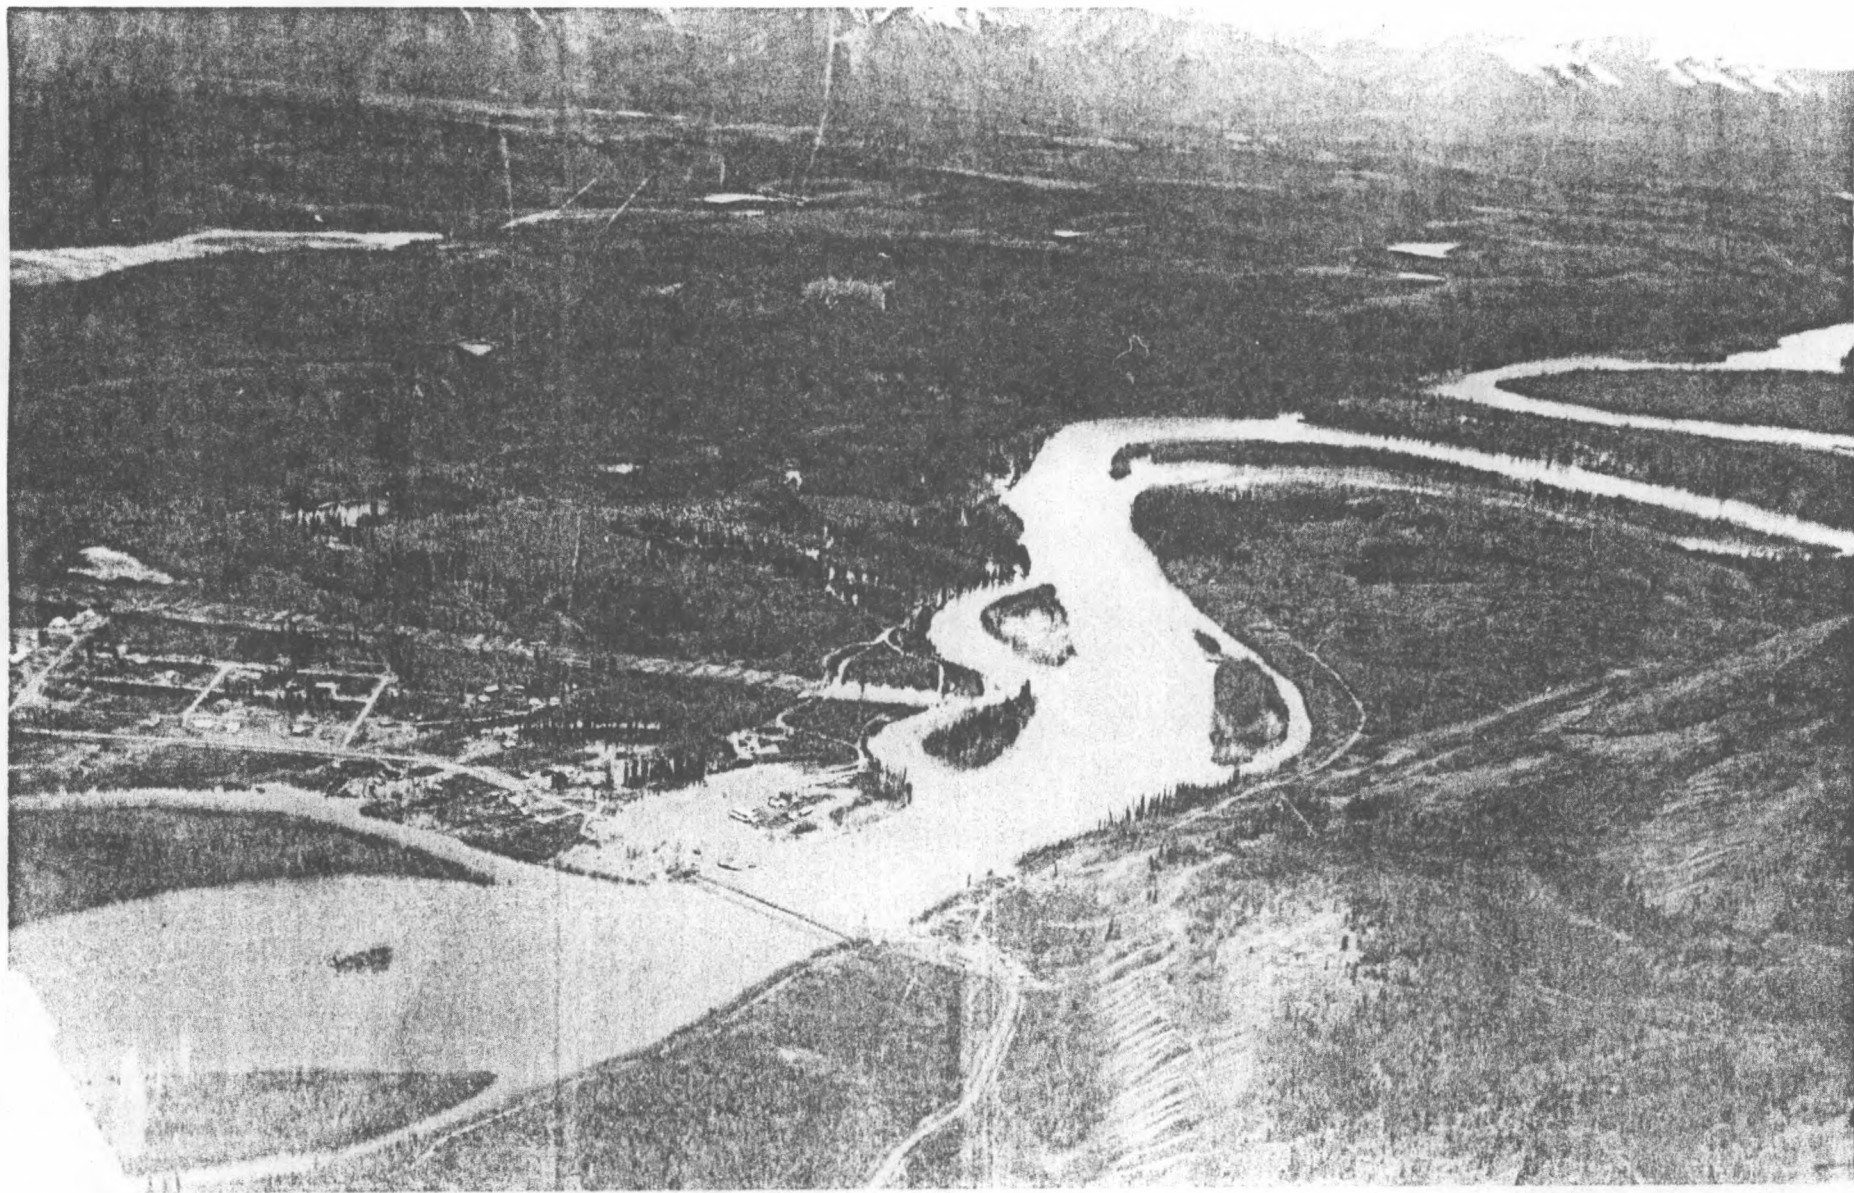
Fig. 17 - Ross River - 1972 Flood

The 1972 flood with an instantaneous peak flow of 62,100 C.F.S. was caused by a very heavy snowmelt runoff due to a high depth of snow at the end of the winter combined with heavy rain in the middle of May and above average temperature at the end of May. Water reached the elevation of 2273.37 G.S.C. on June 1st. (Pictures of the flood are presented in Figures 17 to 23).

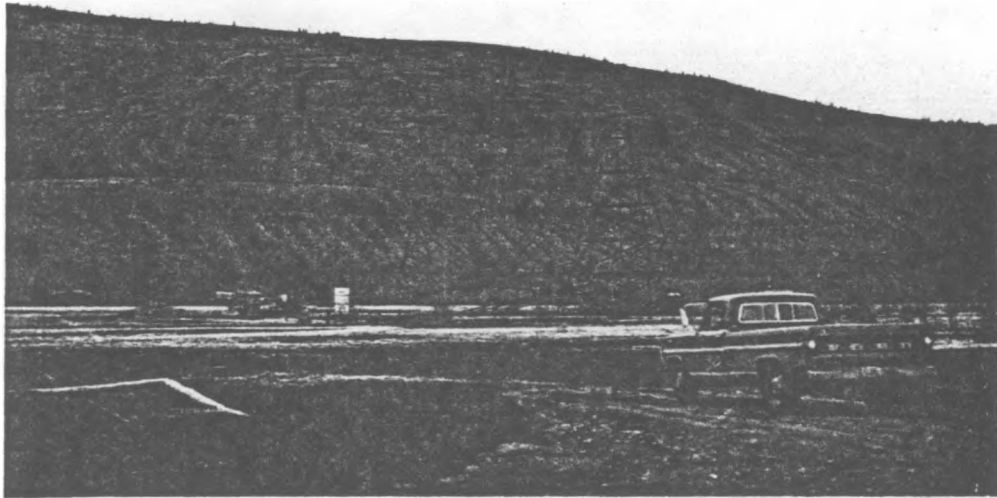
Fig. 18 - 1972 Flood - View of the foot bridge.

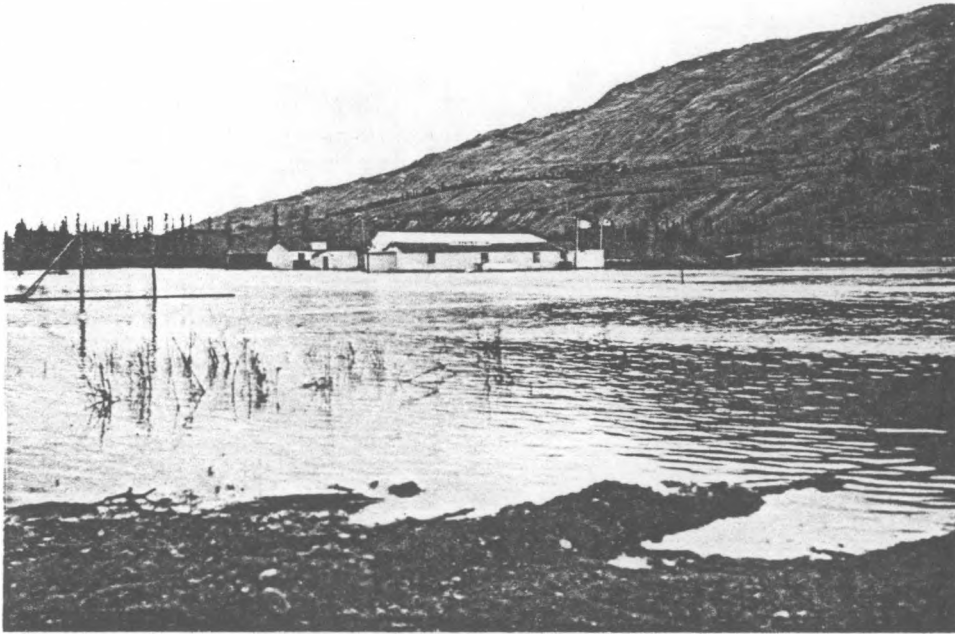
Fig. 20 - 1972 Flood - View of the department store.

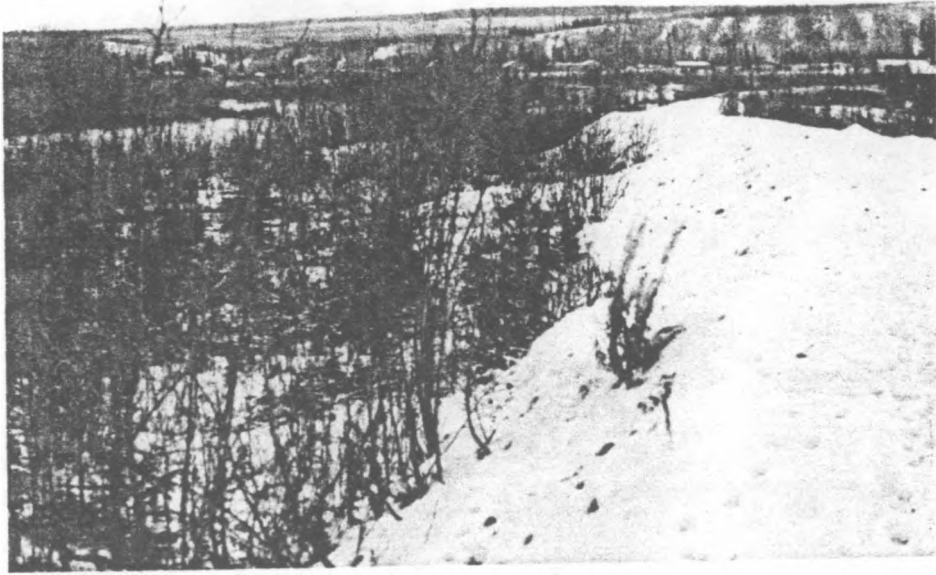
Fig. 22 - 1973 view of the dike.

We recommend that a study be undertaken in order to determine if the extension of the dike downstream of the foot bridge can be economical. A survey of the left bank elevation downstream of the foot bridge should be undertaken along with a river slope measurement at high water in order to assess the cost of construction of a dike against a 100 year flood.

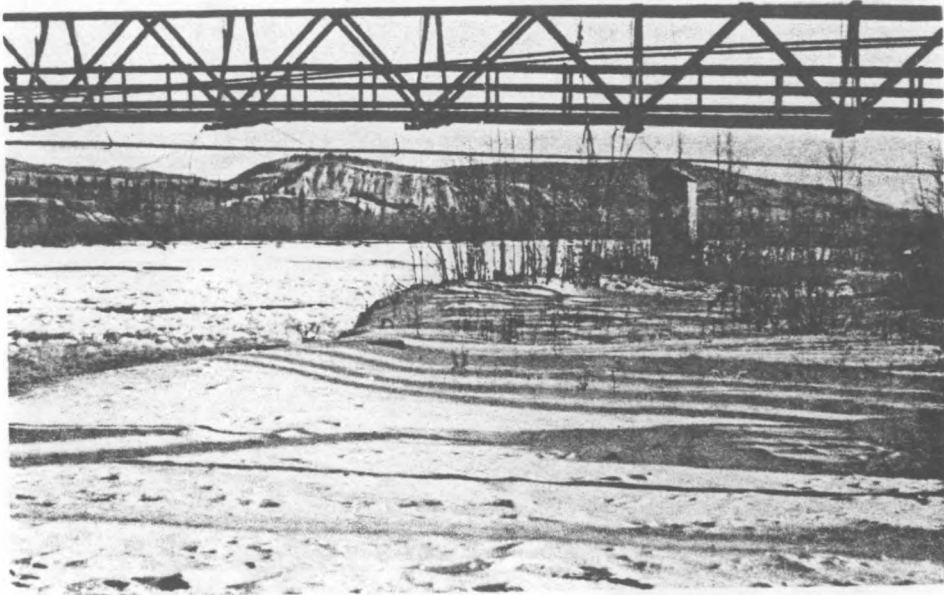
channel has become constricted and shallow. It has been necessary to extend the berm of the ferry landing on the right bank into deeper water. This action itself caused more silting and the whole process became cyclic. The left bank has been eroded just upstream of the foot bridge, undermining the Canada Water Survey gauging station. (11)

Fig. 23 - Pelly River and Water Survey Station -
November, 1973.

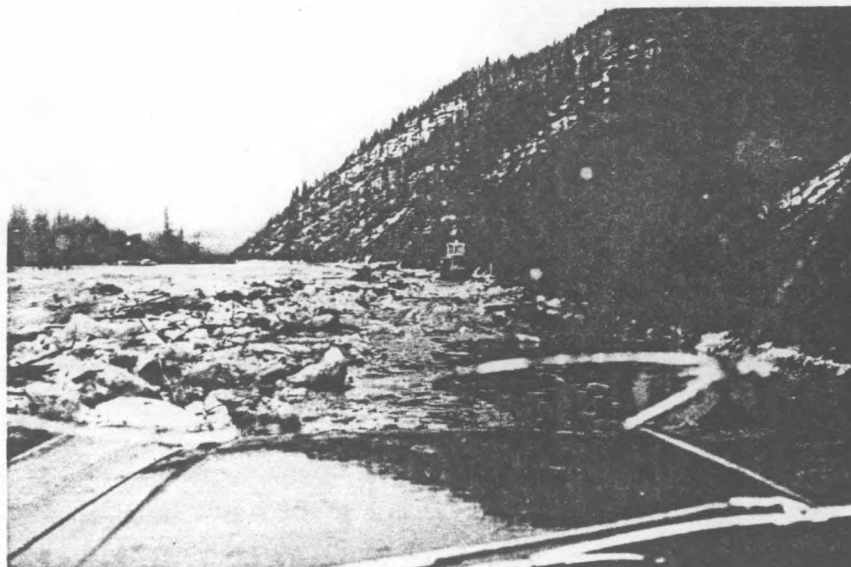
Fig. 24 -
Ice jam on
Klondike.

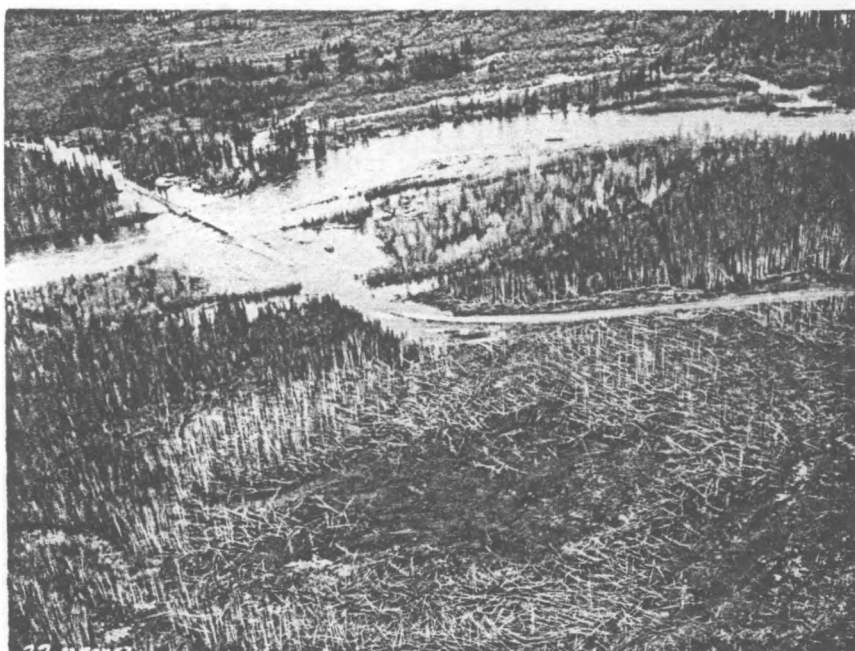
Fig. 25 - Flood of bridge
approach -
McQuesten River
May 23, 1957.

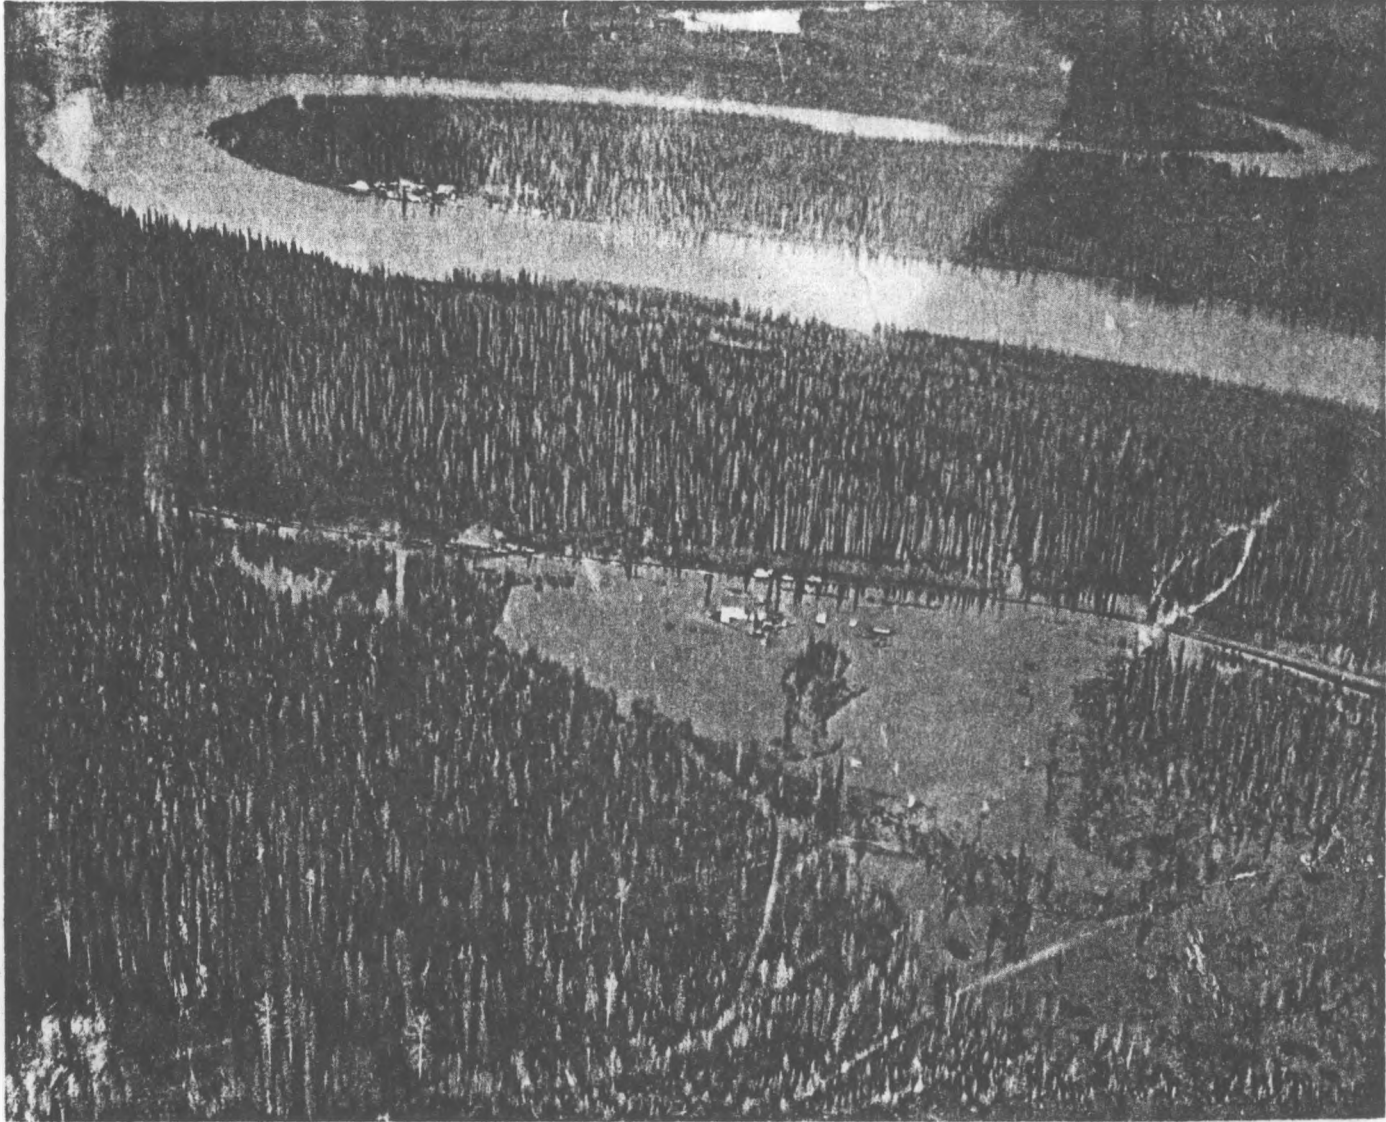
Fig. 27 - Upper Liard - 1972 Flood
