GEOLOGICAL SURVEY OF CANADA
TOPICAL REPORT NO. 9YUKON RIVER DRAINAGE BASIN
DAM SITE INVESTIGATION

SITE NO. 3

HOOTALINQUA DAM SITE
(MAP AND PRELIMINARY REPORT)

E. B. OWEN

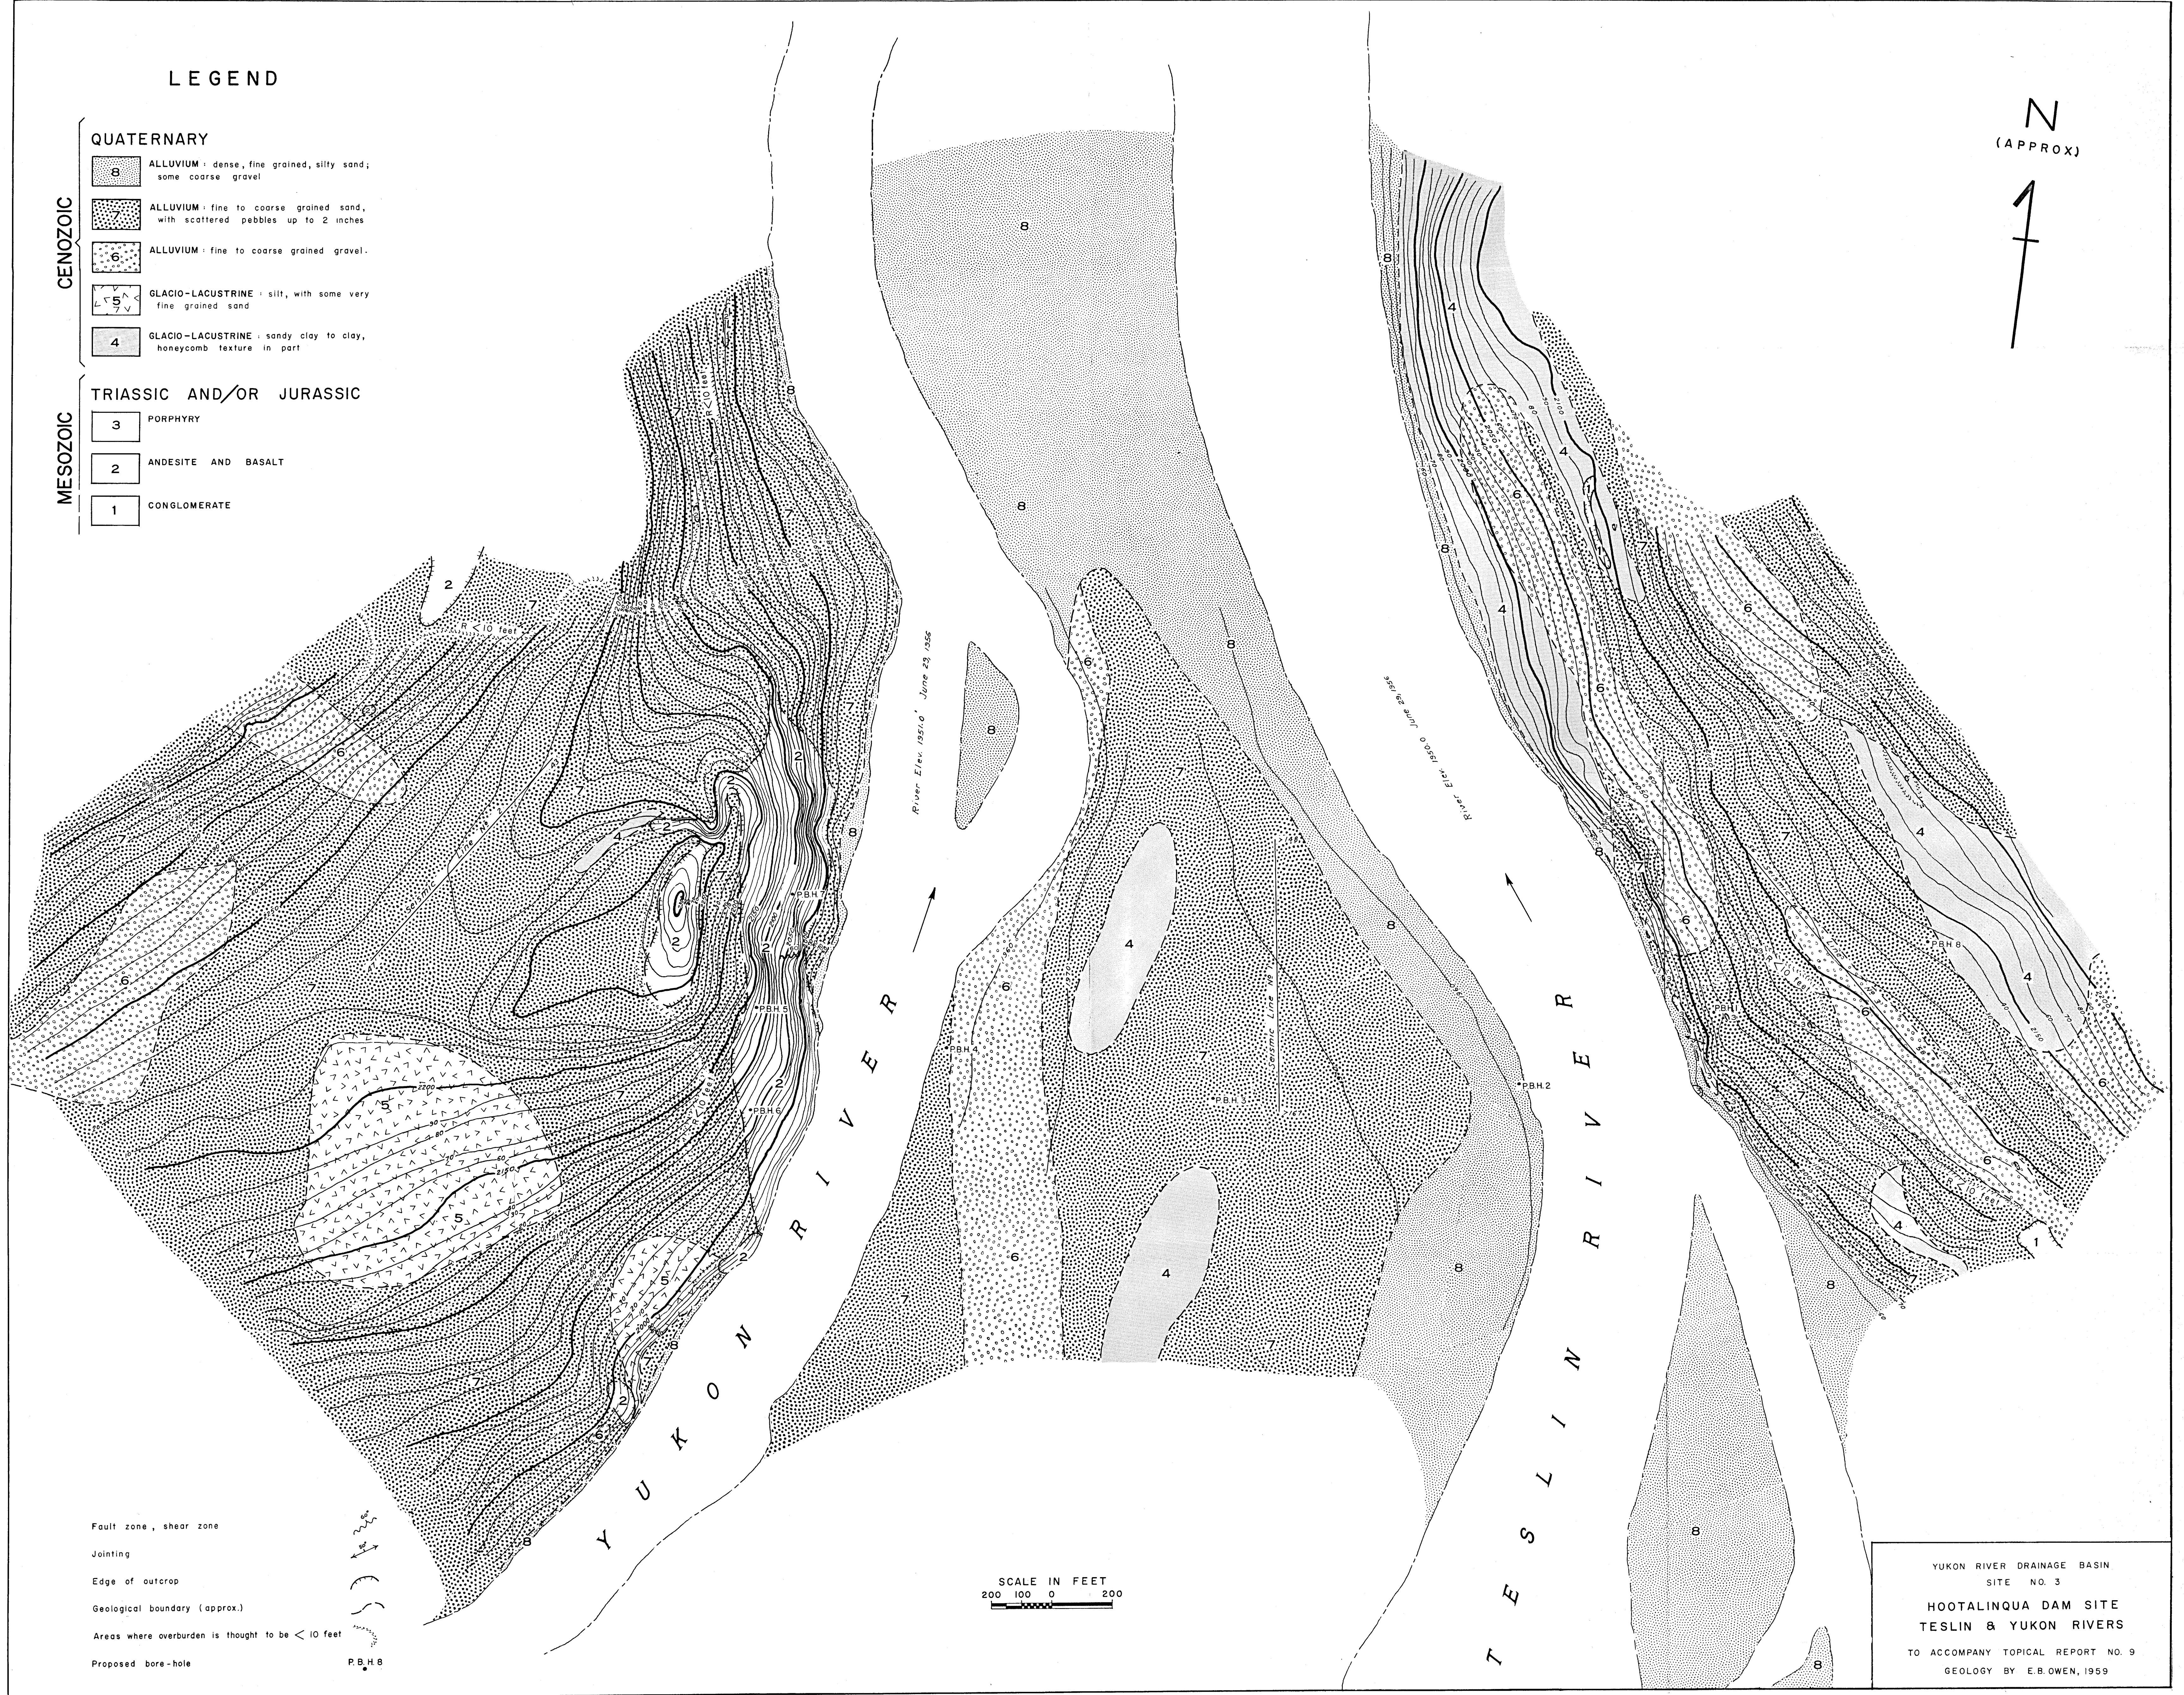
YUKON RIVER DRAINAGE BASIN
 SITE NO. 3
HOOTALINQUA DAM SITE
TESLIN & YUKON RIVERS
 TO ACCOMPANY TOPICAL REPORT NO. 9
 GEOLOGY BY E.B. OWEN, 1959

A fault zone occurring in the left abutment should be investigated further. This fault zone is about ten feet in width. It strikes approximately parallel to the proposed centre line and dips downstream at about 60 degrees.

Accurate information regarding the thickness of the overburden in the vicinity of the proposed site was not available. Areas where bedrock was thought to be ten feet or less from ground surface have been identified on the accompanying plan.

It should be remembered the present geological investigation of the proposed dam site at Hootalinqua is a preliminary one designed to furnish the engineers with as much information as possible before any money is spent on an expensive subsurface investigation. If it is decided more information is required at this site, the following test borings are suggested as part of this program:
