GEOLOGICAL SURVEY OF CANADA  
TOPICAL REPORT NO. 36

YUKON RIVER DRAINAGE BASIN  
DAM SITE INVESTIGATION

KLUANE CANYON DAM SITE  
(MAP AND PRELIMINARY REPORT)

BY  
E. B. OWEN

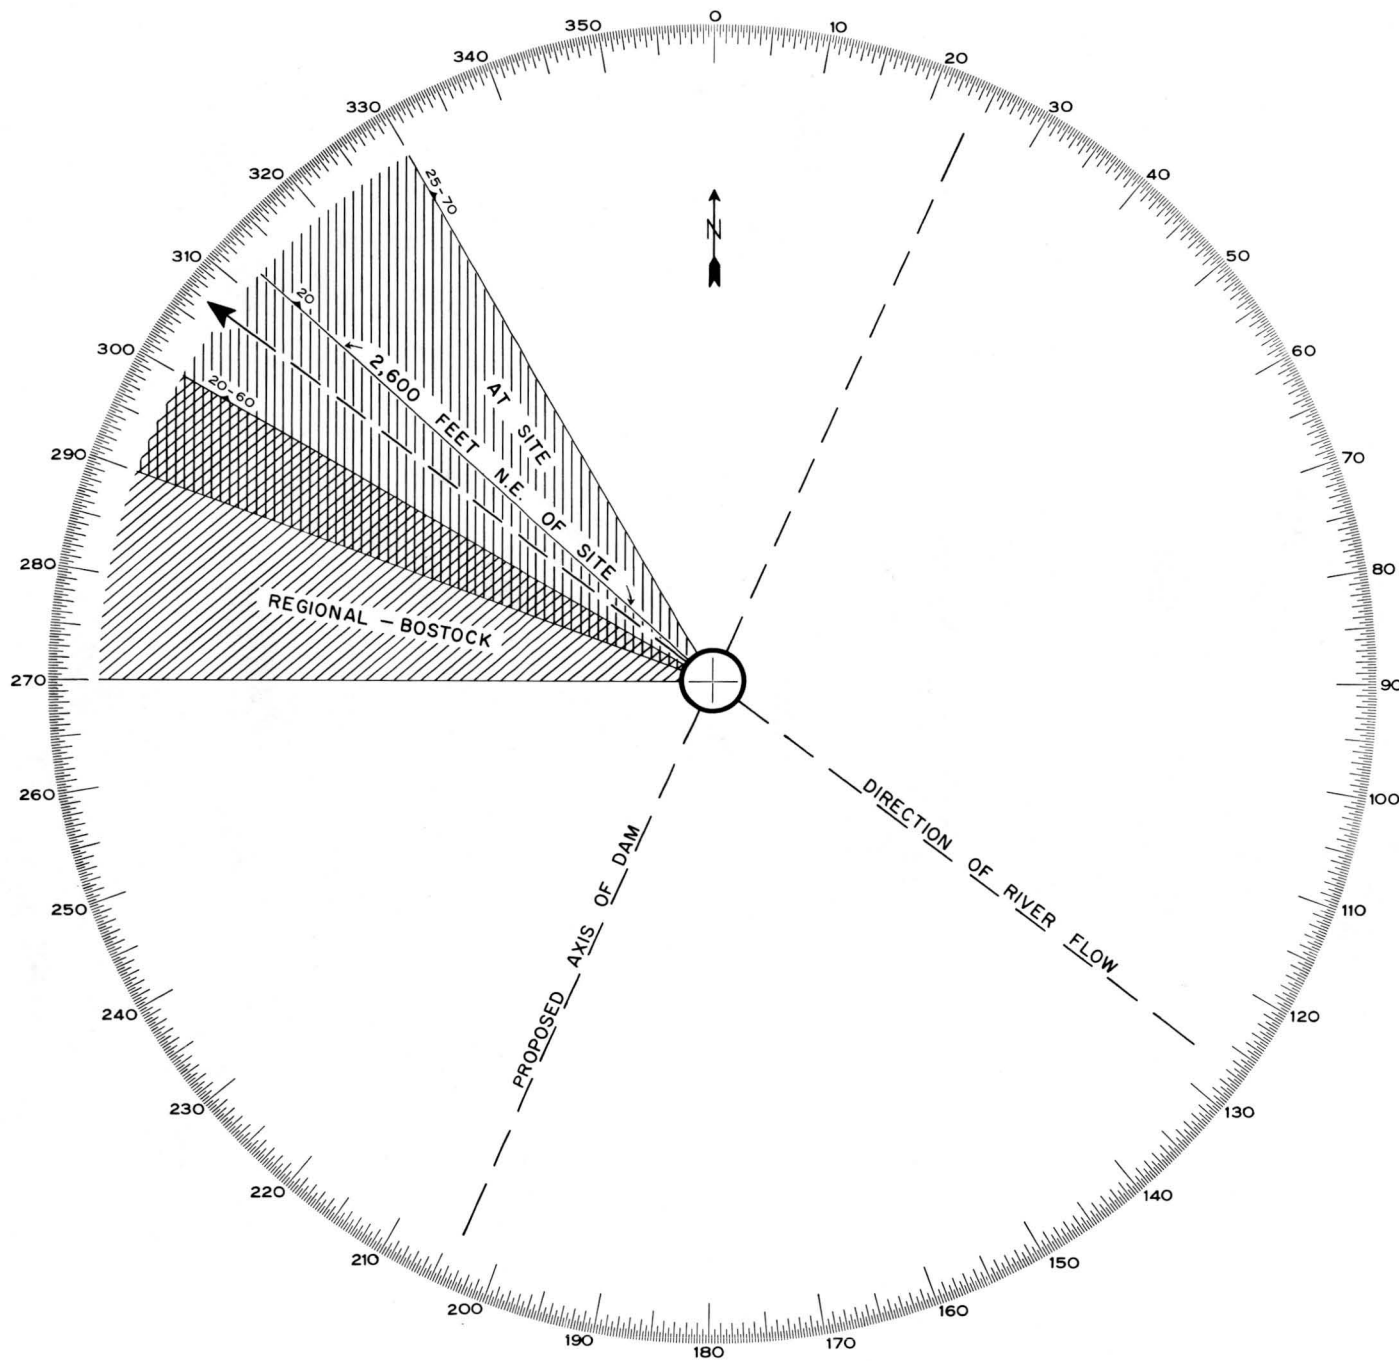
#### FOLIATION ROSETTE

Lake area strikes between north 60 degrees west and west and dips northeasterly to northerly at 20 to 60 degrees. The foliation in the rock exposed at the base of Outlet Hill northeast of the site strikes about north 48 degrees west and dips northerly at 20 degrees. At the site Kluane River is flowing north 53 degrees west or nearly parallel to the general trend of the foliation in this portion of Shawkak Trench. The foliation at the site strikes north 30 to 70 degrees west and dips northeasterly from 25 to 70 degrees. It intersects the River at angles from 20 to 30 degrees and dips toward the right abutment.

The above illustration presents diagrammatically the range of the direction and dip of local and regional foliation in rocks of the Yukon Group exposed at and near Kluane Canyon dam site

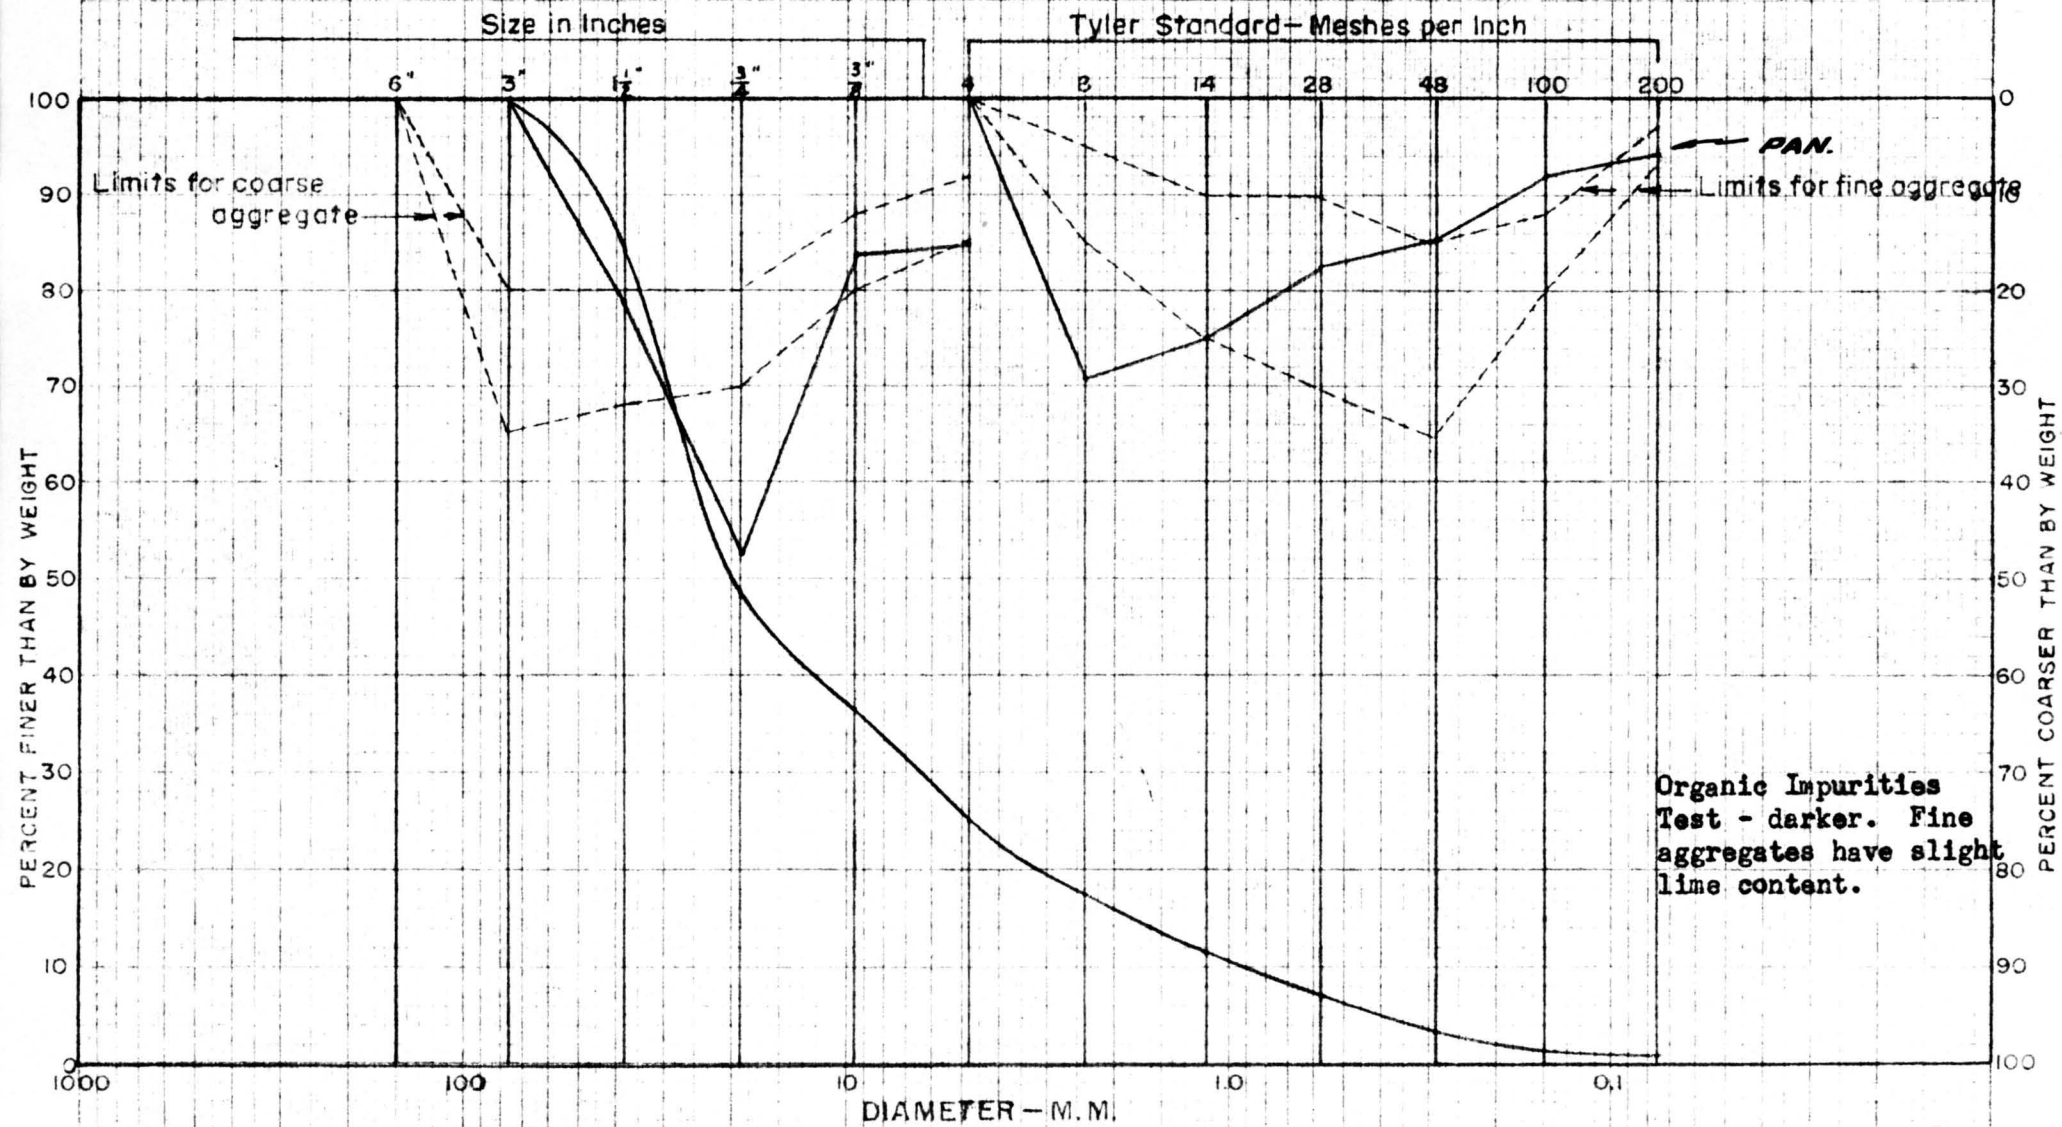
Site Yukon Basin Hole No.          Sample No. 23 Depth          Plotted          Date           
 Study 1961

| Sample Number | Location | Field Description of Material | Field Description of Overburden | Thickness of Deposit | Areal Extent (Estimated) | Remarks |
|---|---|---|---|---|---|---|
| 23 | Pit on south side of Alaska Highway at mile 1095.2; 5 feet below ground surface. | Well graded, sandy gravel; very little silt; many pebbles in the 1- to 3-inch range; a few rounded boulders up to 12 inches; roughly stratified; material is similar to alluvial gravels immediately downstream from Lower Canyon dam site on White River.<br><u>Pebble and Cobble Lithology</u><br>Granitic (granite, syenite) - 40%<br>Volcanic (ryholite, andesite, basalt) - 30%<br>Sedimentary (sandstone, limestone) - 20%<br>Metamorphic (gneiss, schist) - 10% | 3 feet of silt and fine sand. | 10+ feet | Unlimited; pit is 500 feet wide, 1,000 feet long and average 10 feet in depth. | Material was crushed to 1-inch size and used to surface Burwash Flight Landing strip. |

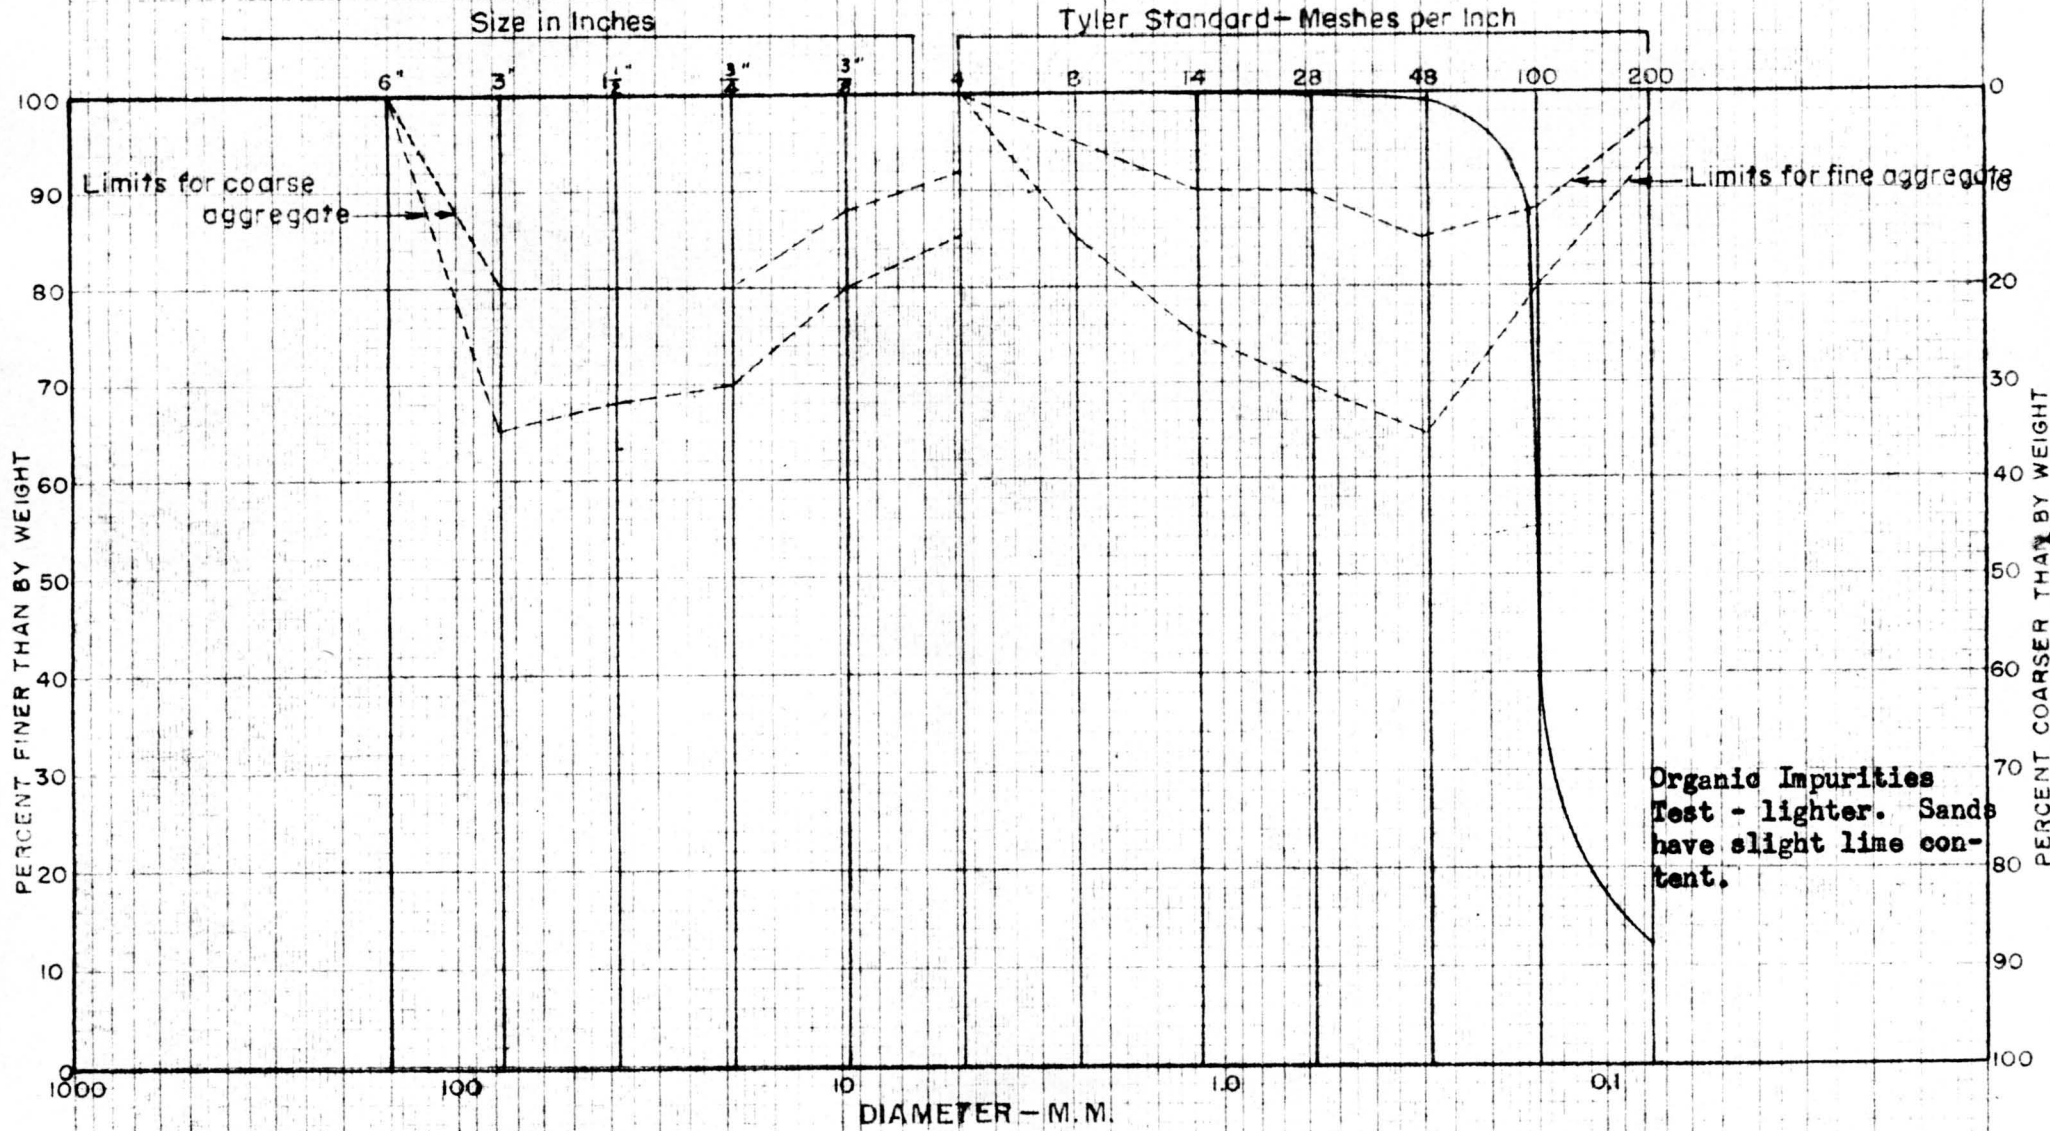
Site - Yukon Basin Study 1961 Hole No. Sample No. 26 Depth Plotted Date

| Sample Number | Location | Field Description of Material | Field Description of Overburden | Thickness of Deposit | Quantity Available | Permeability (cm./sec.) |
|---|---|---|---|---|---|---|
| 26 | From a 35-foot bluff on right side of Kluane River; 1,000 feet downstream from rock outcrop; 18 feet below ground surface and 4 feet below till. | Poorly graded (well sorted), fine-grained sand; loose when dry; about 10 percent silt; underlies till. | 24 inches of silt. | 10+ feet | Limited | $10^{-3}$ |

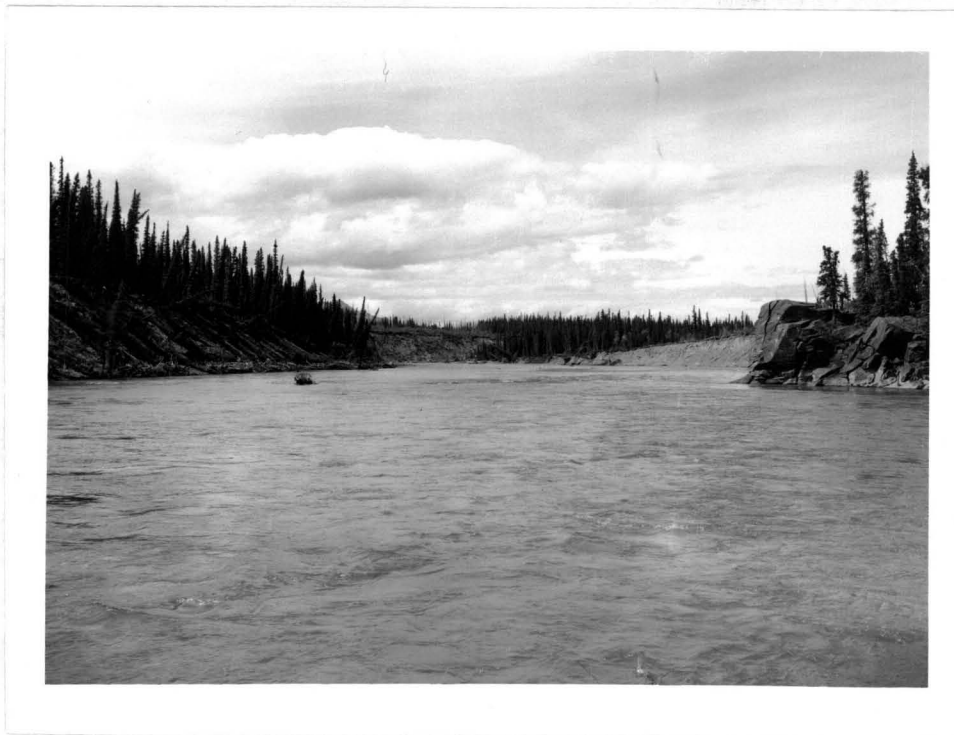
Plate 1

Kluane Canyon looking downstream; it is proposed that bedrock on the right side of the photograph form the right abutment of the dam and that either the till bluff directly opposite or bedrock exposed some 150 feet upstream form the left abutment.

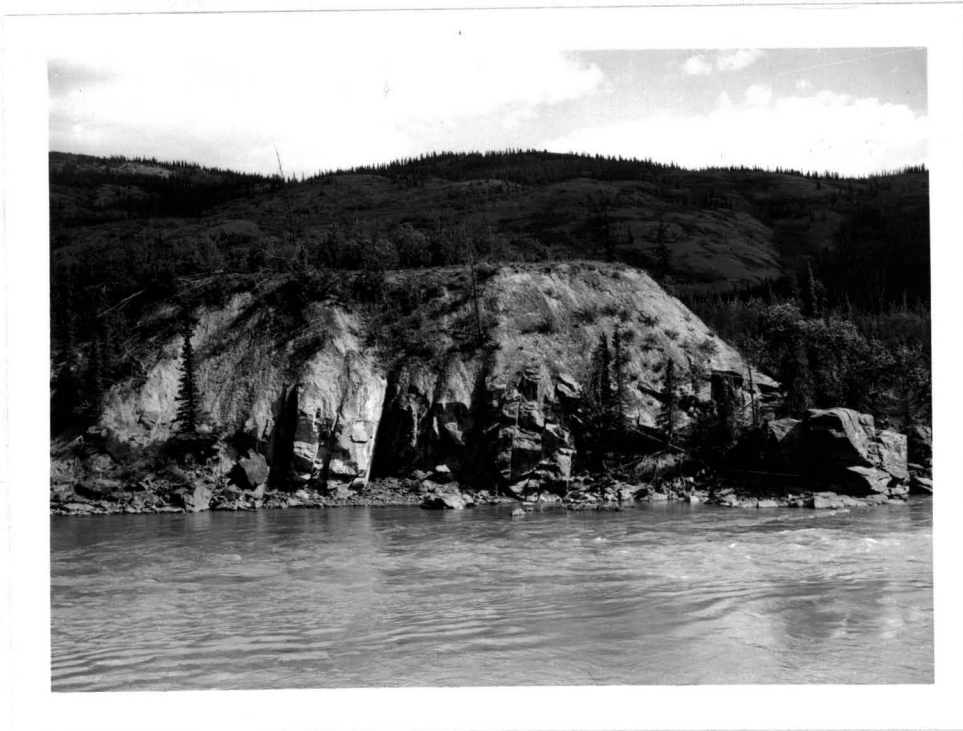
Plate 2

Right abutment; prominent jointing in bedrock is parallel to the proposed axis and dips steeply downstream; northeast side of Shakwak Trench in background.
