Occasional Papers in Archaeology No. 16

THE *A.J. GODDARD*: RECONSTRUCTION AND MATERIAL CULTURE OF A
KLONDIKE GOLD RUSH STERNWHEELER

The *A.J. Goddard*, a steamboat built for the Klondike Gold Rush of 1897-1898, wrecked in 1901 on Lake Laberge, Yukon Territory. It lay undisturbed until its rediscovery in 2008. The complete and undisturbed nature of the wreck site, which is the only known site from this period to show such remarkable preservation, provides an unparalleled opportunity for studying the construction features of one of the Klondike steamboats and its associated material culture.

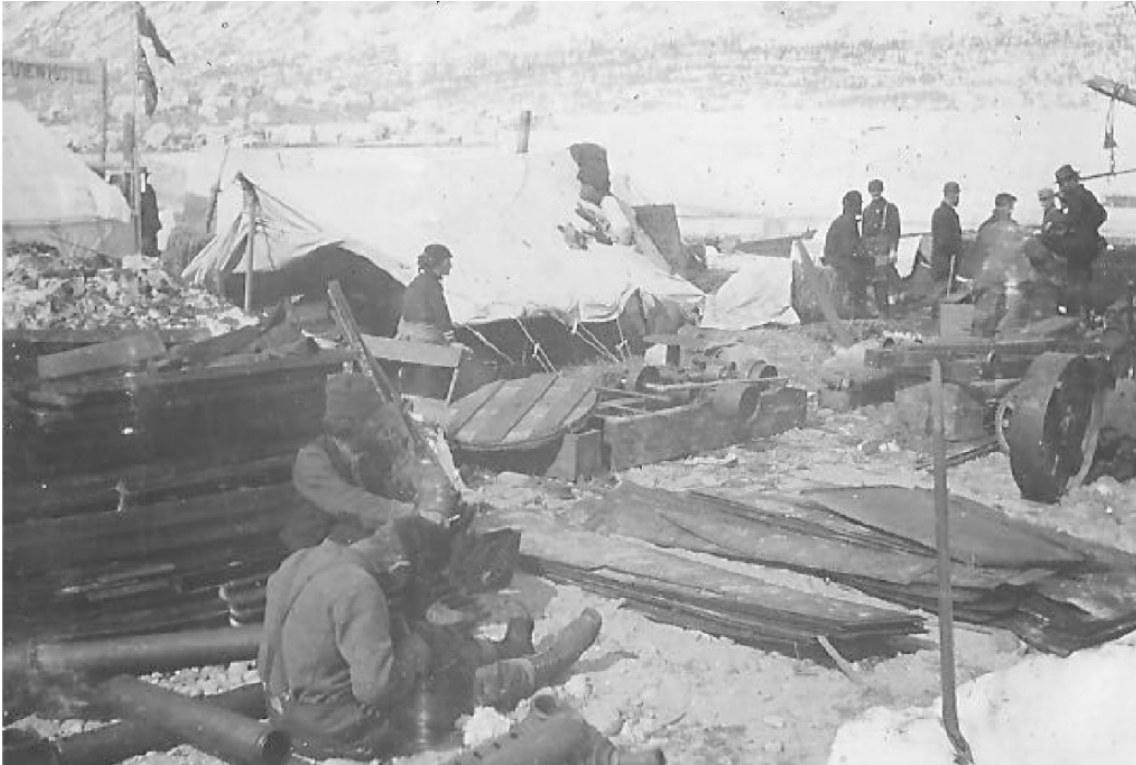
FIGURE 3.12. The steamboats *A.J. Goddard* and *F.H. Kilbourne* being assembled at Lake Bennett (Goddard collection, courtesy of Fay Goddard).

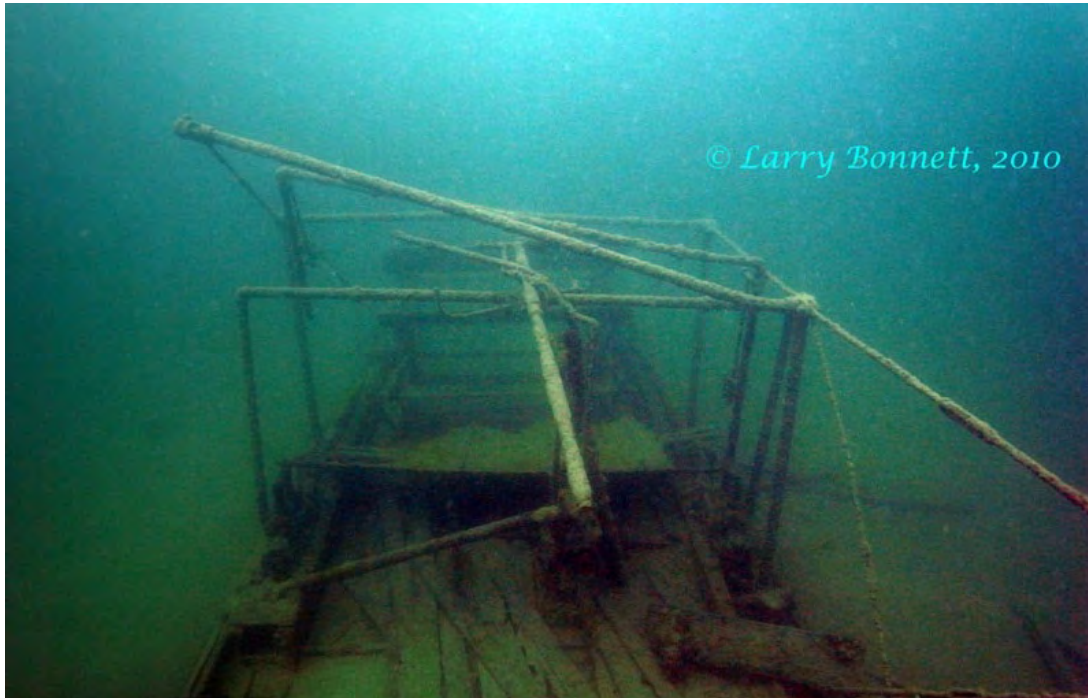
Though this ice is clearly too thin to affect the site directly, it may have indirectly caused damage to the hogging system in the stern (Figure 3.6). While it is impossible to determine with certainty what caused this damage, the submerged root mass of a large 45-foot long (15 m) dead tree, called a dead-head, became stuck or anchored upright in the approximate location of the *A.J. Goddard* for two years approximately 20 years ago (Jenine Caruthers 2010, pers. comm. per Doug Davidge). The ice that annually forms on the surface of the Lake surrounded the top of the dead tree at the surface, and any movement by the ice would exert more pressure upon the tree and thus upon the hogging system that it may have been stuck in. If the heavy root mass of the dead tree was indeed trapped in the hogging system, wind and wave driven movement of the ice would have caused great pressure on the tree, bending the hogging system and steam pipes until the tree could break free. The ice would need to move only approximately two ft. (0.61 m) to cause the damage seen on the wreck.

FIGURE 3.6. Damage to the hogging system in the stern (Photo by Larry Bonnett).

the boat settled into the sediment 25 ft. (7.62 m) below the surface of the Lake. The boat stayed relatively undisturbed by physical forces after this point, until structural damage was caused to the hogging system and steam pipes at the stern of the boat.

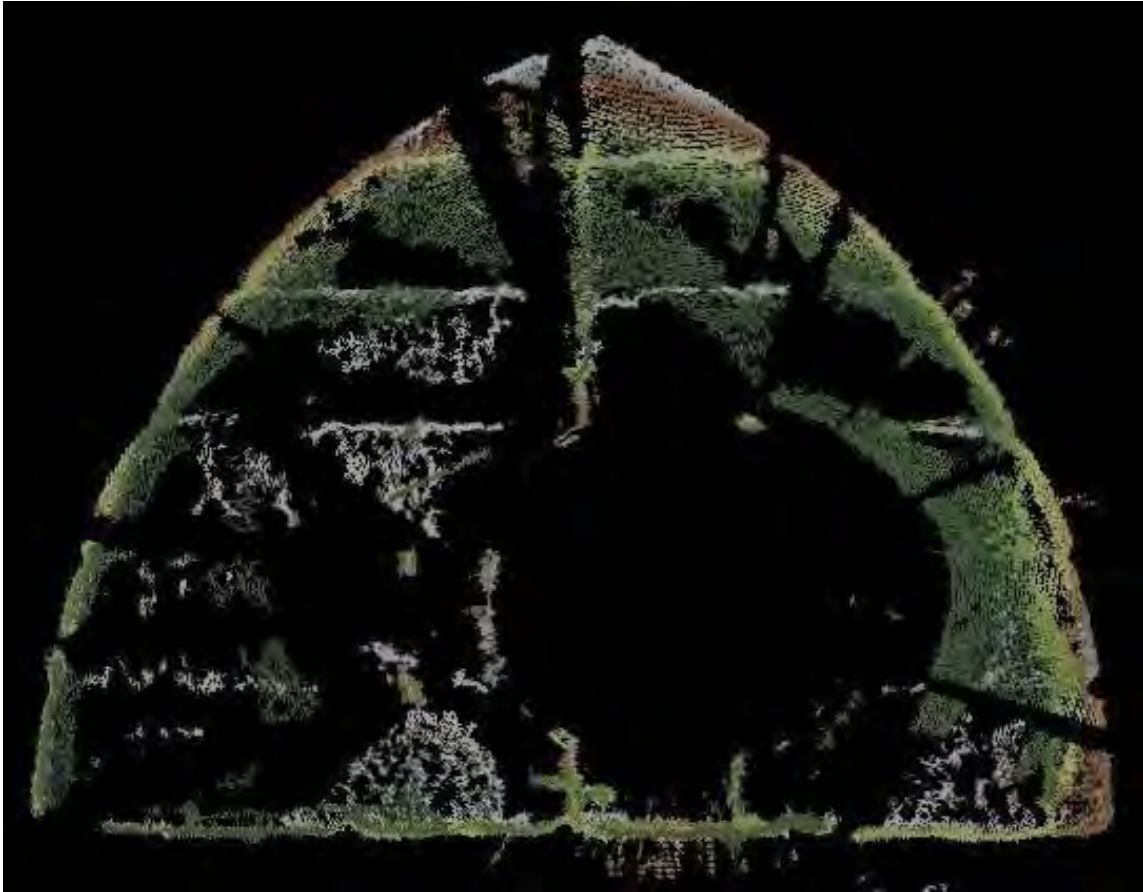
FIGURE 4.10. Interior scan of the *A.J. Goddard's* bow showing deck beams (Courtesy of BlueView Technologies and OceanGate Inc.).

While the BV-5000 can quickly give an accurate overview of the boat and general dimensions, details such as rivets and small artifacts cannot be captured with the BV-5000. Because of this, it is necessary to continue mapping with a slate and tape in order to obtain more detailed measurements. The most useful aspect of the BV-5000 for the 2010 *A.J. Goddard* project was its ability to be suspended inside remote sections of the hold, which was inaccessible to divers due to the small size of the hatches and hold. Hull construction details that were otherwise inaccessible to divers, such as the spacing of deck beams, were visible and measurable on the computer screen within minutes of the scan (Figure 4.10).

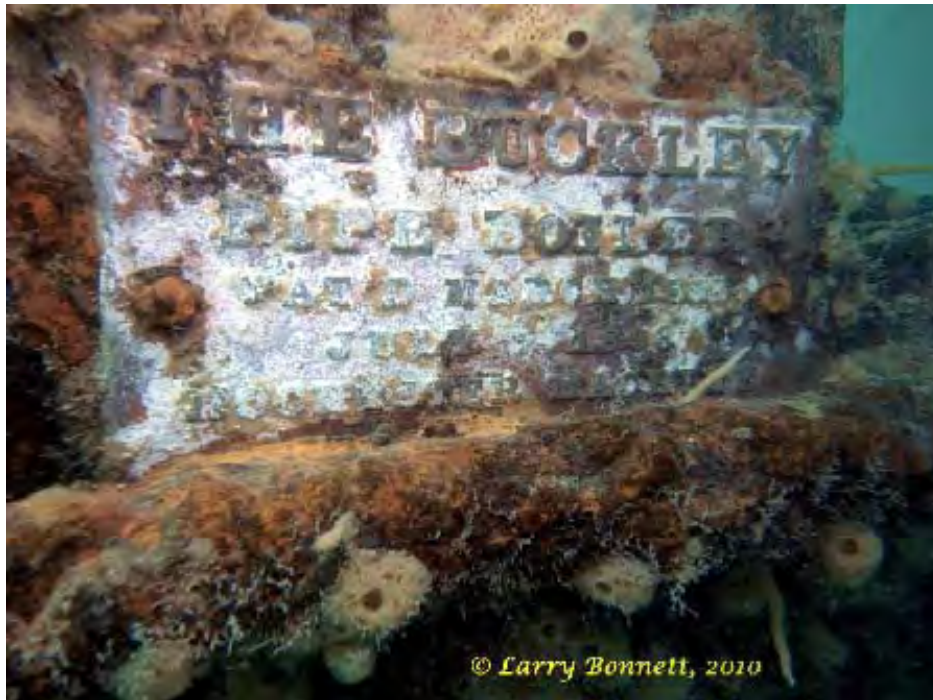
FIGURE 5.8. Boiler name plate. (Photo by Larry Bonnett).

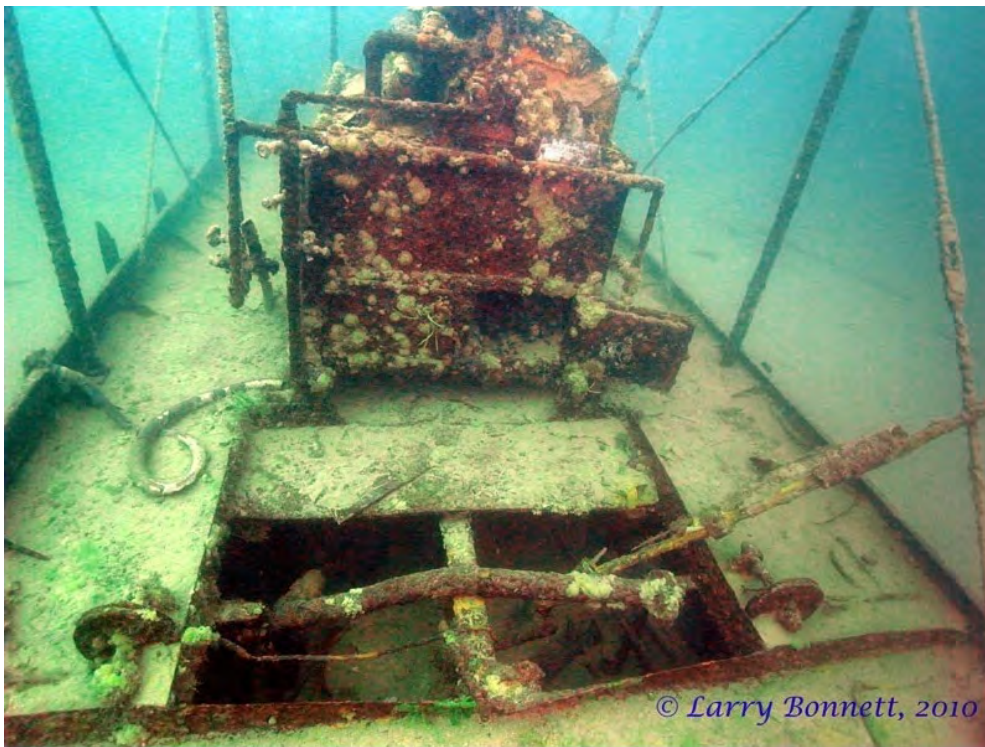
FIGURE 5.9. Boiler and largest set of hatches (Photo by Larry Bonnett).

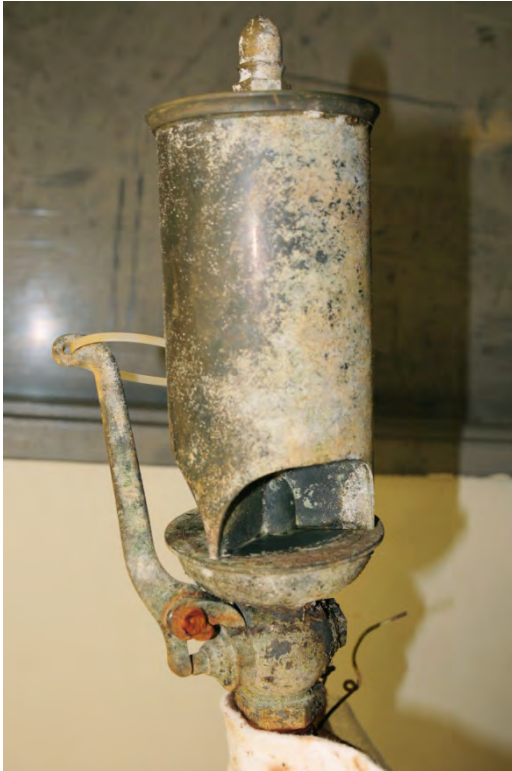
FIGURE 5.10. Steam whistle.
(Yukon Government).

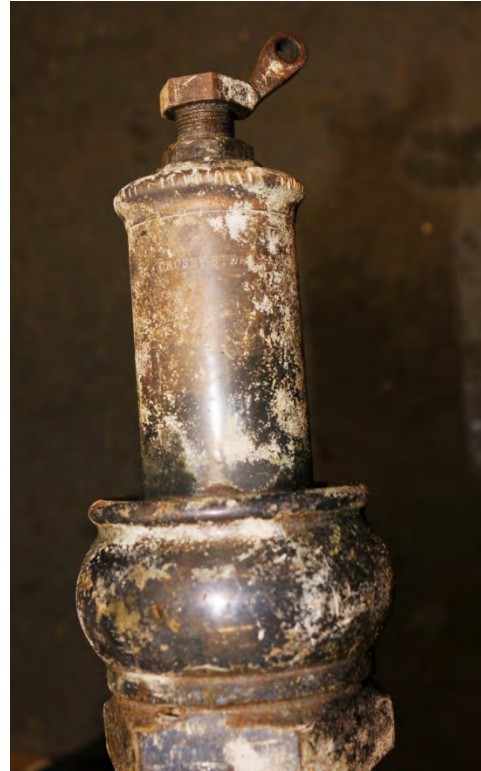
FIGURE 5.11. Safety valve.
(Yukon Government).

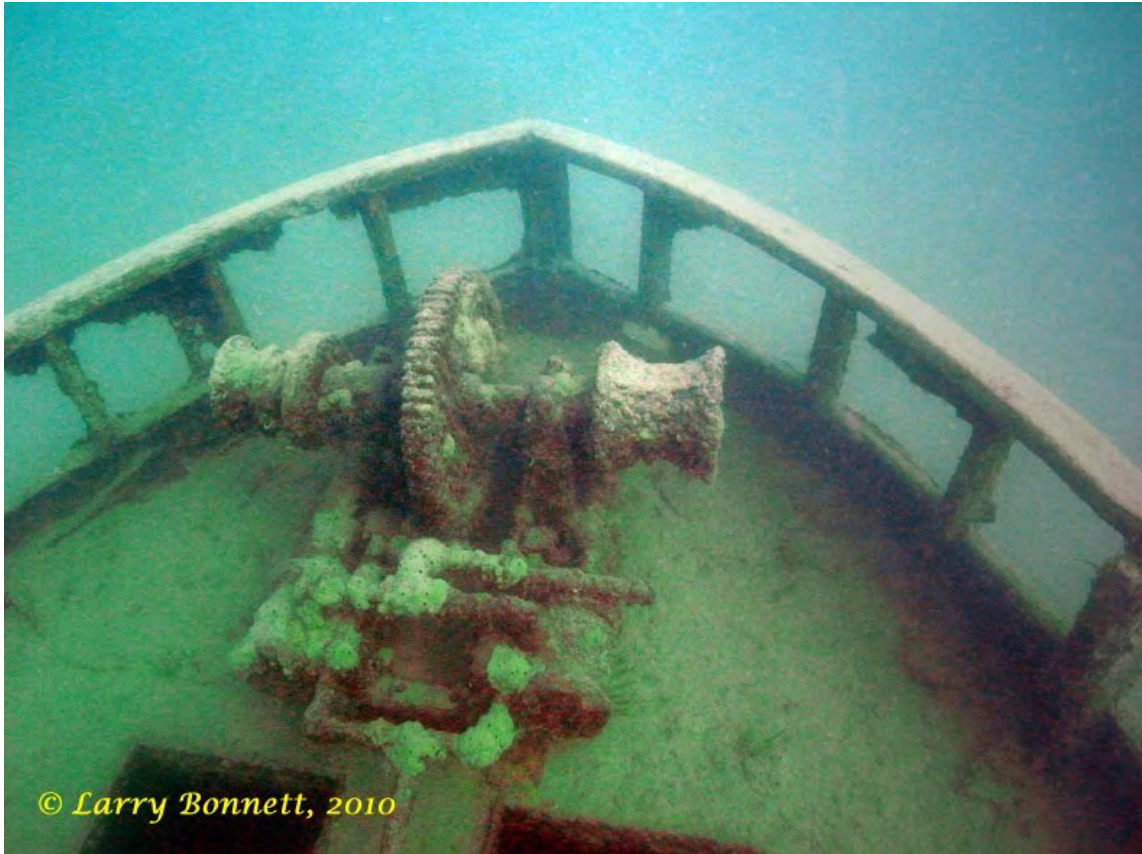
FIGURE 5.13. Windlass (Photo by Larry Bonnett).

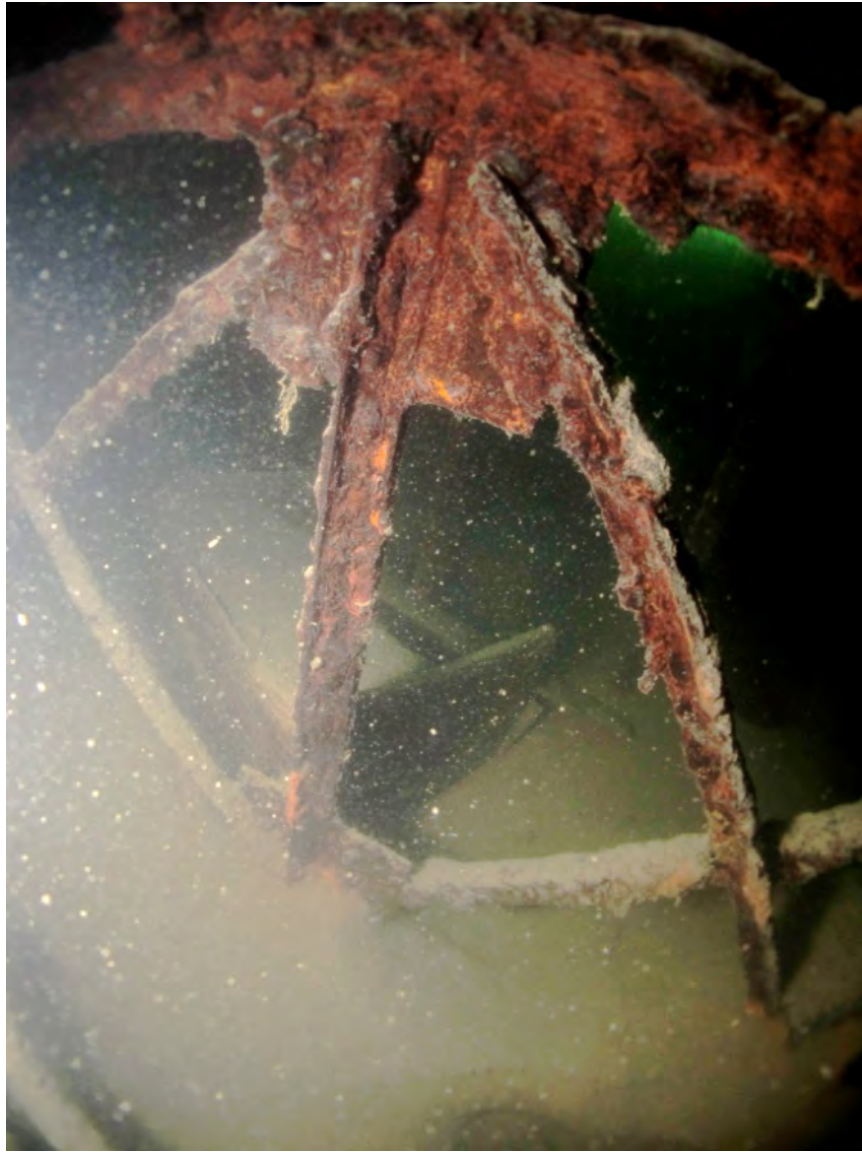
FIGURE 5.15. Diagonal trusses inside the hold (Photo by Geoff Bell).

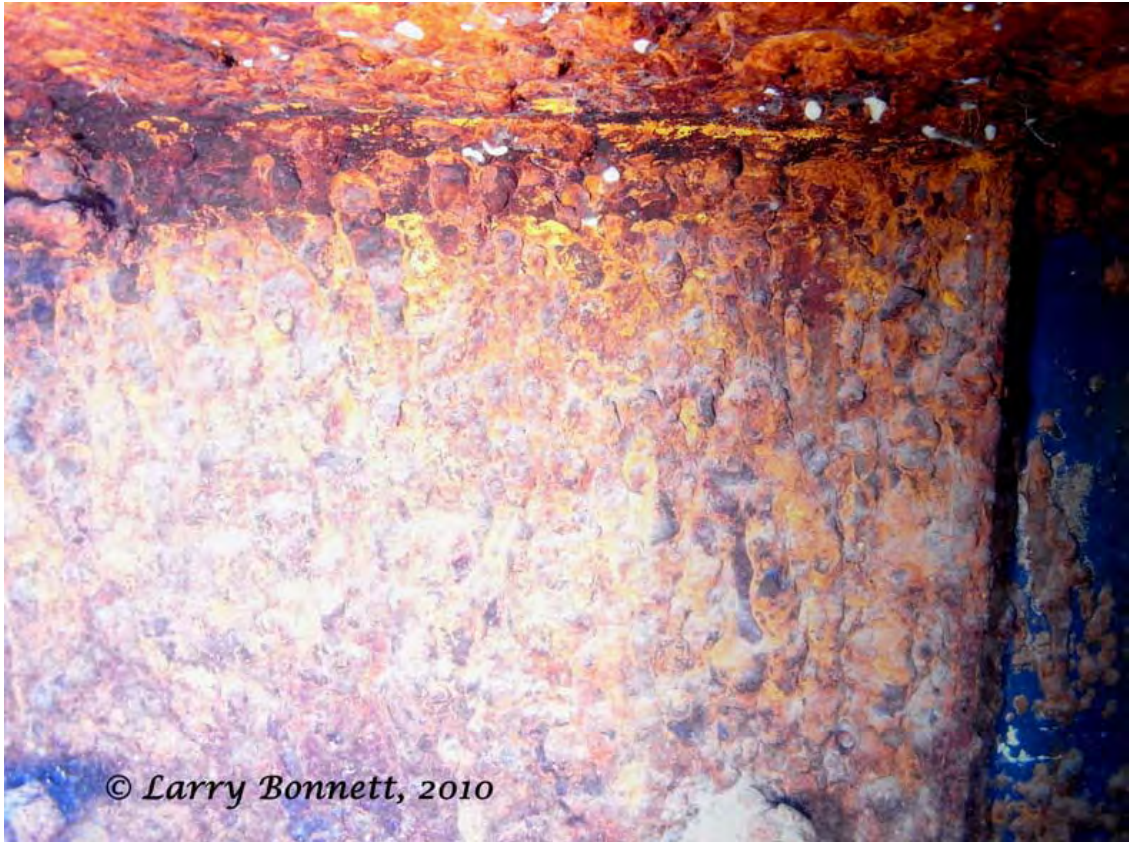
FIGURE 5.16. 2 in. (5.08 cm) angle iron clamp underneath deck (Photo by Larry Bonnett).

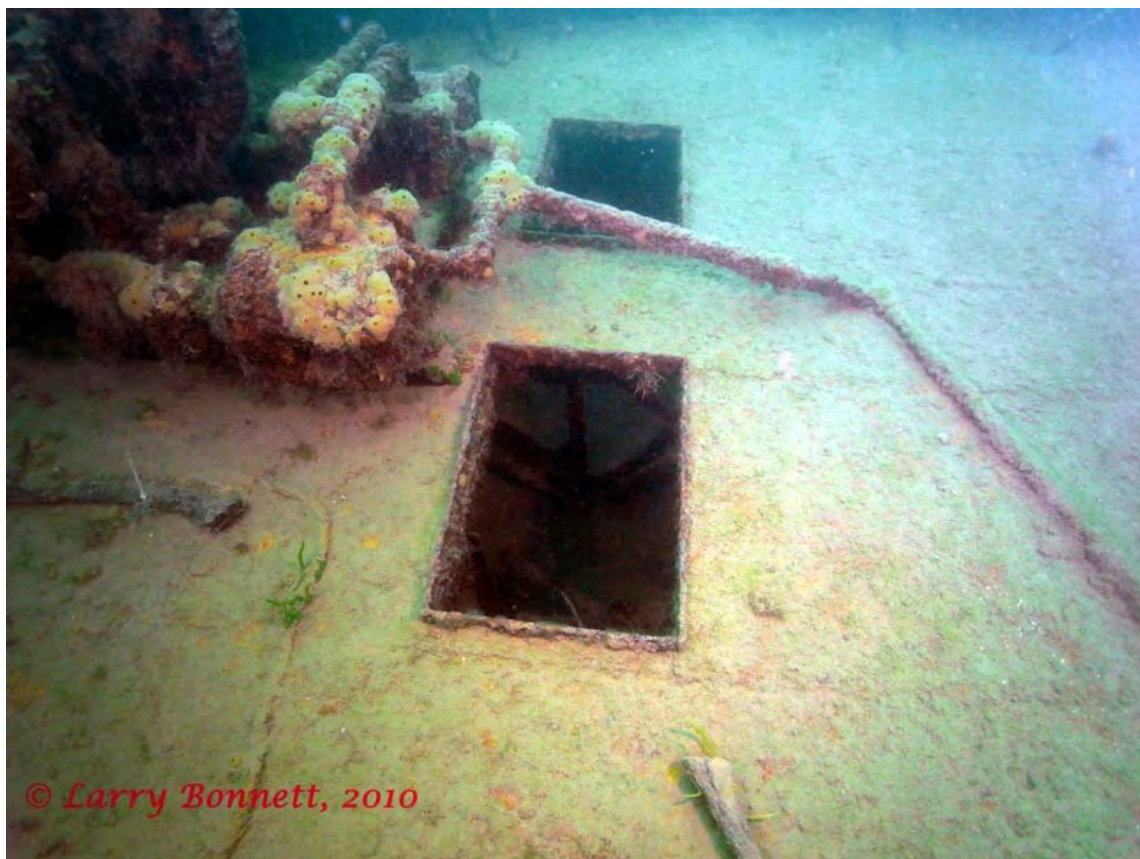
FIGURE 5.18. Chain lockers aft of windlass (Photo by Larry Bonnett).

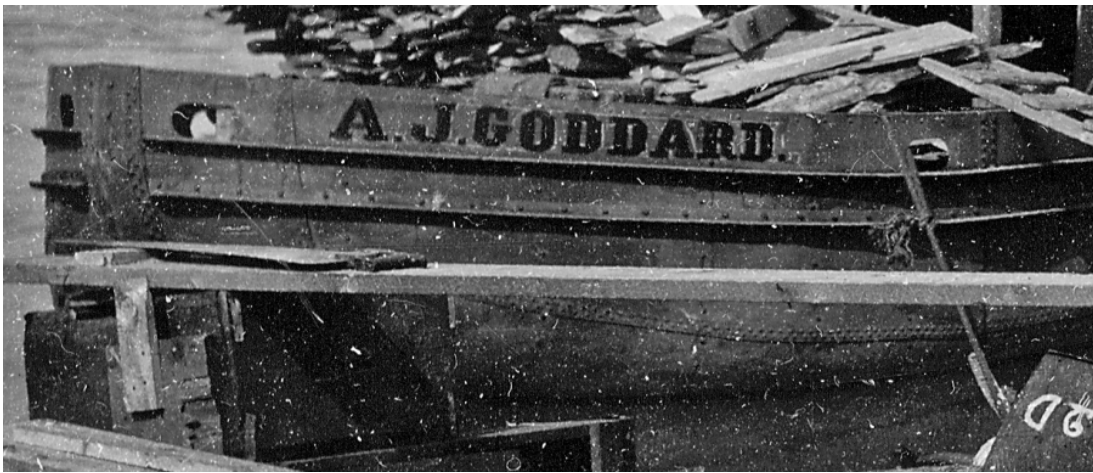
FIGURE 5.19. Rivet pattern on hull (Candy Waugaman Collection, Klondike Gold Rush National Historic Park, National Parks Service, U.S. Department of the Interior).

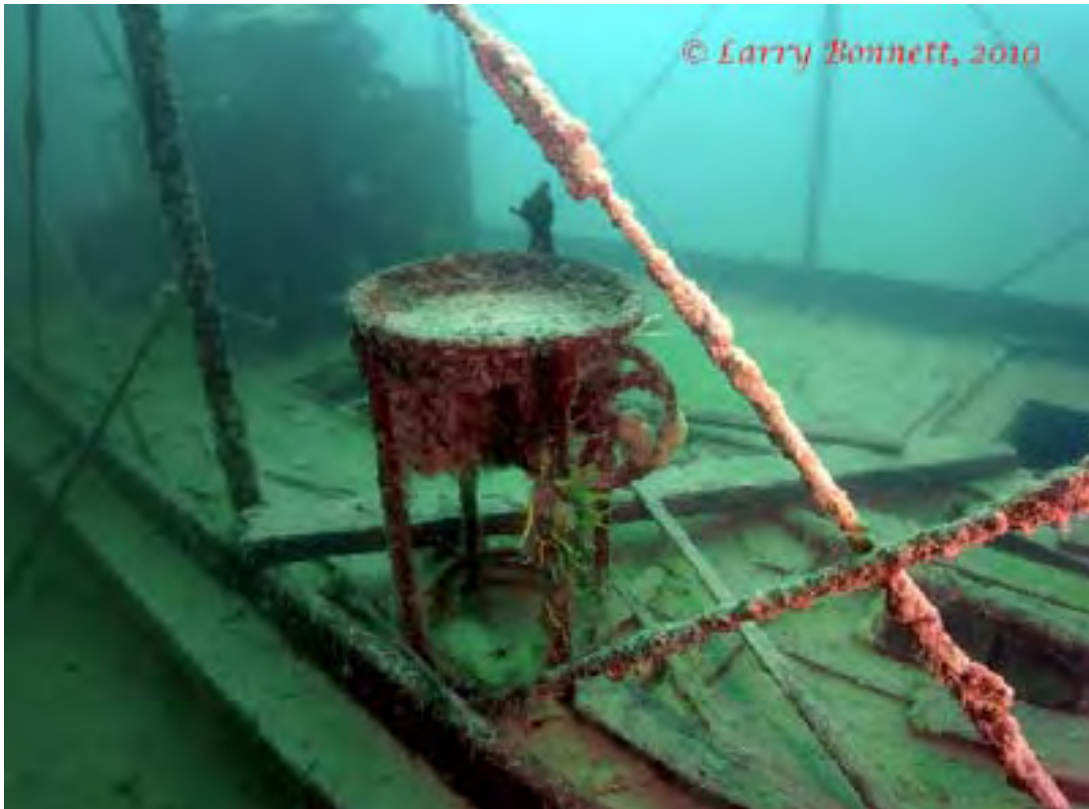
FIGURE 7.1. Forge on the deck (Photo by Larry Bonnett).
