Yukon Flood Study

May, 1974

YUKON FLOOD STUDY

NORTHERN NATURAL RESOURCES
AND ENVIRONMENT BRANCH
INDIAN AND NORTHERN AFFAIRS
WHITEHORSE, YUKON TERRITORY

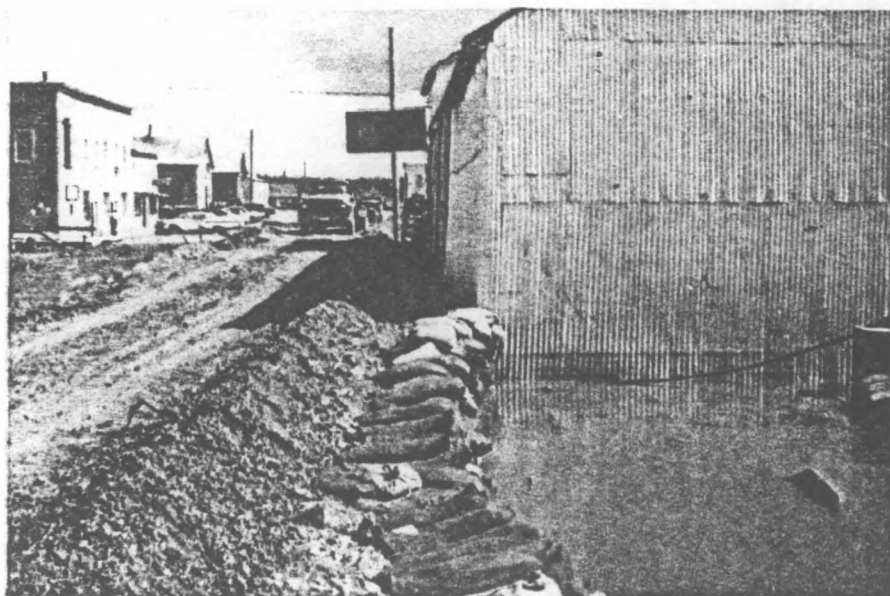
town. The dike was built along the Stewart River during the flood and was raised along the Mayo River. Consolidation of the dike was done with sand bags. This flood was due to an especially high snowfall in April and May. Fig. 8 to Fig. 11 show pictures taken during the construction of the dike and pictures of the dike in its present state. Sand bagging is illustrated on Fig. 13.

Fig. 8 - 1964 Flood
Dike
Construction.

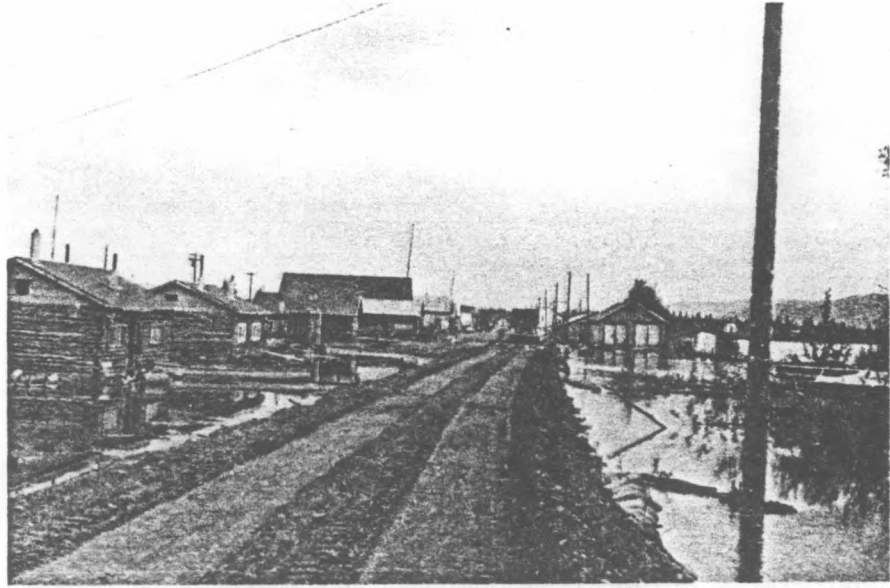
Fig. 11 - Construction of the dike during the 1964 Flood.

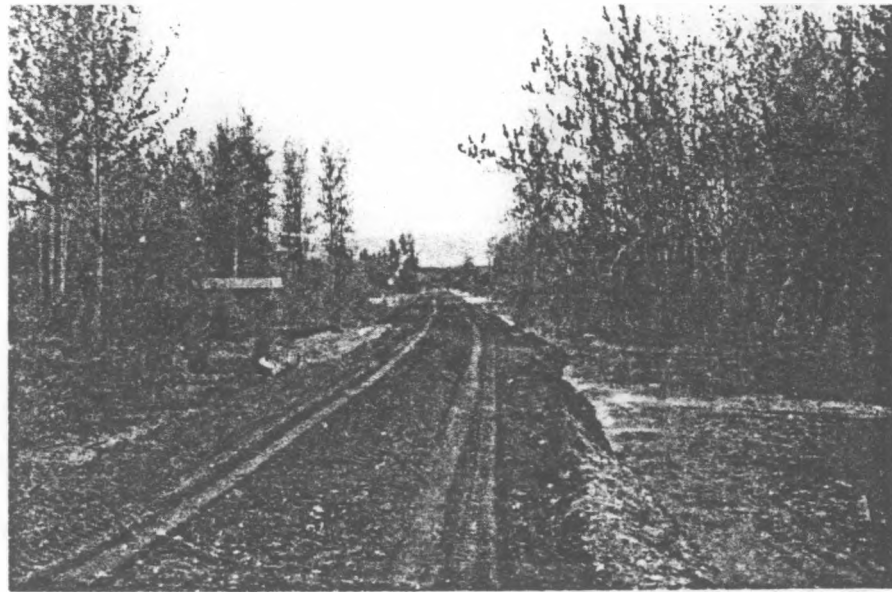
Fig. 13 - Construction of the dike along the Mayo River
1964 Flood.

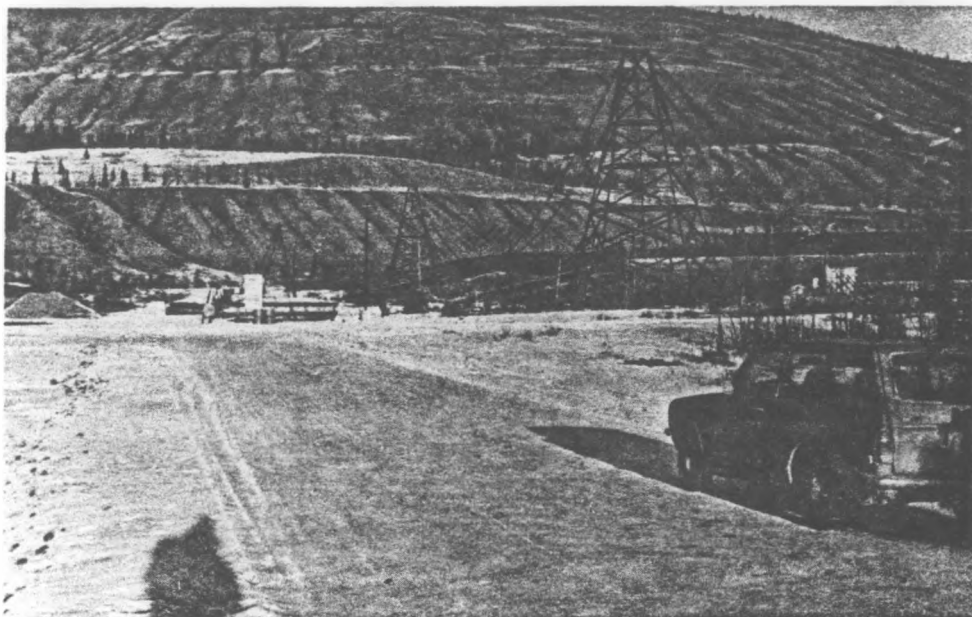
Fig. 19 - November, 1973 - Similar view.

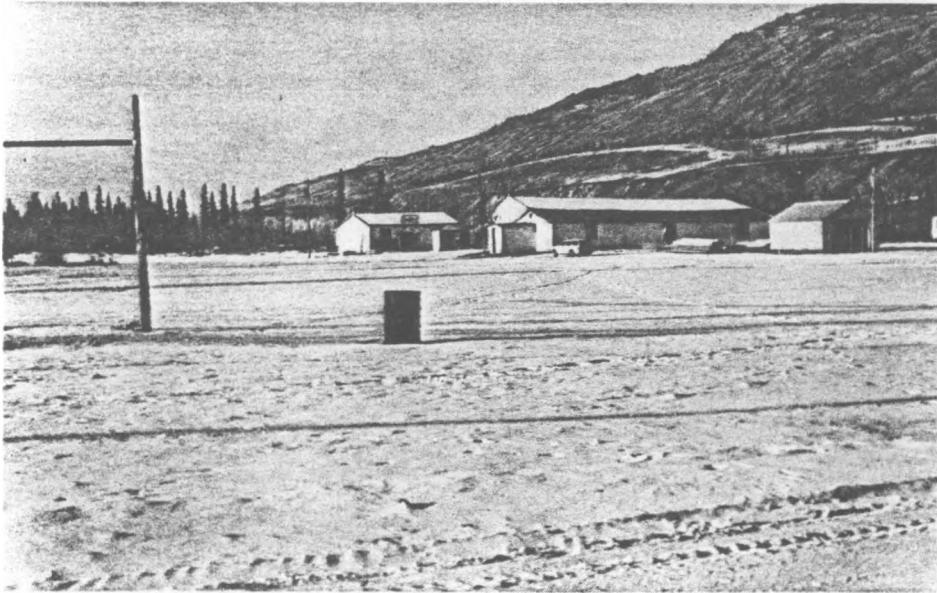
Fig. 21 - Similar view - November, 1973.

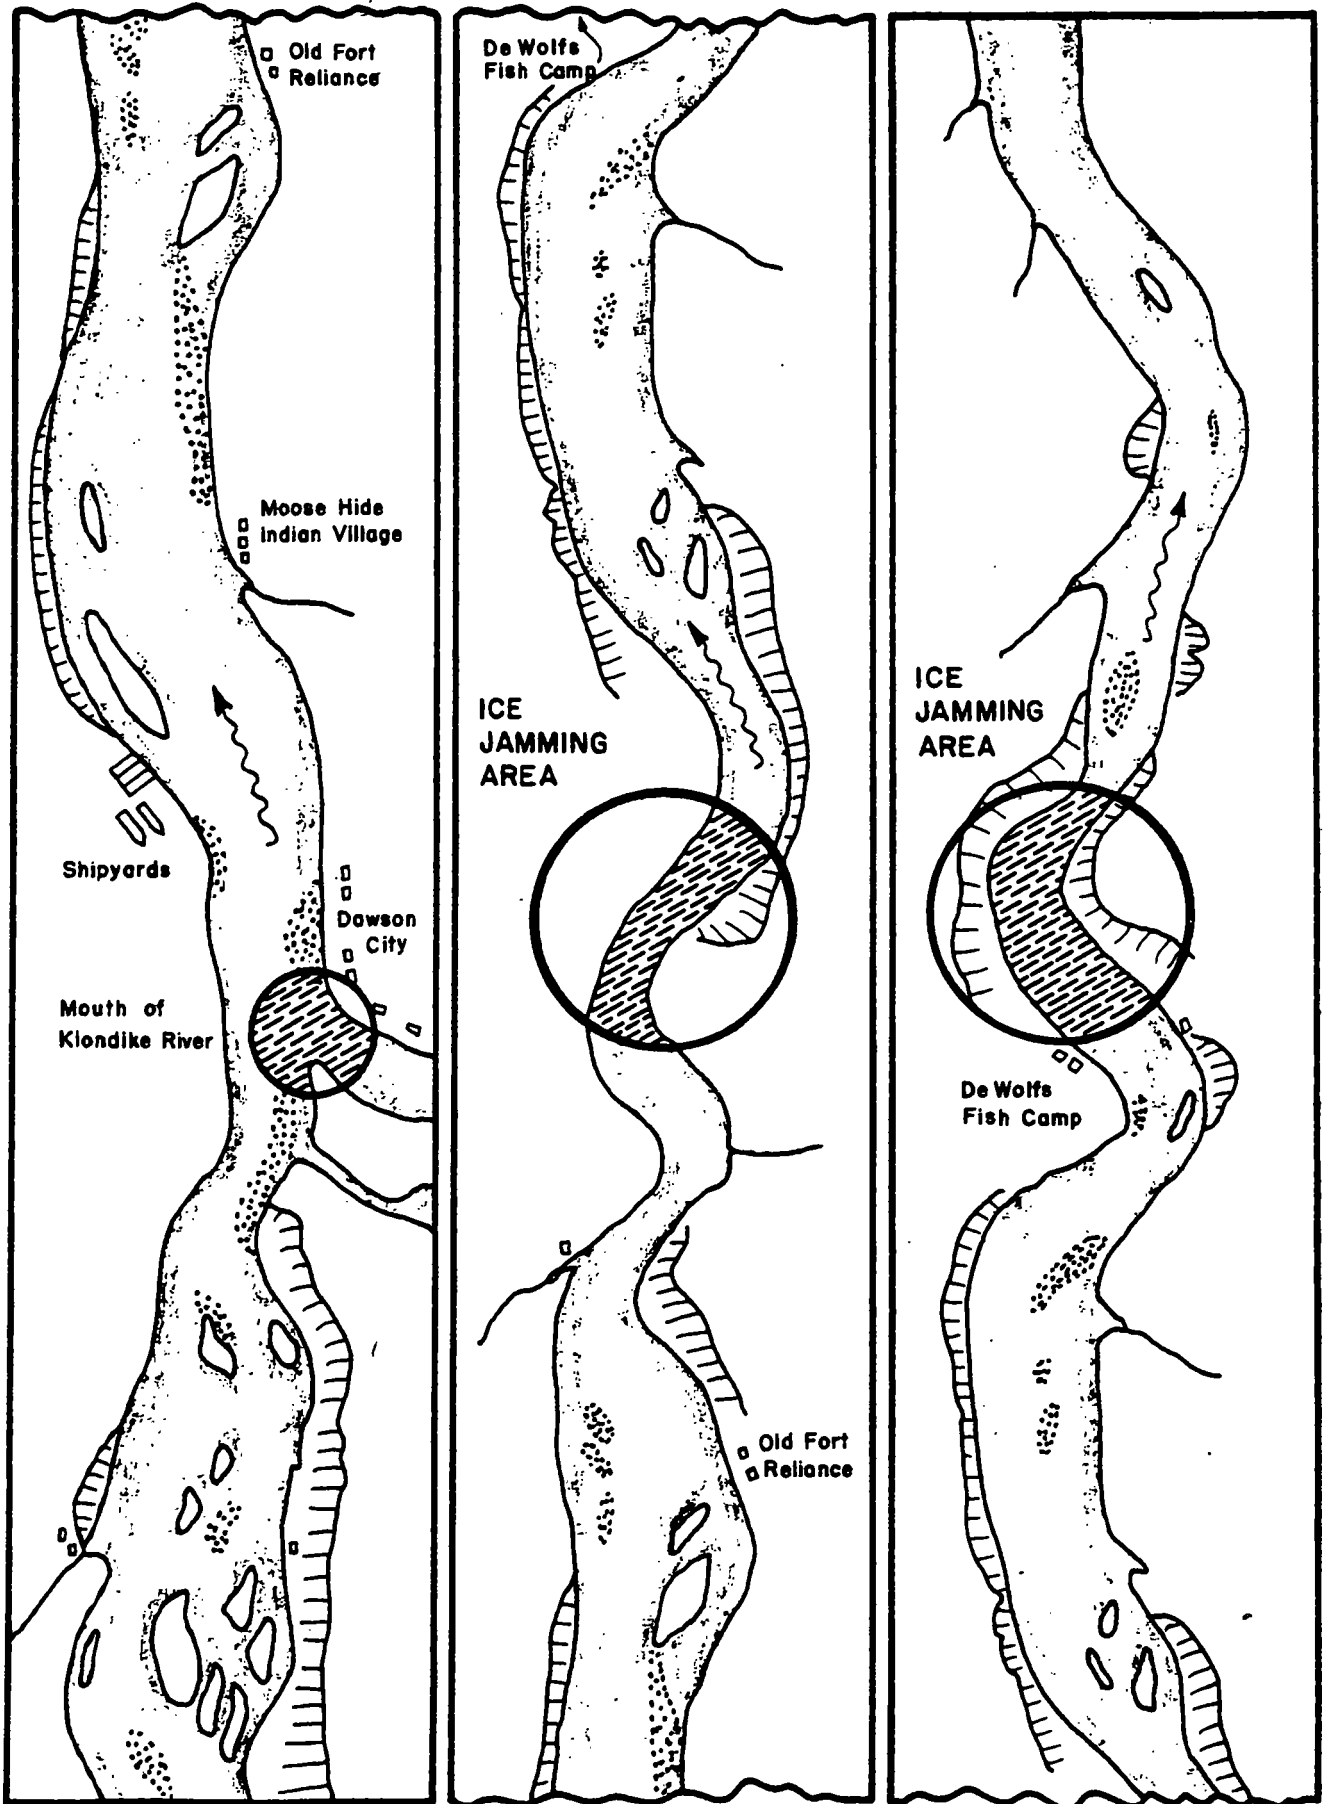
Fig. 38 shows the most common locations of the jams on the Yukon River in the vicinity of Dawson.

LOCATION OF ICE JAMMING

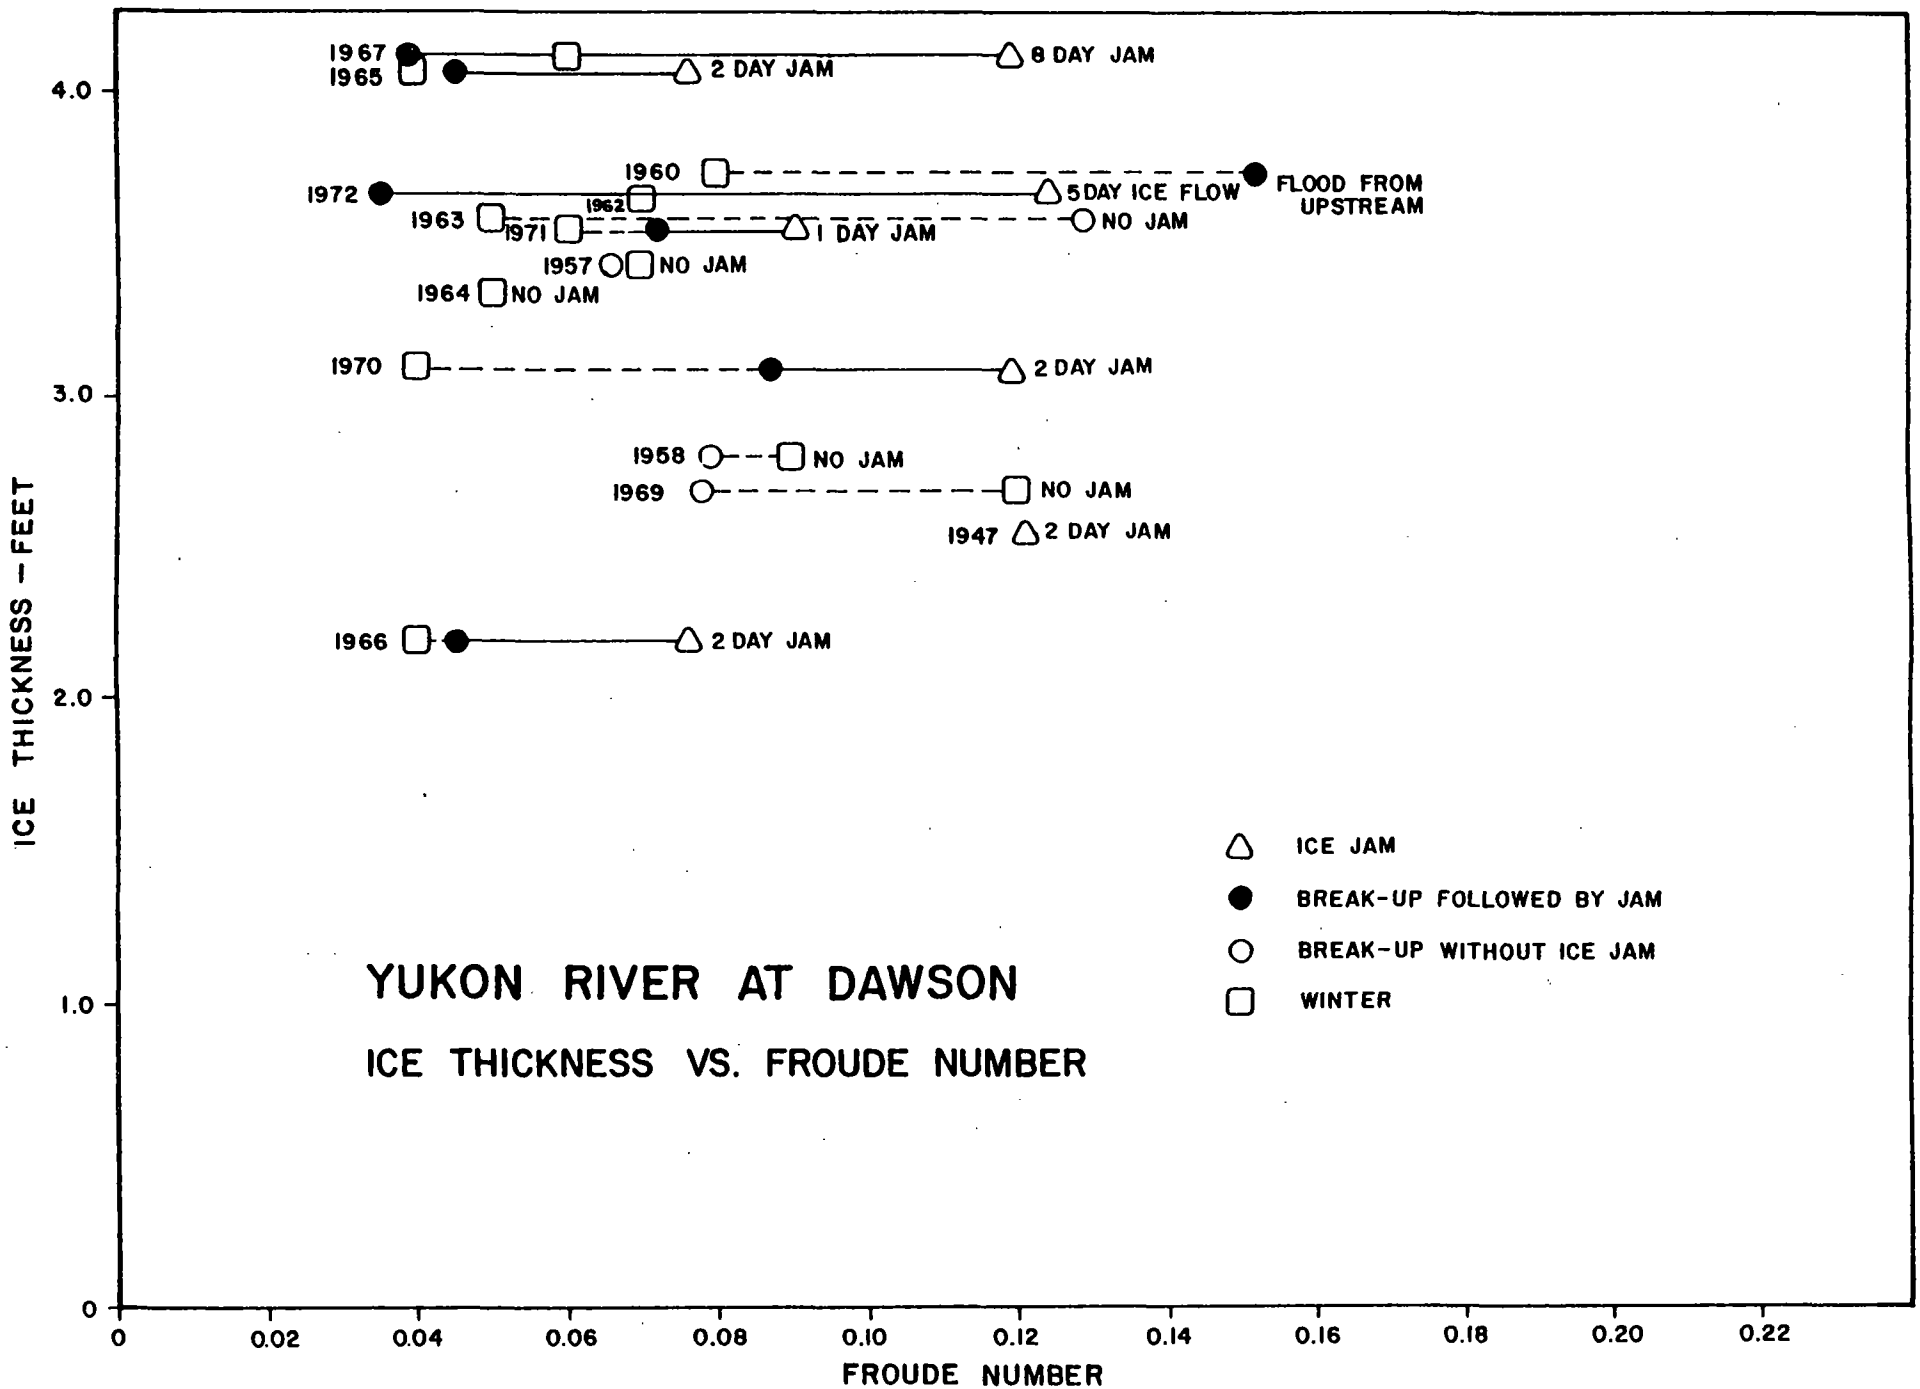
Fig. 39

2. The hydraulic considerations seem to be the governing factor for ice break-up and jamming. An upper limit of the Froude number is found in order to start a break-up (Fig. 39). This upper limit does not seem to depend on ice thickness. The Froude number varies from 0.04 to 0.12 for an ice thickness from 2 feet to 4 feet. Another upper limit is found for the break-up of ice jams. This limit is usually higher than the one to start a break-up, with a Froude number between 0.08 and 0.12. It shows that it takes a higher Froude number to break a jam than it takes to start the river break-up. It should be noted that the ice thickness used for this analysis was measured at time ranging from March 23 in 1946, to May 1 in 1967. During the only year when two ice thickness measurements were undertaken (on March 7 and April 23 in 1969), it was found that the ice thickness varied only 0.39 feet from 2.68 to 2.29. Whithin the scope of this study, ice thickness was assumed to stay almost constant during the last two months prior to break-up and no

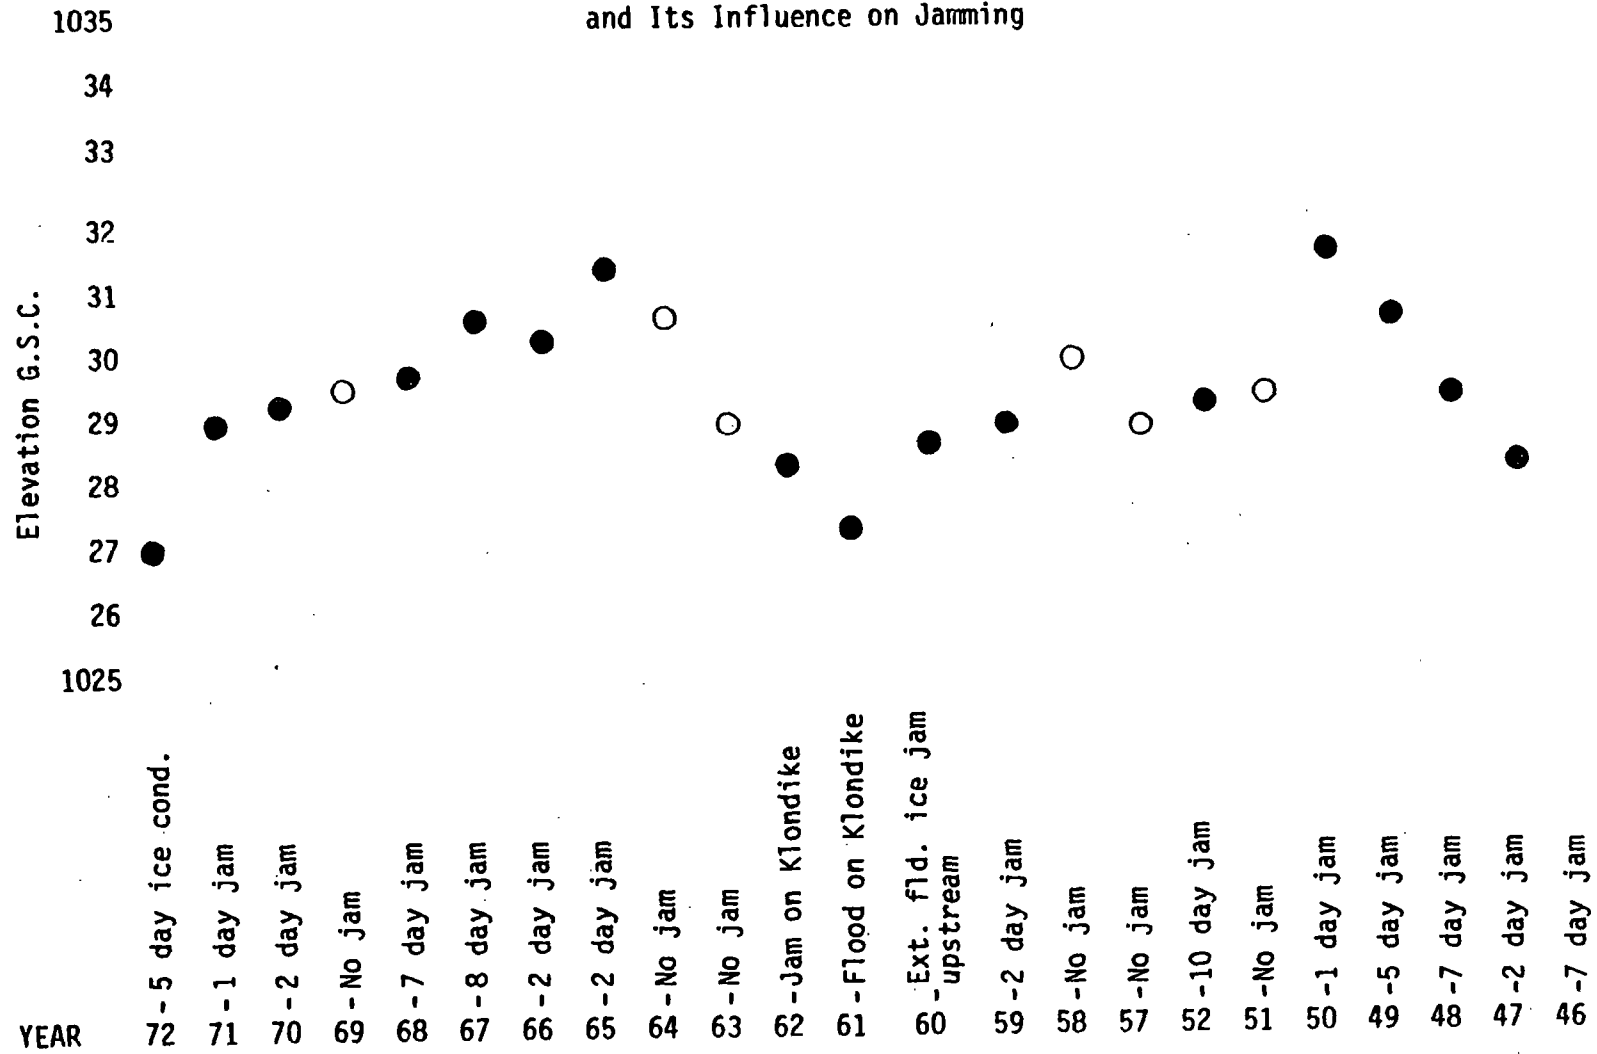
Fig. 40

3. Water elevation at the time of freeze-up has been plotted on Figure 40 for the years 1946 to 1973. Results show that this has very little influence on ice jamming, although there seems to be a slightly higher frequency of ice jam when water level was low at freeze-up time. In this case ice will freeze solid to the bottom in the shallow reaches of the river and cause more jams to form during spring, although this type of jam is the mildest one and causes least danger of flooding.

Water Elevation One Day Before Freeze-Up
and Its Influence on Jamming

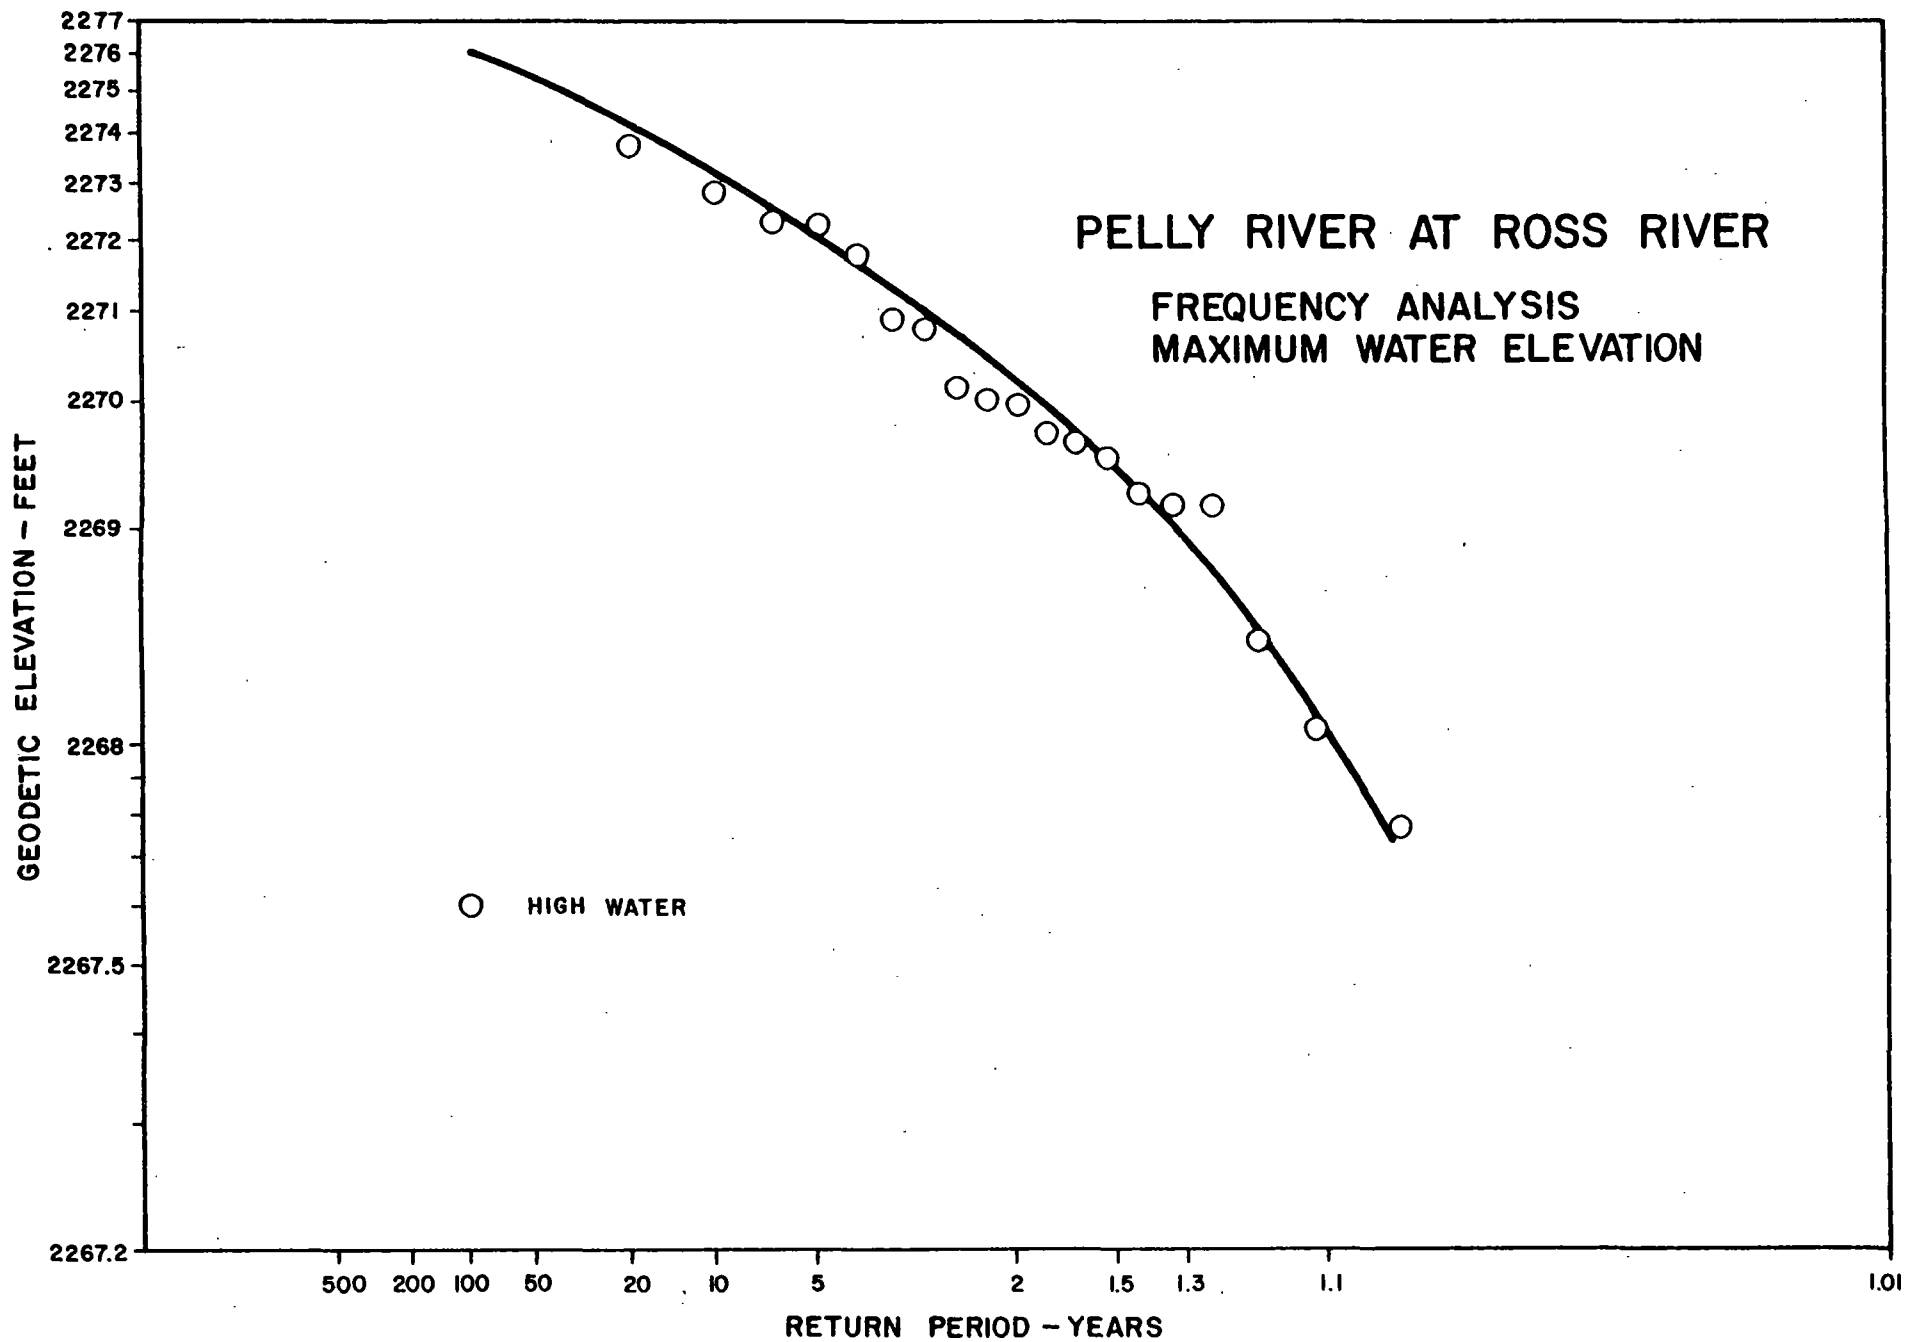
Fig. 42

A frequency analysis for the Pelly River at Ross River has been plotted on log probability paper (Fig 42). It shows that the 100 year return water elevation is 2276 G.S.C. On Fig. 43, the flooded parts of the settlement are shown for the elevation of 2276. Comparatively few houses will be under water for that elevation. The aerial photo 17 taken during the 1972 flood shows, by comparison, the level of the 1972 high water. It outlines very clearly that the two areas with low or no protection (hole in the middle of the east dike and north end of the community) are the most exposed to the floods. The dike, in its present condition, is of little help against high water during the floods; it

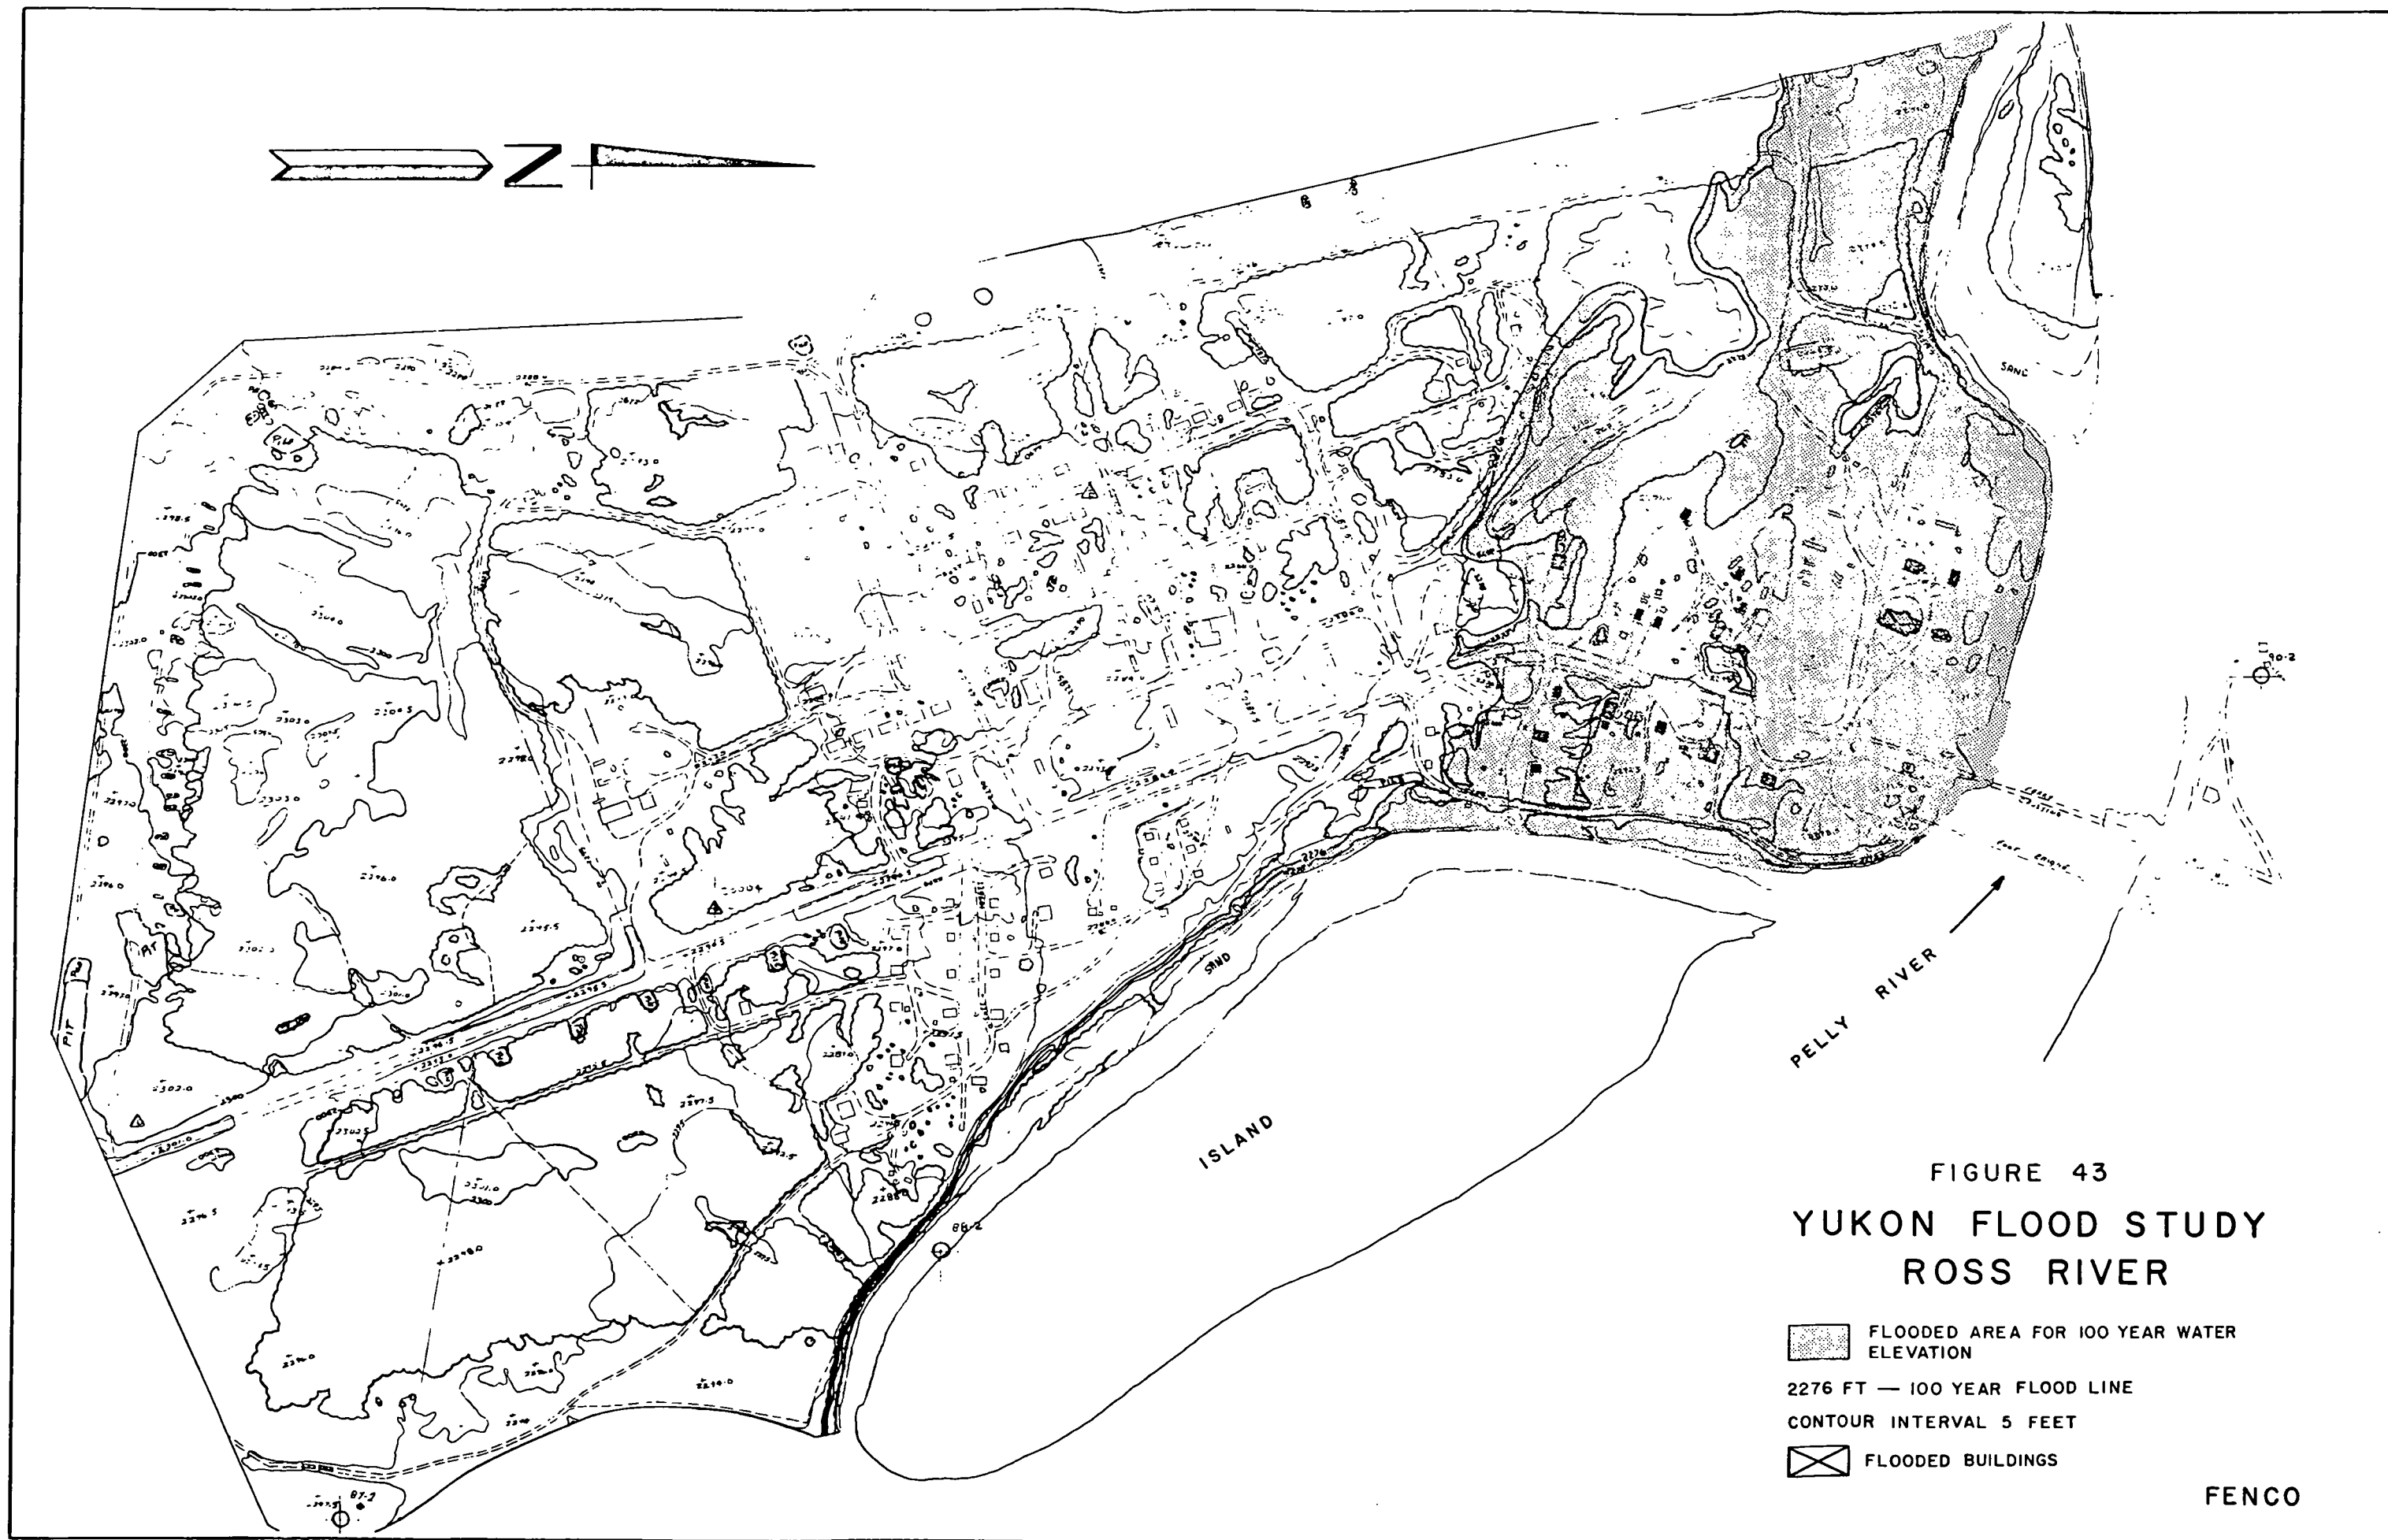
FIGURE 43
 YUKON FLOOD STUDY
 ROSS RIVER

FLOODED AREA FOR 100 YEAR WATER ELEVATION
 2276 FT — 100 YEAR FLOOD LINE
 CONTOUR INTERVAL 5 FEET
 FLOODED BUILDINGS

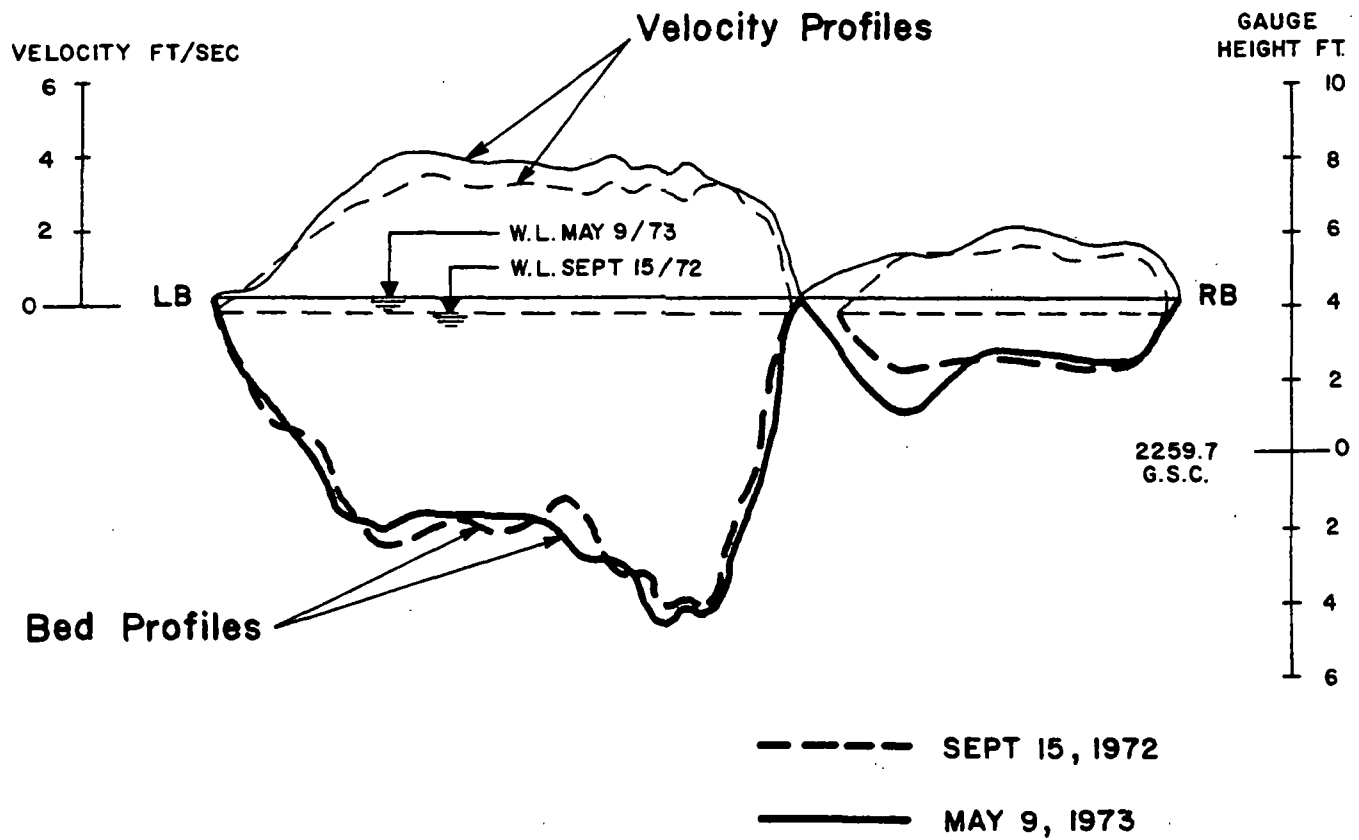
Fig. 44

1. Ice conditions in the winter do not change the bottom profile (Fig. 44).
2. Spring floods tend to equalize the bottom

WINTER RIVER REGIME

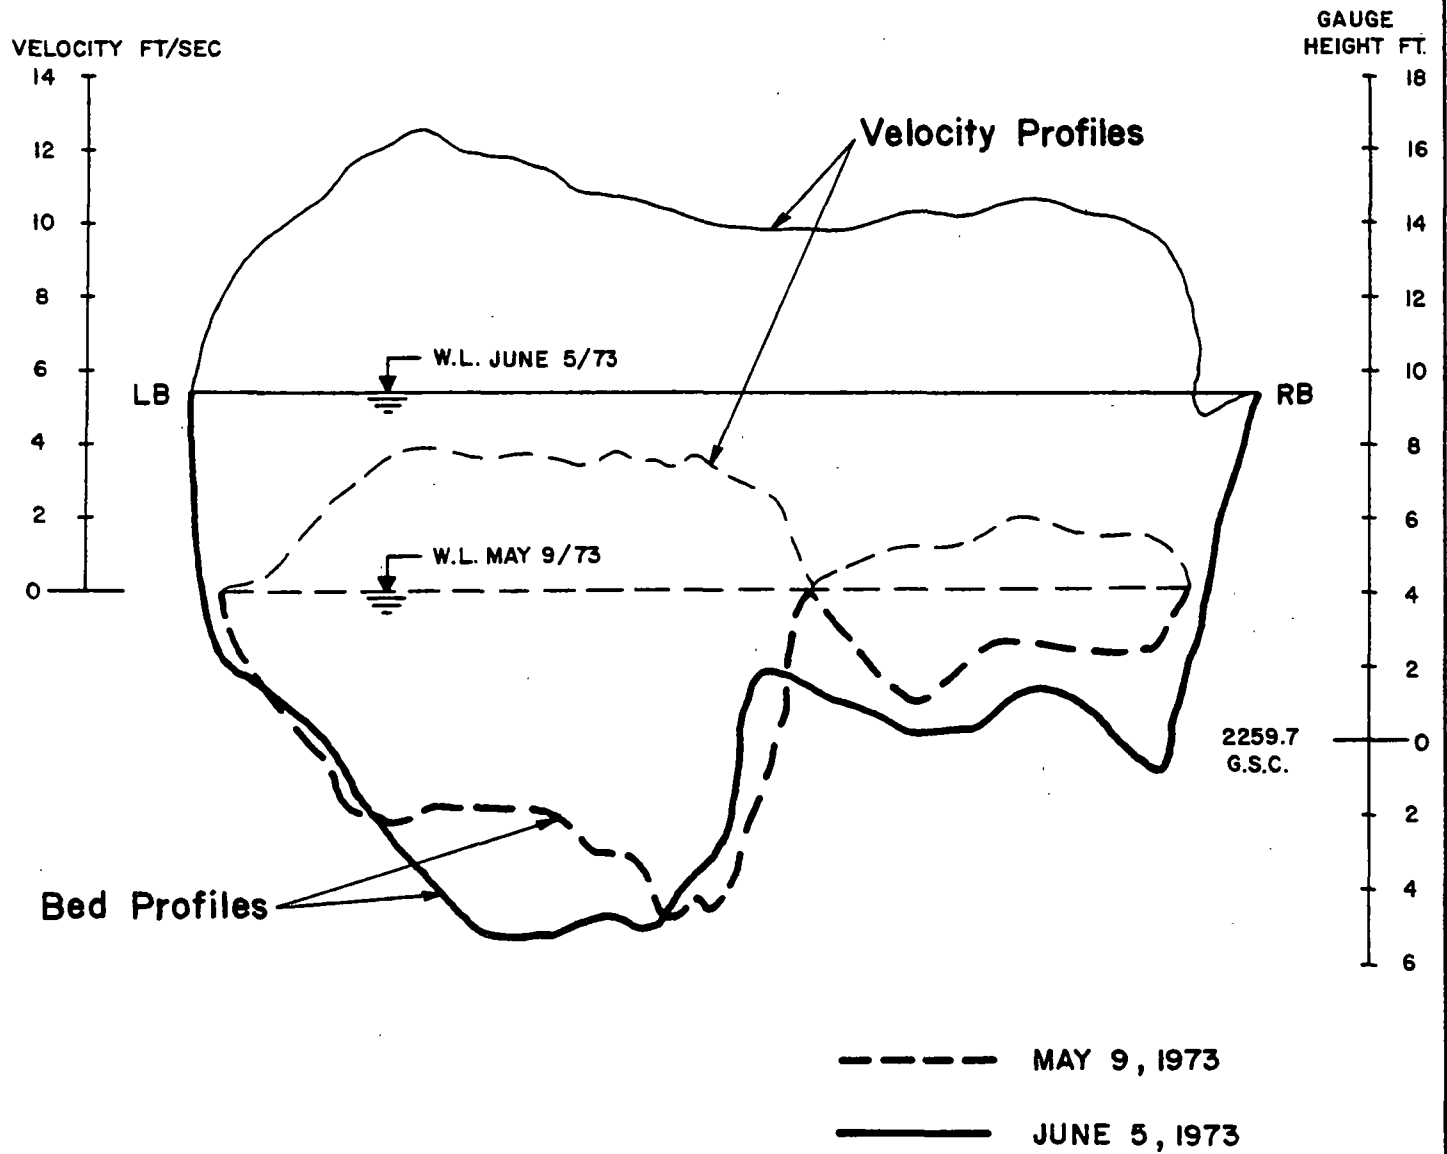
Fig. 45

of the river and enlarge the river width.
(Fig. 45)

SPRING FLOOD RIVER REGIME

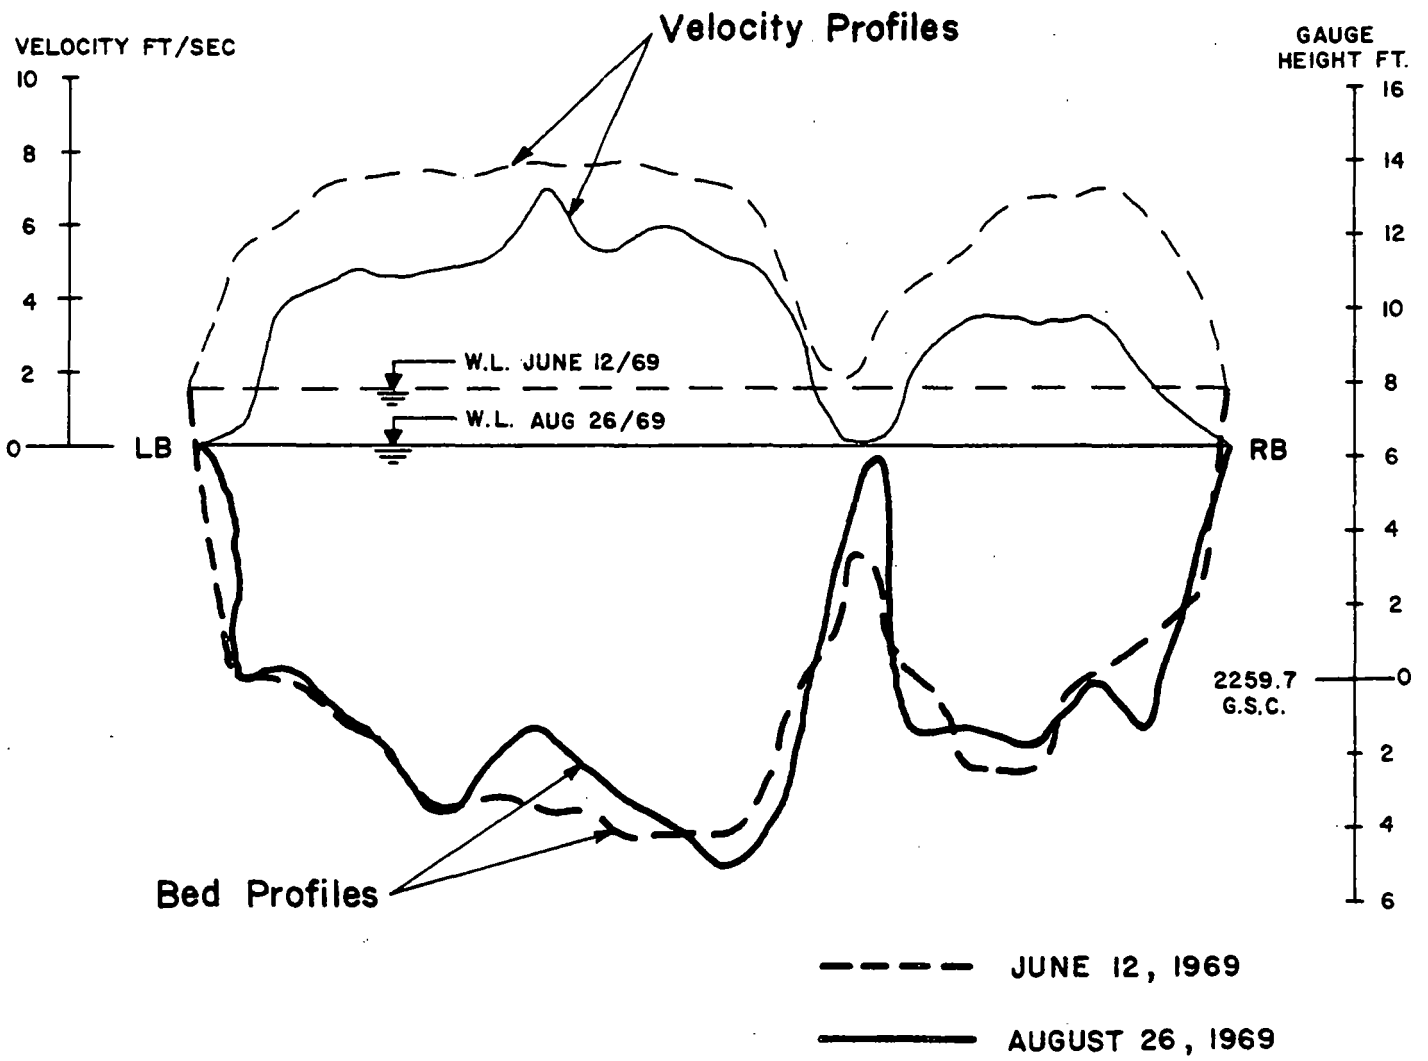
Fig. 46

3. Sand deposition and bar creation happen after the floods during late summer flow and tend to divide the river into two channels separated by a sand bar in the middle. (Fig. 46)
4. The constriction of the channel is very noticeable and happens during the summer months. (Fig. 47)
5. Silting is more important in the north channel than in the south channel with the main part of the river flowing along the south side. (Fig. 47)
6. The constriction of the channel has increased faster during the past few years. (Fig. 48)

SUMMER RIVER REGIME

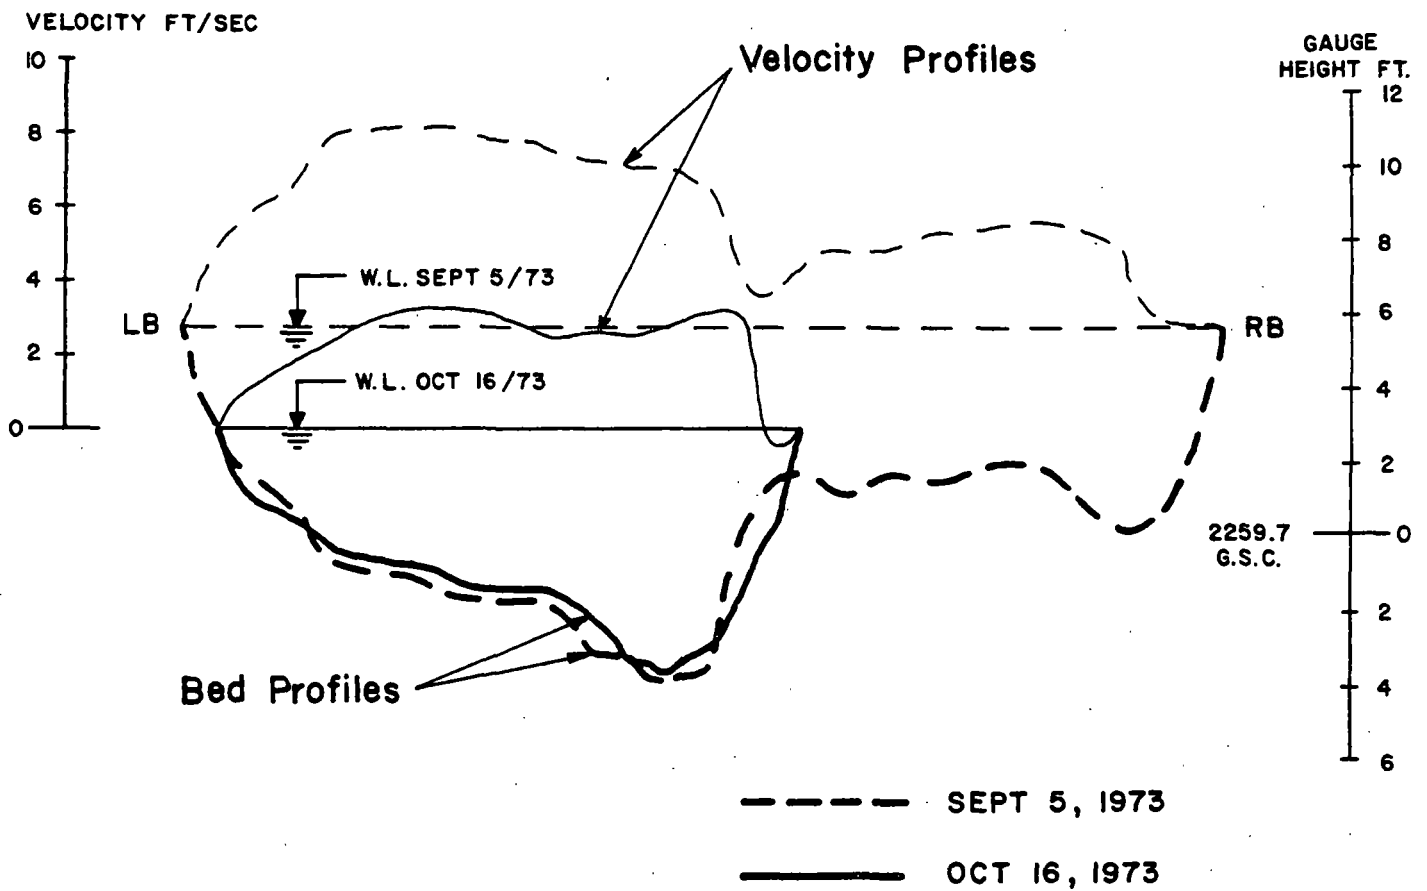
Fig. 47

NORTH CHANNEL RIVER REGIME
