Yukon Flood Study

May, 1974

YUKON FLOOD STUDY

NORTHERN NATURAL RESOURCES
AND ENVIRONMENT BRANCH
INDIAN AND NORTHERN AFFAIRS
WHITEHORSE, YUKON TERRITORY

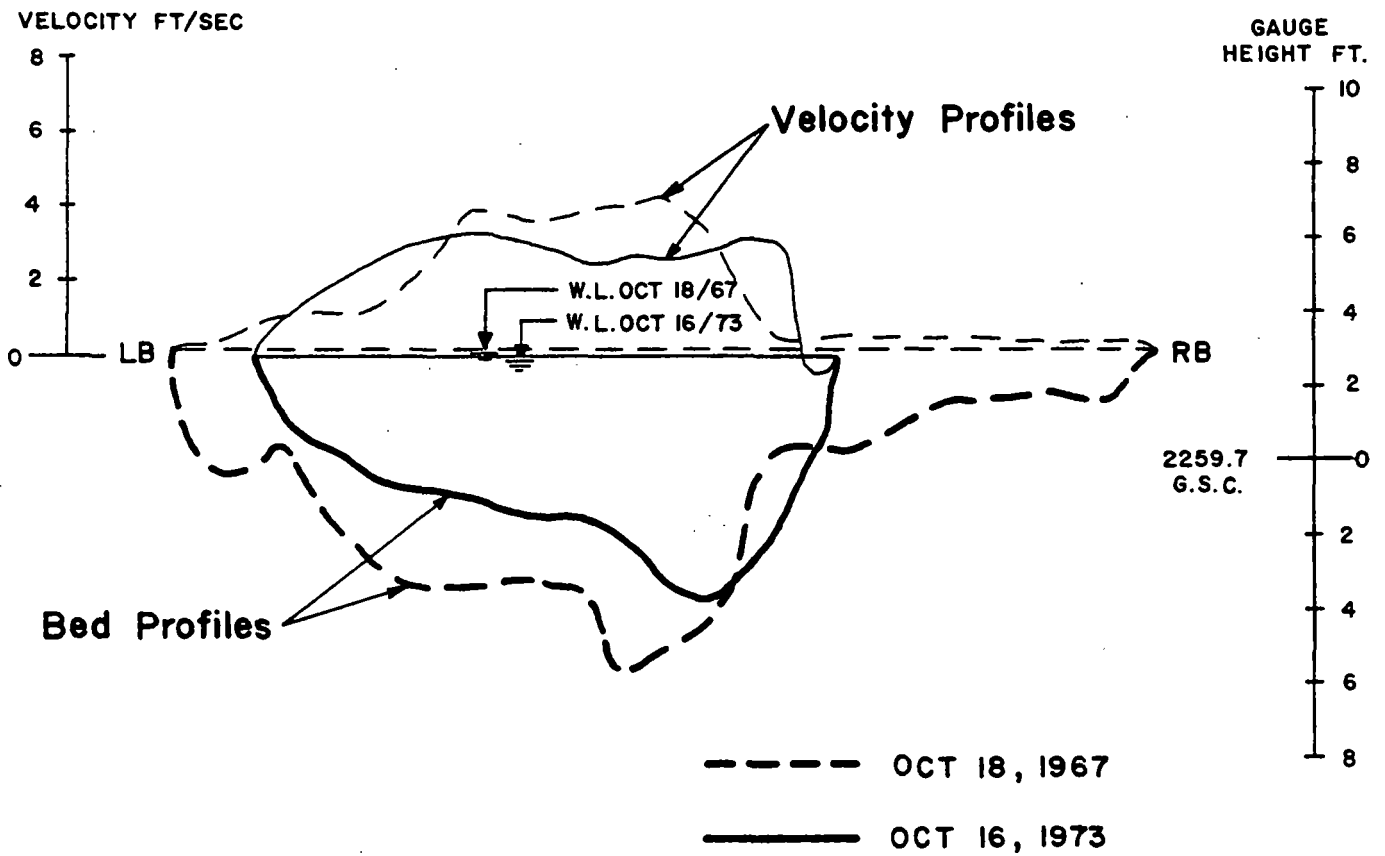
Fig. 48

3. Sand deposition and bar creation happen after the floods during late summer flow and tend to divide the river into two channels separated by a sand bar in the middle. (Fig. 46)
4. The constriction of the channel is very noticeable and happens during the summer months. (Fig. 47)
5. Silting is more important in the north channel than in the south channel with the main part of the river flowing along the south side. (Fig. 47)
6. The constriction of the channel has increased faster during the past few years. (Fig. 48)

YEARLY RIVER REGIME
