GEOLOGICAL SURVEY OF CANADA
TOPICAL REPORT NO. 37

PACIFIC COASTAL DRAINAGE
DAM SITE INVESTIGATION

KATHLEEN LAKE DAM SITE
(MAP AND PRELIMINARY REPORT)

BY
E. B. OWEN

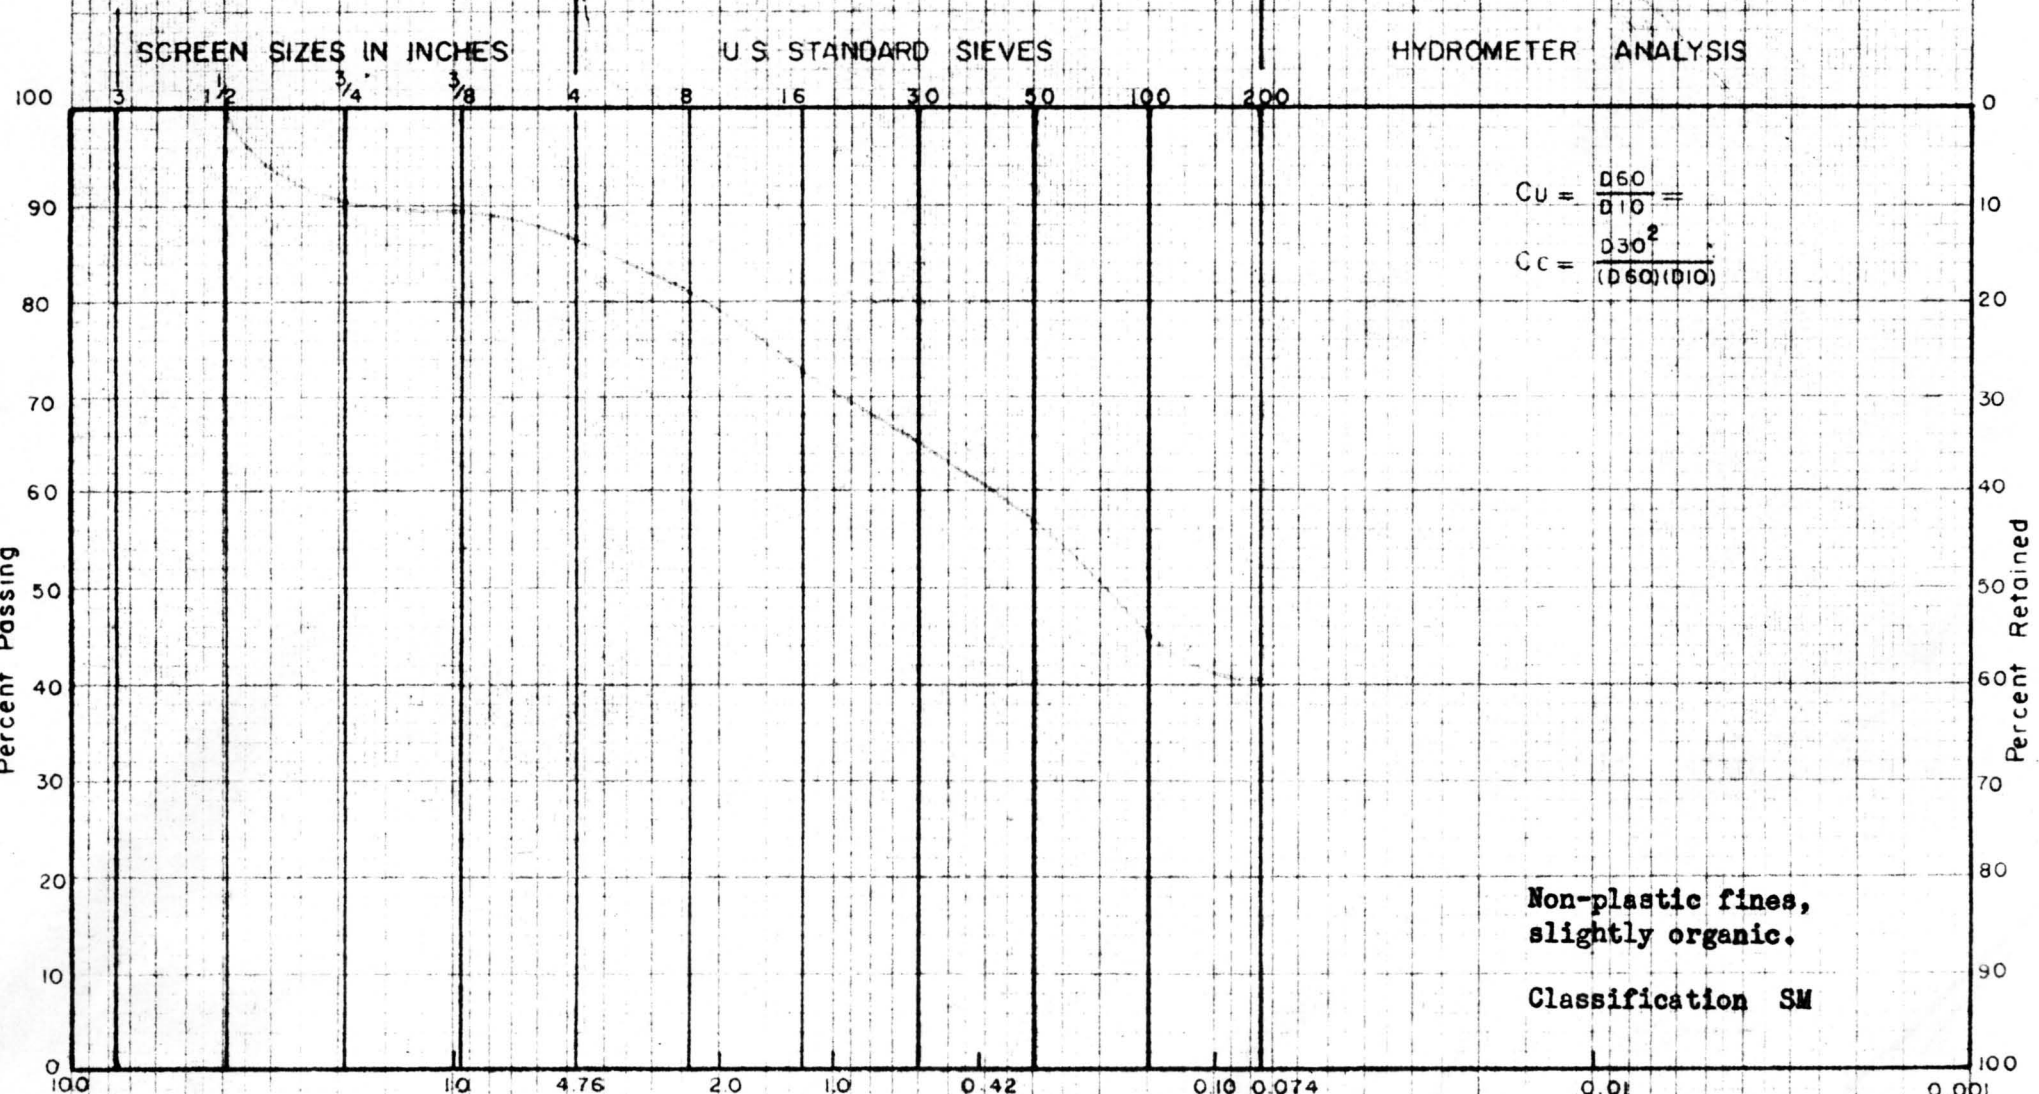
Site Kathleen Lake Pit Sample #2 Depth Plotted

| Sample Number | Location | Field Description of Material | Field Description of Overburden | Thickness of Deposit | Areal Extent (Estimated) | Permeability* (cm. per sec) |
|---|---|---|---|---|---|---|
| 2 | On centre line of Haines-Fairbanks oil pipe line; 1,300 feet north of north side of Kathleen River; 3 feet below ground surface | Silty sand; friable; grades downward into medium-grained sand. | none | 4 feet | Unlimited | 10^{-4} |

WATER RESOURCES BRANCH
 GRAIN SIZE ANALYSIS

$$C_u = \frac{D_{60}}{D_{10}} = \frac{0.30}{0.075} = 4.0$$

$$C_c = \frac{D_{30}^2}{(D_{60})(D_{10})} = \frac{0.15^2}{(0.30)(0.075)} = 0.4$$

Non-plastic fines,
 slightly organic.
 Classification SM

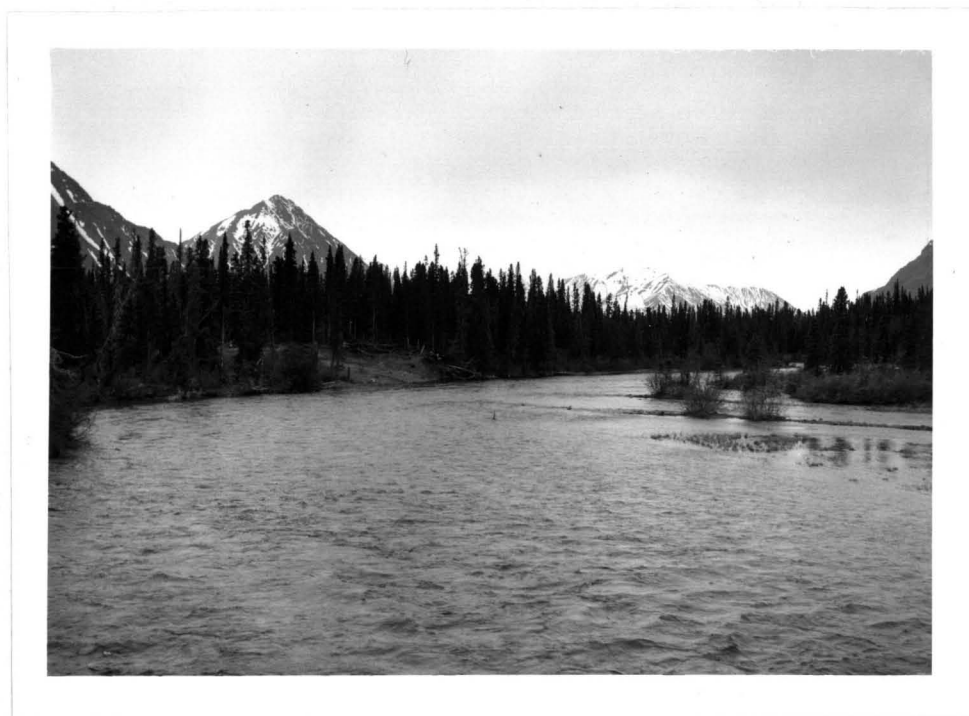
Plate I

Kathleen River looking upstream from Haines
Road bridge. Haines-Fairbanks oil pipe line
crosses River in centre of photograph.
