Title: Maps; Data, and Survey

Maps Data and Survey

Department of Indian and Northern Affairs

March 1974

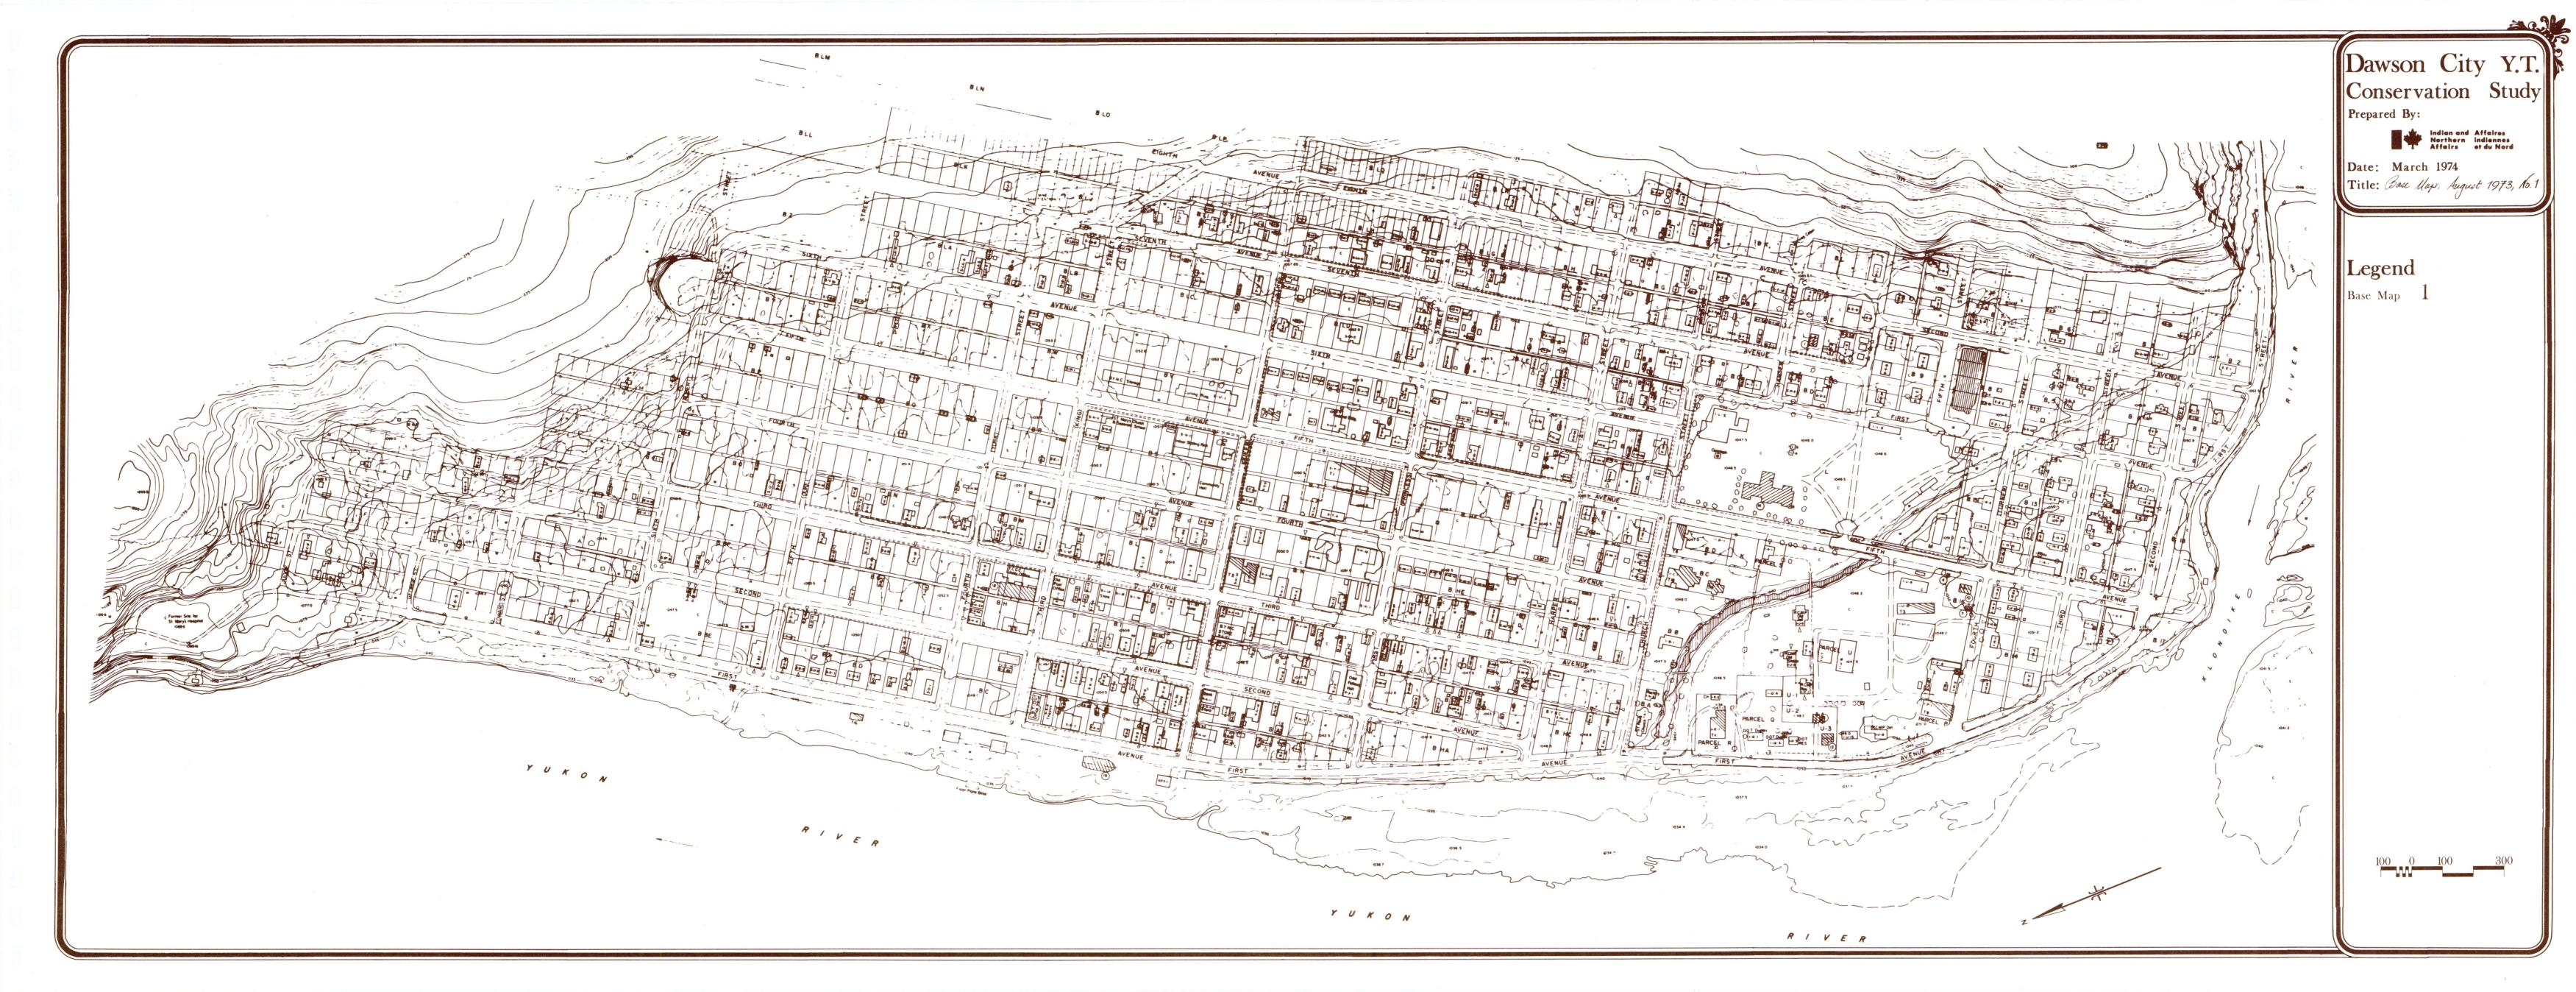
Base Map

The "Base Map" opposite, which has been used throughout this study as the foundation for all topographical survey and presentation of material, is derived from a map entitled:

The original map was compiled from a photographic survey made by the Royal Canadian Air Force on 18 May 1960, and was completed on 18 December 1964.

The 1964 map was corrected for this present study by inspection of the site during 1973.

A supplement to the information already provided on the 1964 map has been made by adding in lines of land division, to show the lots - which have been identified by "estate", "block", and "lot". This supplementary material has been derived from the:

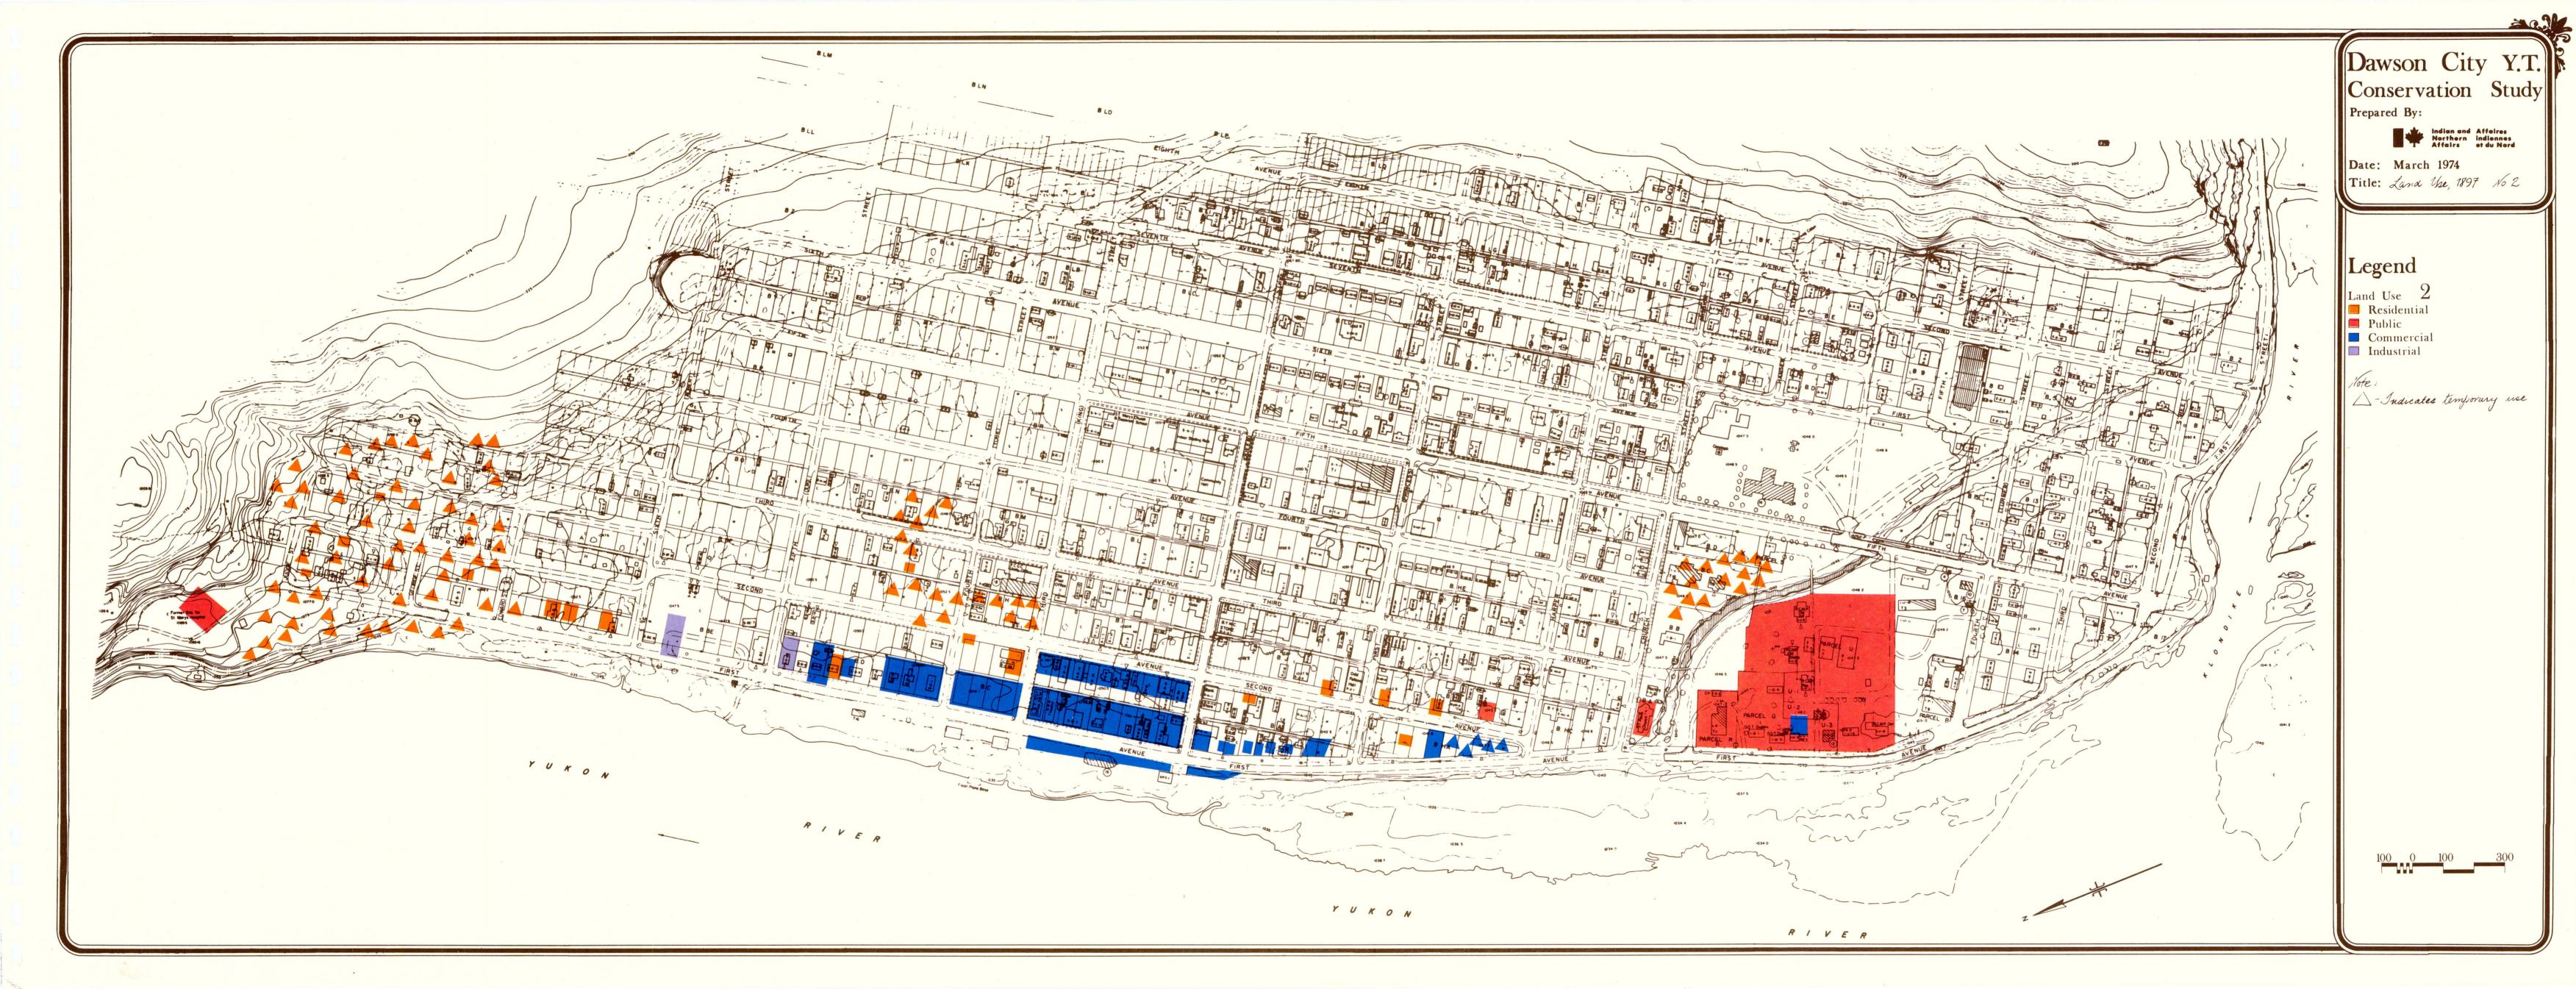
Land Use 1897

This map illustrates Dawson in the fall of 1897. It was compiled almost exclusively from photographs.

In the 1897 and 1899 maps, temporary tent structures have been identified by triangular shapes tinted the shade of the appropriate use category. This was done to indicate land usage as temporary; marking the map in the regular lot method would have produced a distorted impression of development.

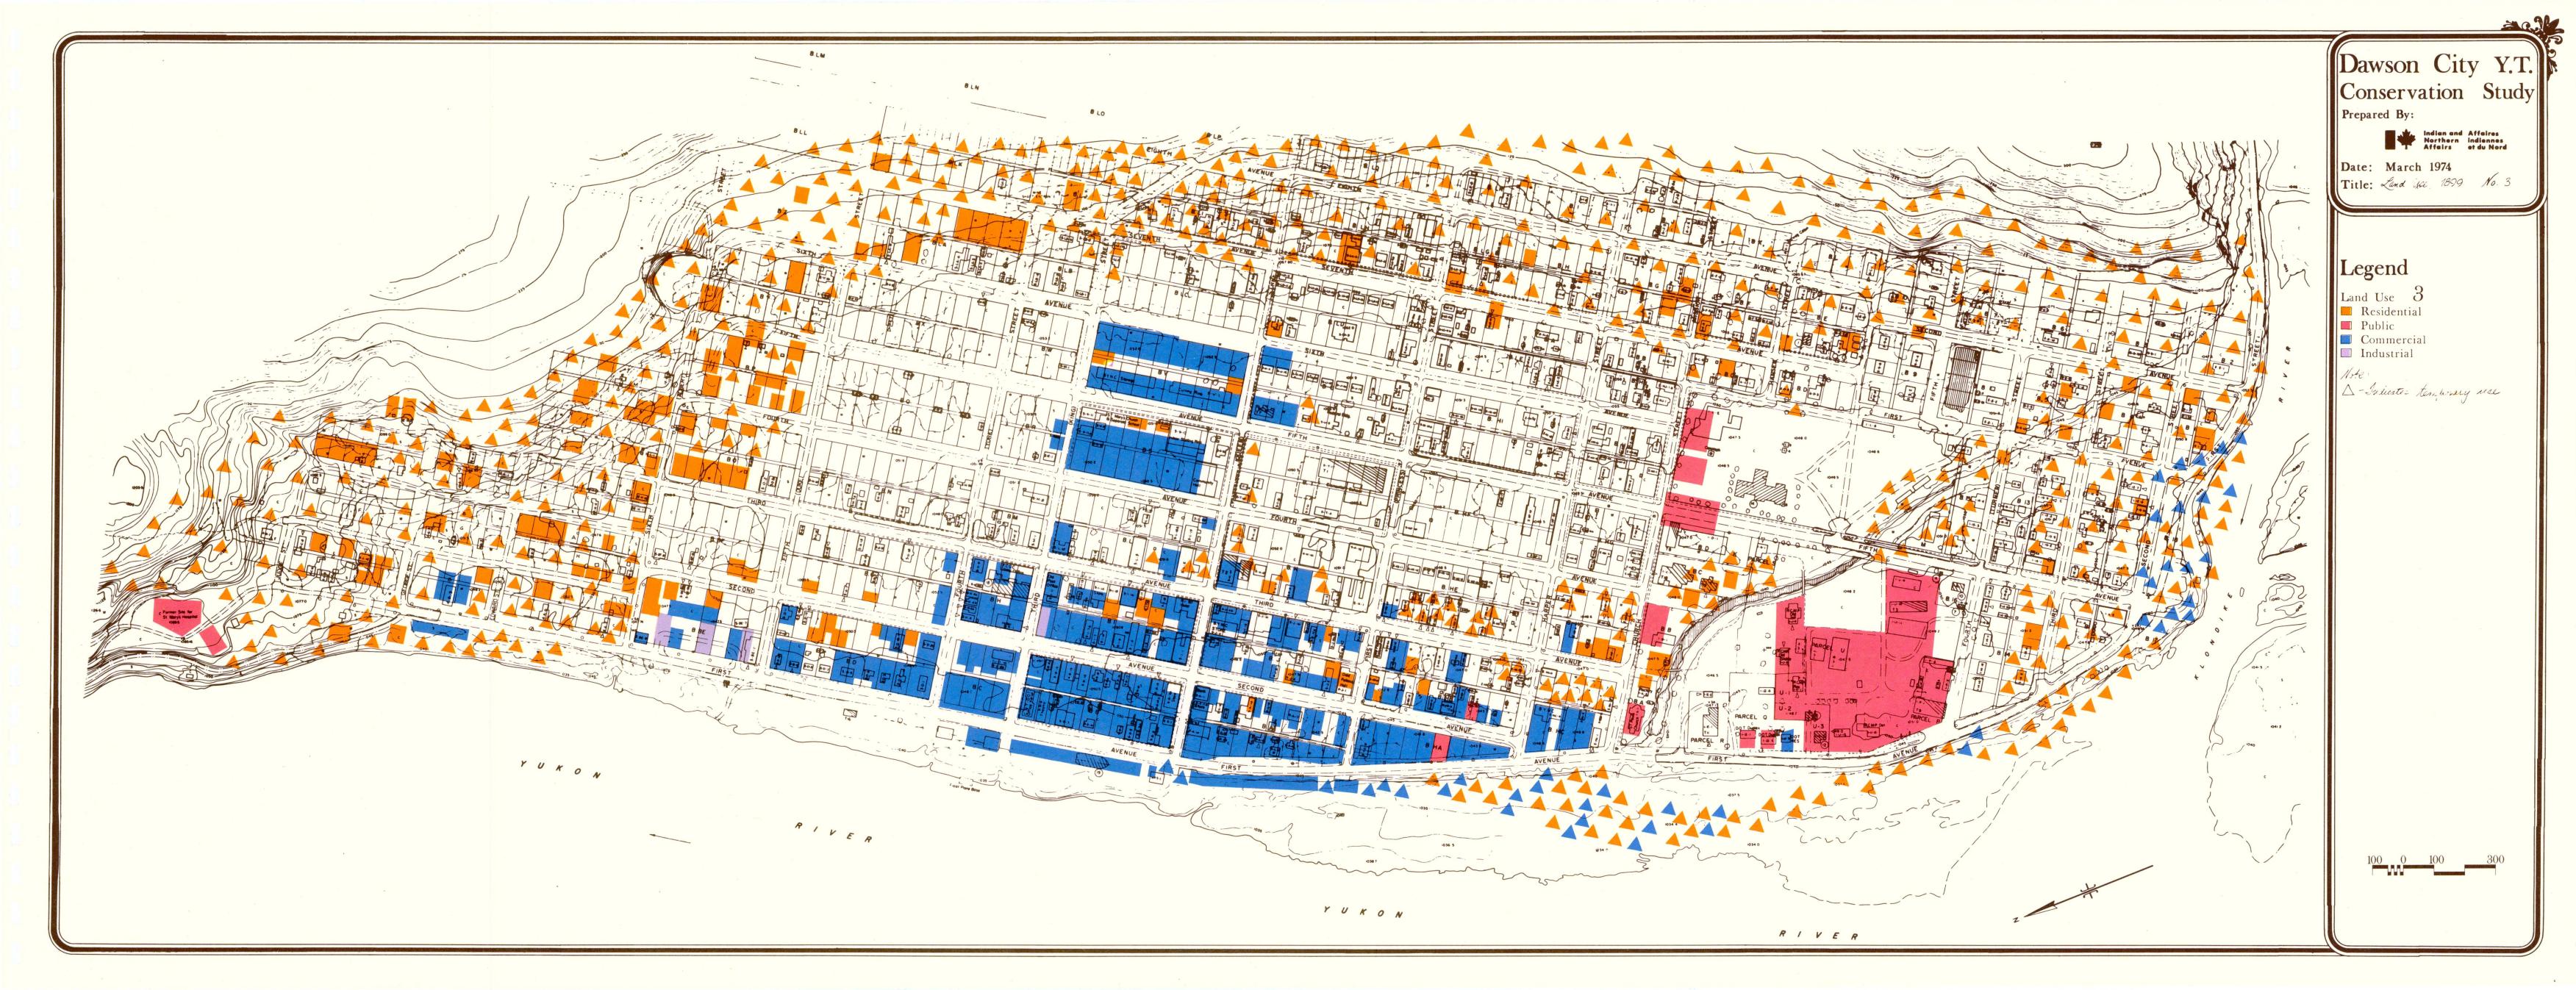
Land Use 1899

The 1899 use map was compiled from photographs taken during late summer of that year, and from contemporary newspapers. Both the Klondike Nugget for 1898 and 1899, and the Dawson Daily News for 1899 were checked for lists of people, businesses and addresses. These were cross-checked with structures in the photographs of the period to determine their uses as closely as possible. Where no newspaper addresses existed, and structures were visible in the photographs, street signs often supplied the needed specific use. Often the comments of contemporary writers provided clues necessary for additional information; for example, Martha Black mentions there were two streets in the scow section of the waterfront in her book My Seventy Years. The general functions of specific buildings were often obvious from their locations when no other information existed. In a few cases, educated guesses were necessary, but the possibility of distortion through this is slight.

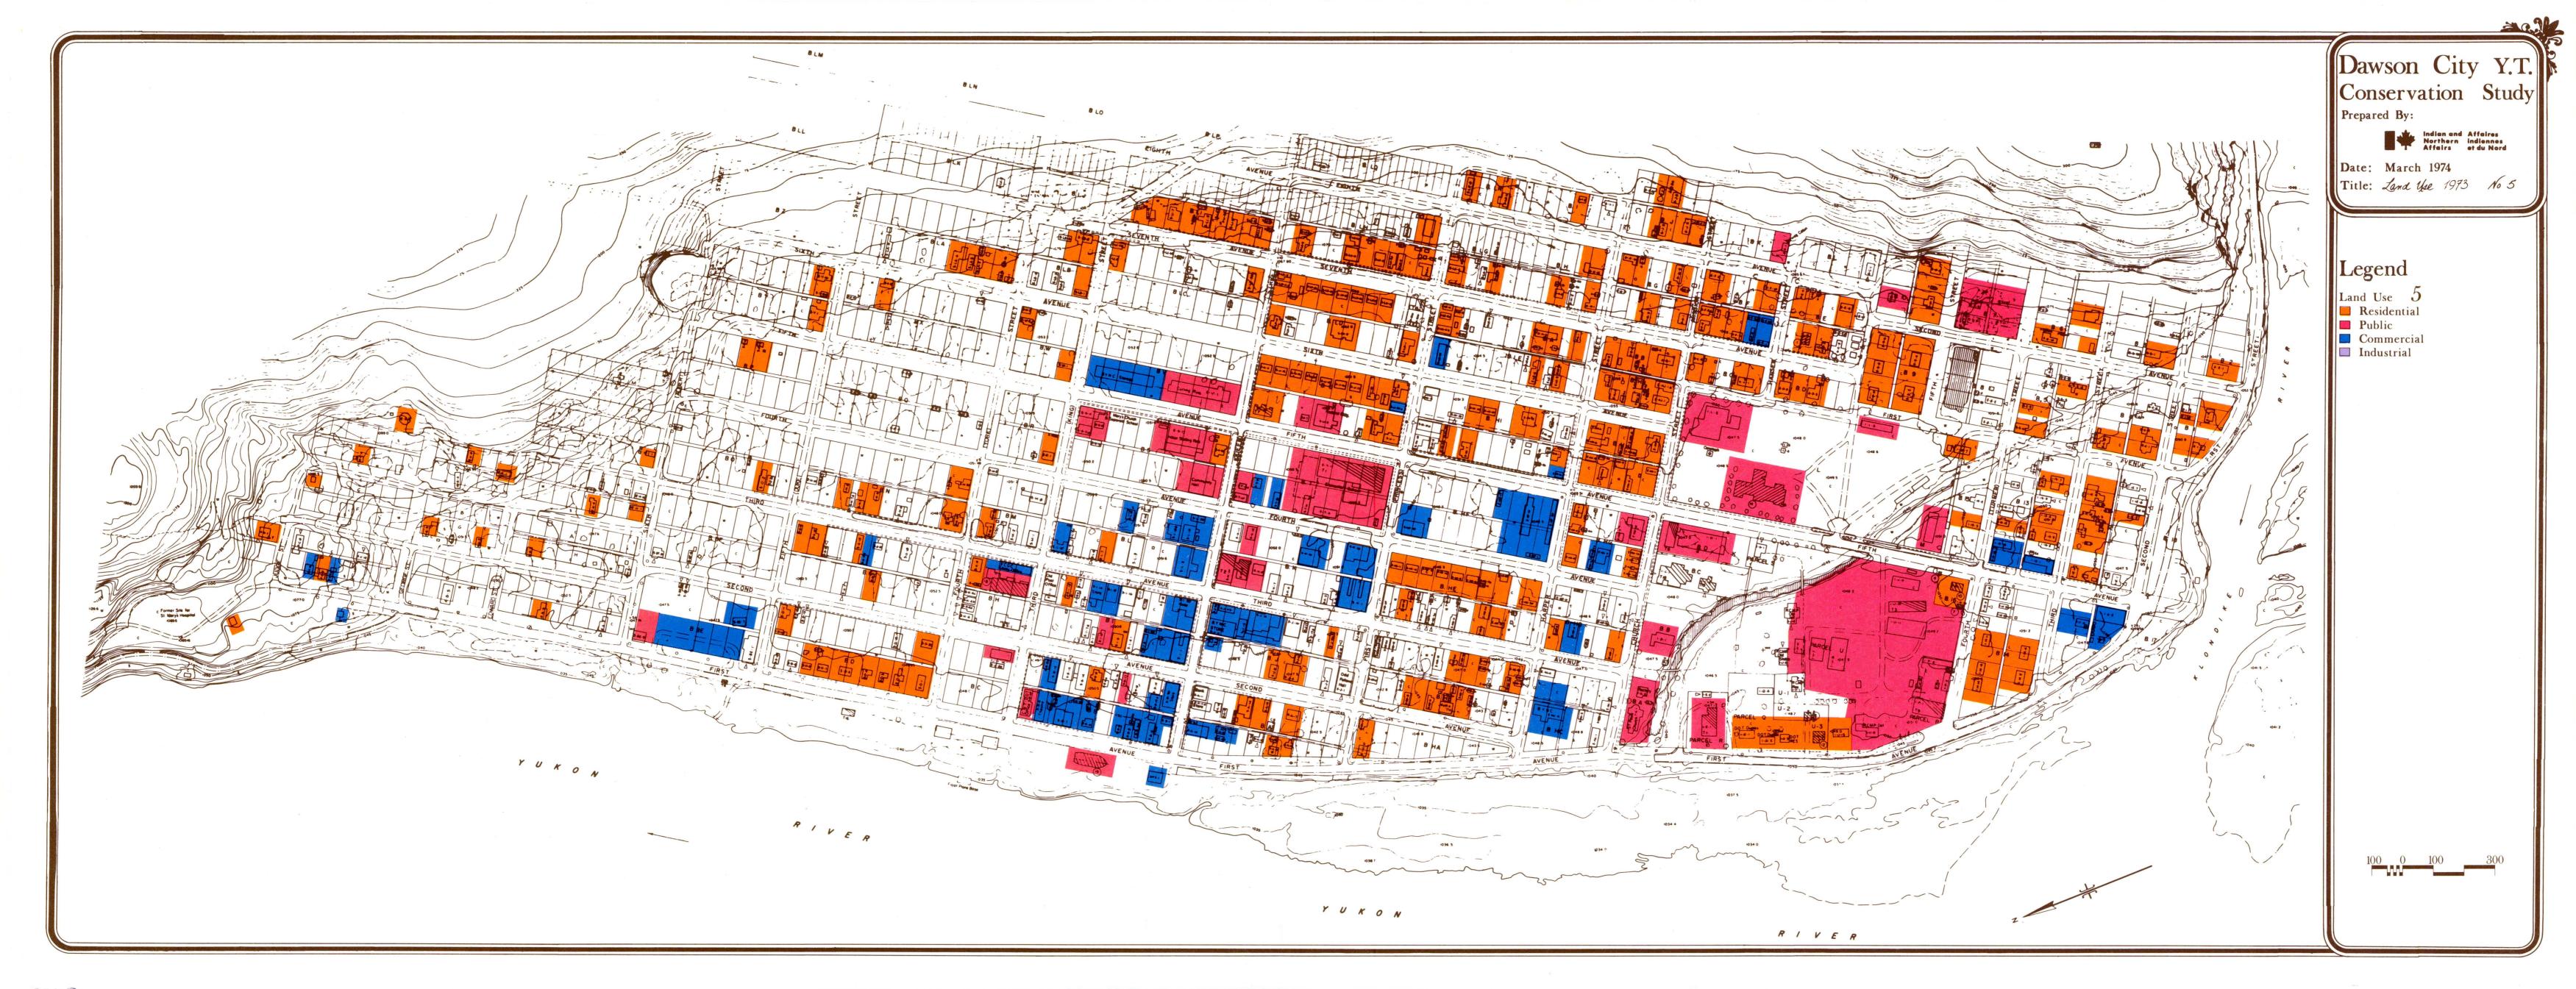
The "1973 Land Use" and the "1973 Building Use" maps - Nos. 5 and 6 - are based on a survey made for this study during the summer of 1973.

The Land Use Map, opposite, has been prepared to complete the sequence of "Land Use" surveys illustrated in Maps 2, 3 and 4. Like them, it shows only the main use for each lot; and, like them, shows that use only if the lot is in active occupation.

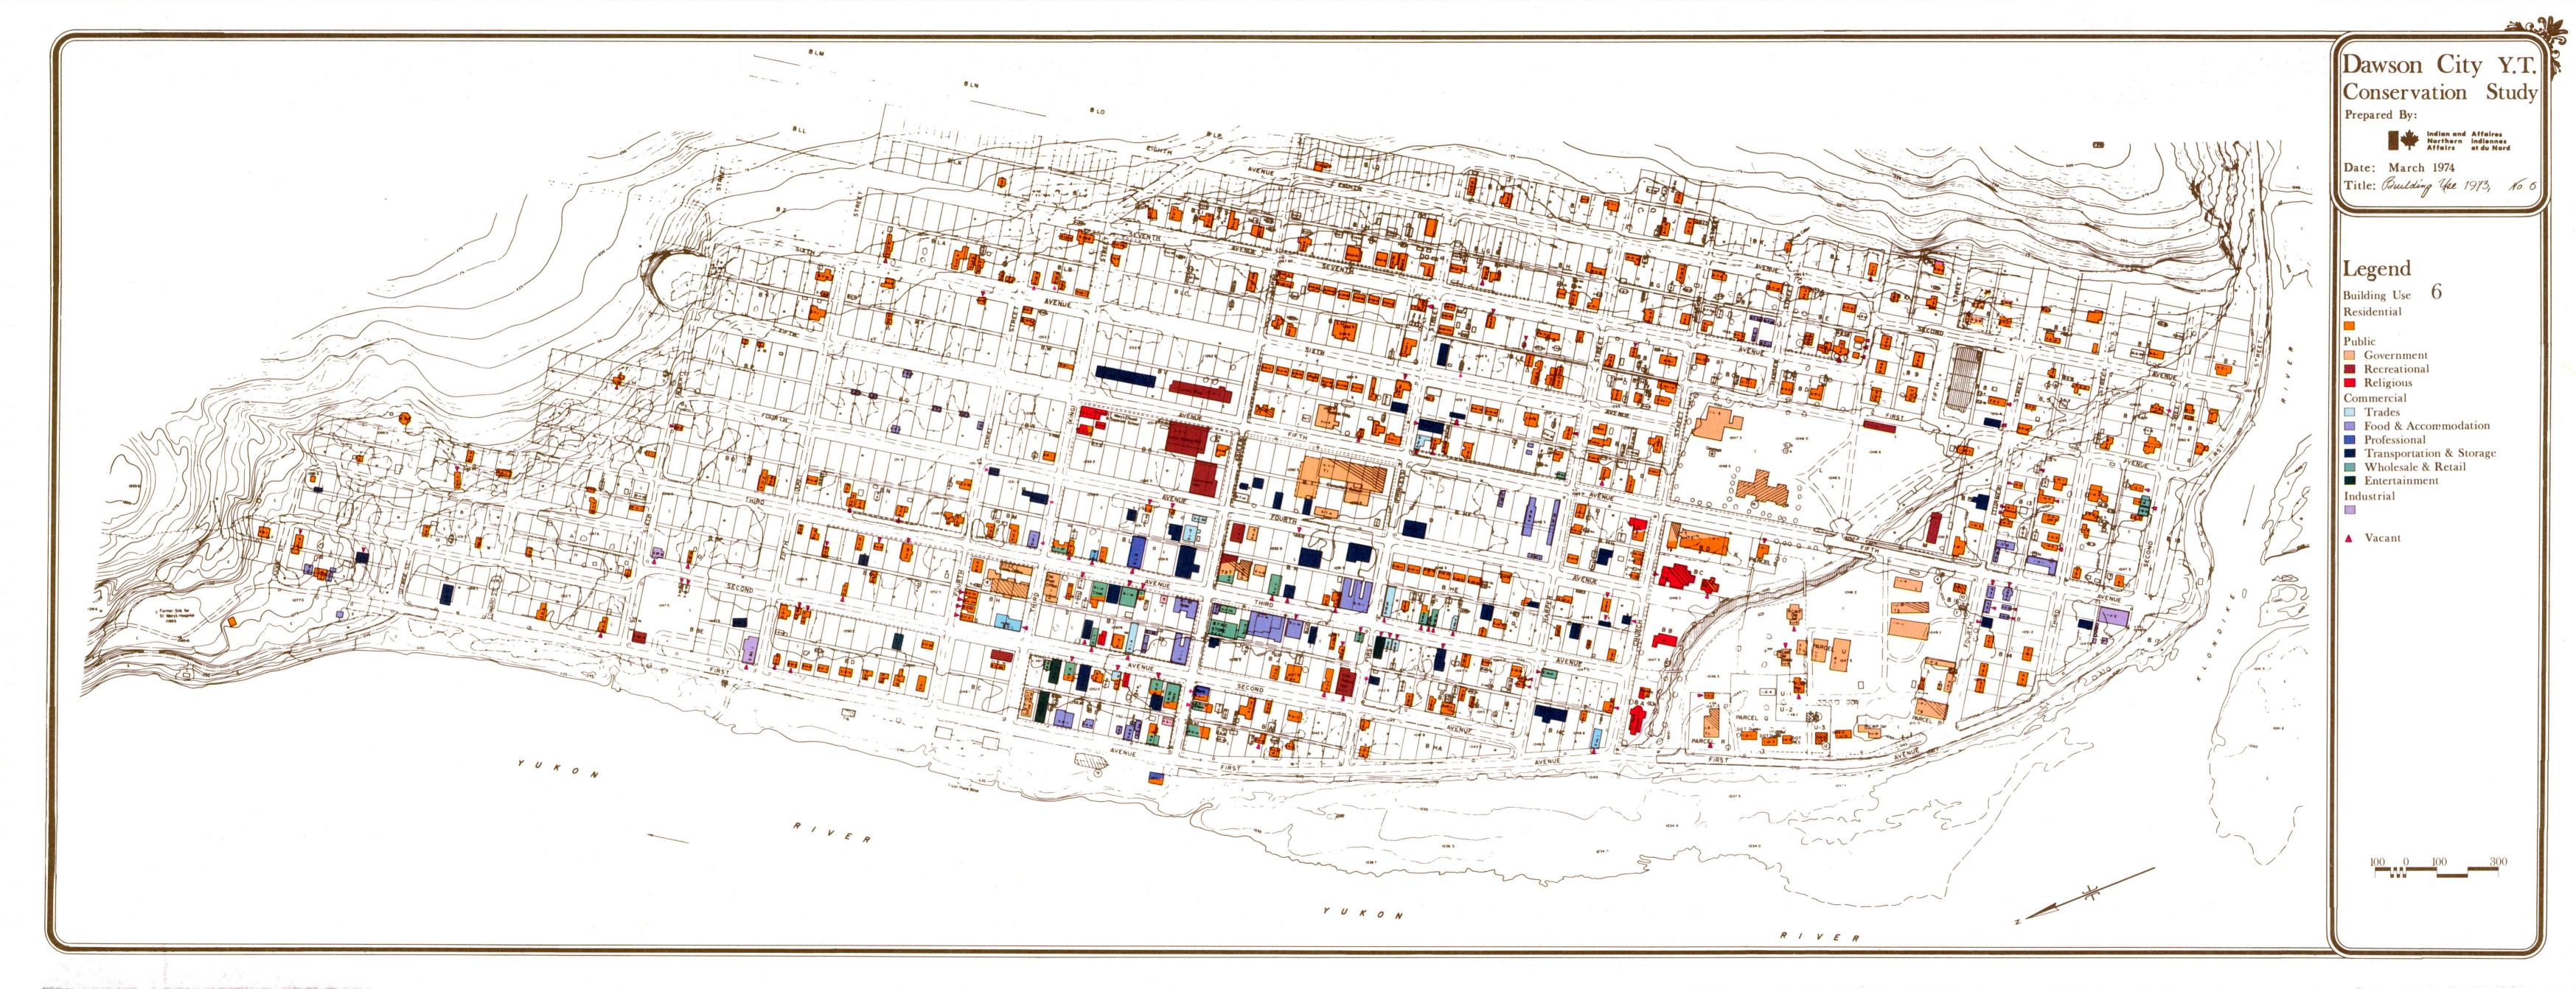
The map following, "Building Use", is intended to show the usages current in 1973, for the individual buildings of Dawson City. The main categories of use are those defined for the preceding sequence of "historic" use maps; on this particular sheet, however, they have been broken down into the sub-categories, indicated by variations in the basic tints.

If the building in question was vacant at the time of survey it is so marked on the map.

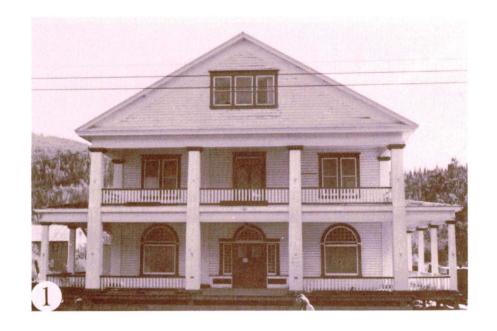
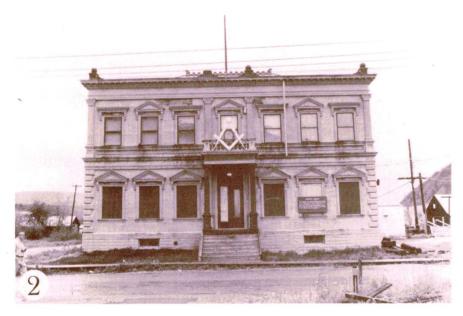
1st. grade

The first and highest grade of interest included only eleven buildings, of which the Commissioner's Residence, (1), and the Carnegie Library, (2), are typical. This assessment has been made very largely on a visual basis. While, therefore, the initial judgement has been refined by reference to historical research, Map 7 represents the opinion of the authors of this study that certain buildings are of interest, either because of their intrinsic design qualities, or because they seem typical of the general appearance of building during the "historic" period of the City's development.

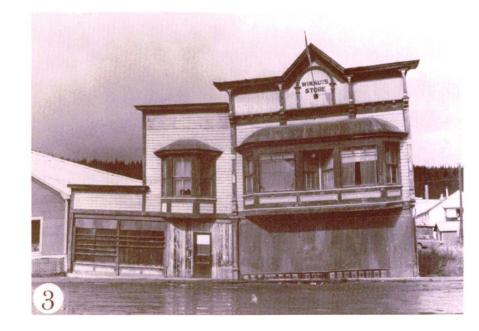
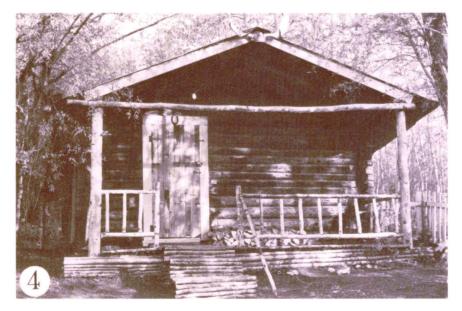
2nd.grade

The second grade covers thirty seven buildings, of which Winaut's Store, (3), and the Robert Service Cabin, (4), are typical.

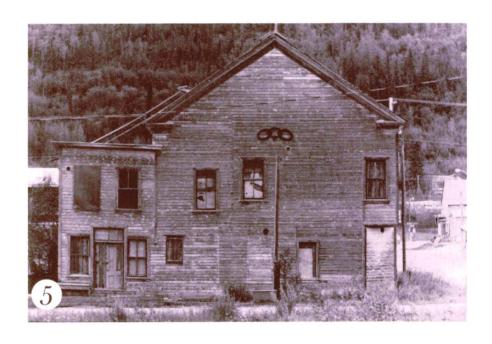
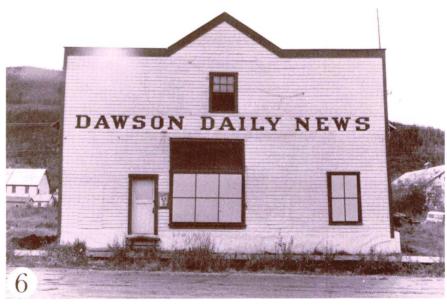
3rd. grade

The third grade included the remaining buildings. The Odd Fellows Hall, (5), and the Dawson Daily News building, (6), illustrate the range of buildings which this grade includes.

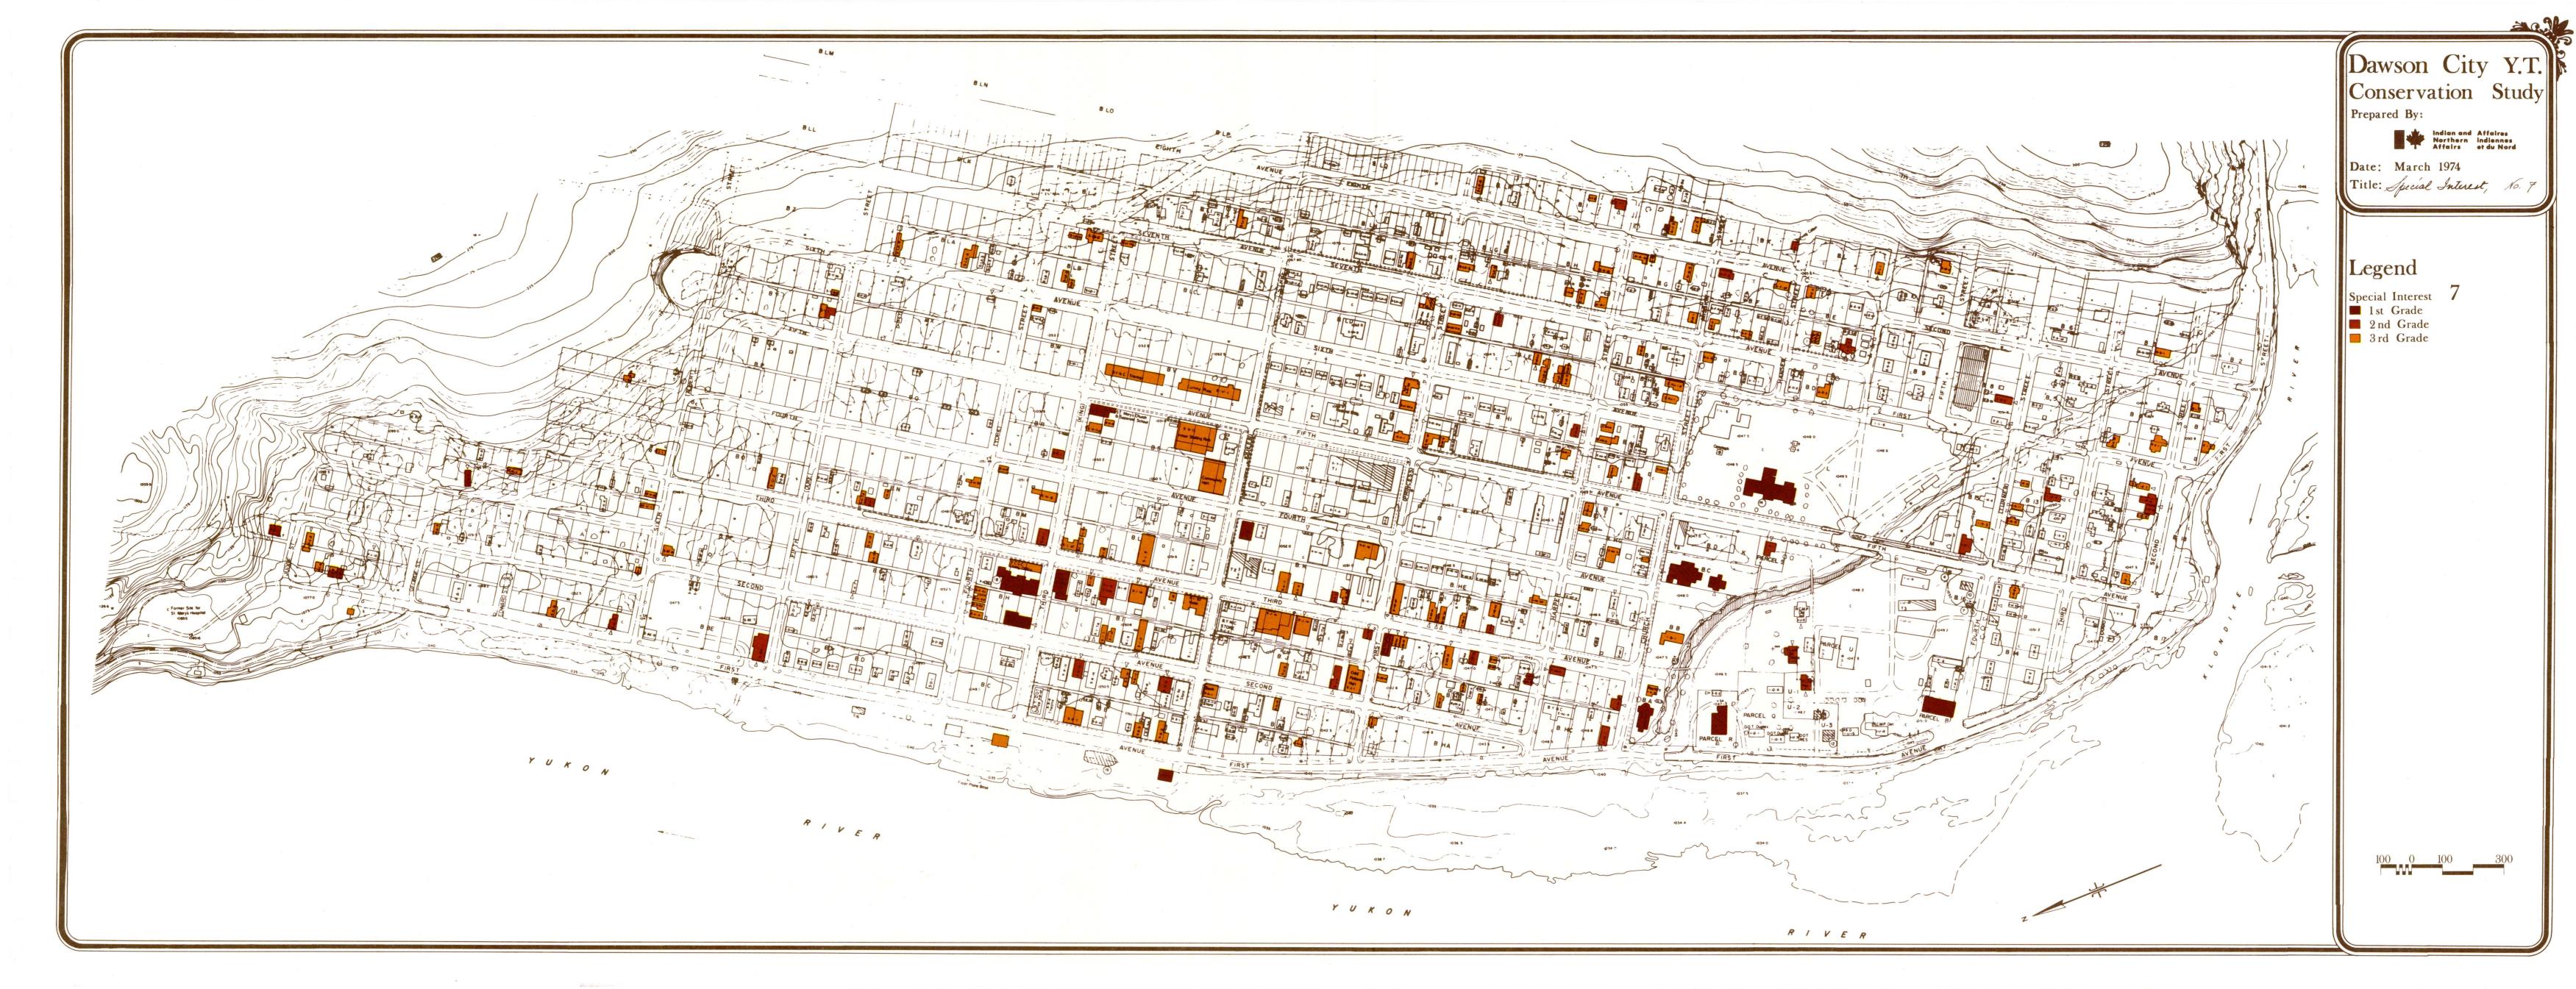
Special Interest

Map 7 deals with individual buildings. It differs from preceding maps, in that they are records of fact, while this map records an assessment of quality: "Special interest to the City of Dawson by reason of architectural of historic character".

Some 212 buildings appeared to possess the requisite character. In order that — for future administrative action — it should be possible to subdivide this total into some order of relative significance, the map has been drawn to show three gradings of interest, indicated by variation of the basic tint.

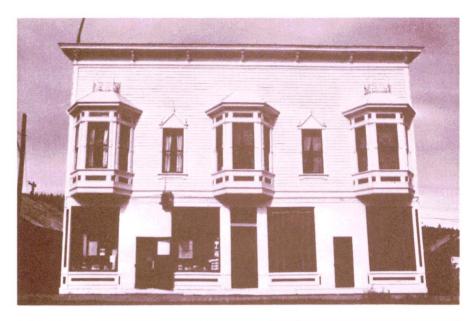
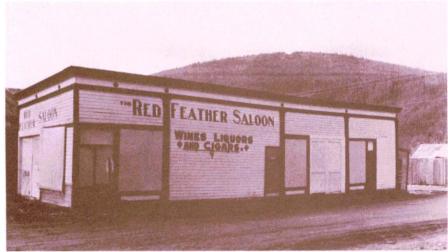
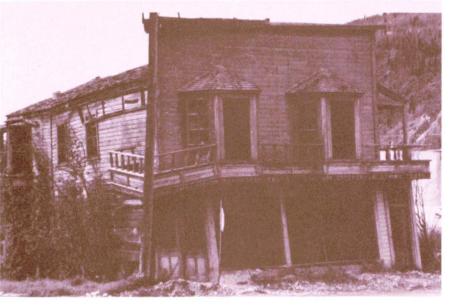
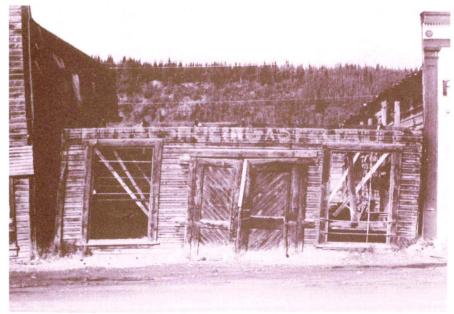
In such condition as not to require present reinforcement or consolidation. Caley's Store is in such condition.

Indicates the building requires reinforcement; the Red Feather Saloon being a case in point.

3 Indicates the building to be in urgent need of immediate reinforcement and consolidation. Strait's Store is an example here.

4 Indicates the building to be past restoration, but still able to provide evidence upon which reconstruction could be based. The Third Ave. Blacksmith Shop, is such a building.

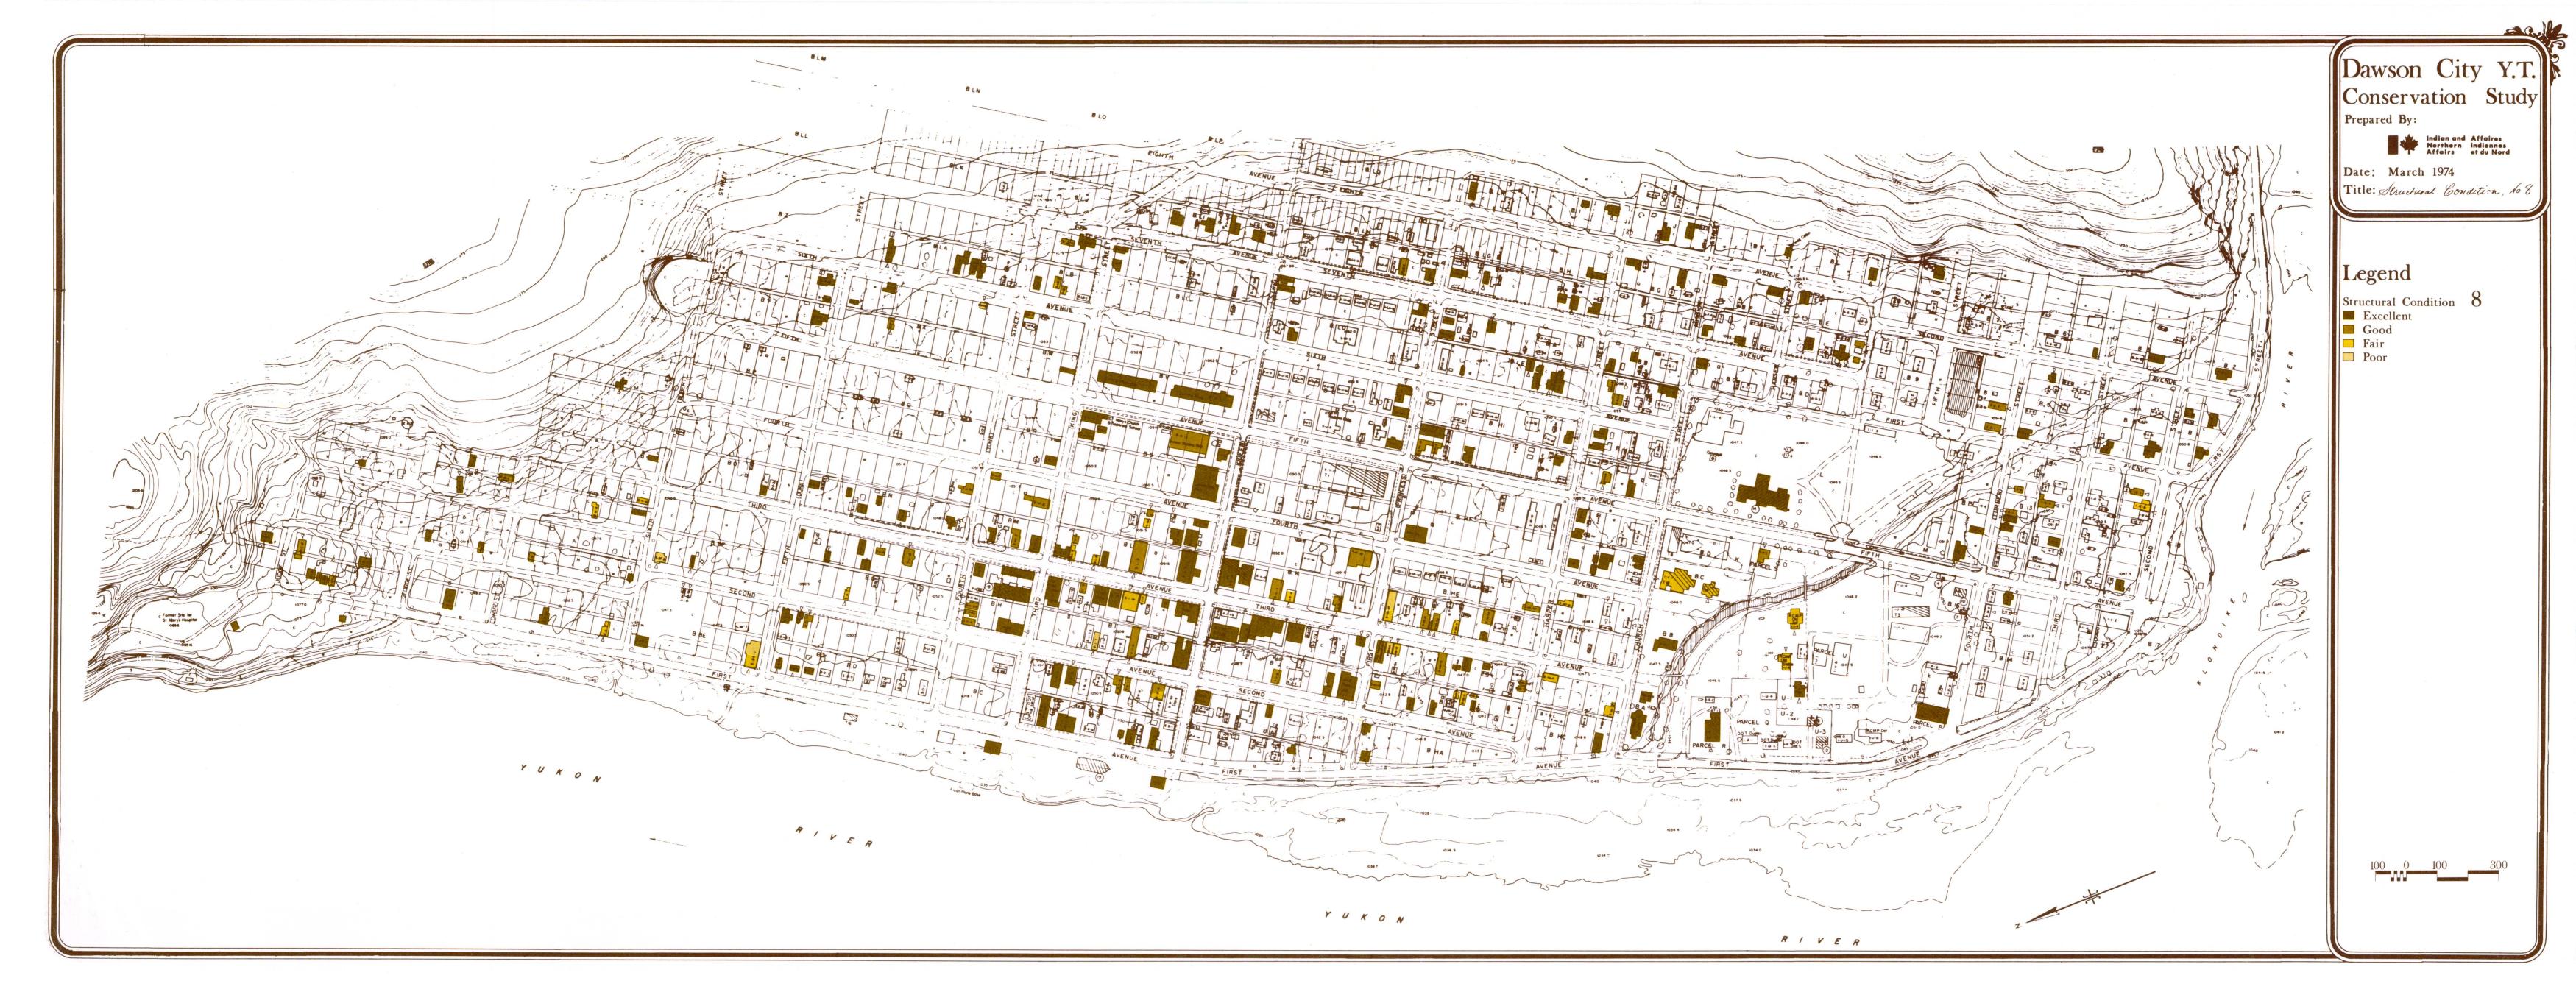
Structural Condition

Map 8 covers rather more buildings than are included in Map 7. While it was compiled on a similar selective basis, the standard for inclusion was not quite so high as that adopted for Map 7. While the latter map deals only with buildings of "special" interest, Map 8's content is concerned more generally with buildings which, in the opinion of the authors of this study, make a contribution to the architectural or historic character of Dawson City.

While the use and special interest surveys were being made, during 1973, note was also taken of the structural condition of buildings thought to be of interest. This information is presented on the map opposite. The selected buildings are graded in terms of whether their condition was:

- 1. Excellent
- 2. Good
- 3 . Fair
- 4 Poor
