PUBLIC ROADS

VOL. 24, No. 3

JANUARY-FEBRUARY-MARCH 1945

Page
Ice Formation on the Alaska Highway	55
An Empirical Method of Interpretation of Earth Resistivity Measurements	75

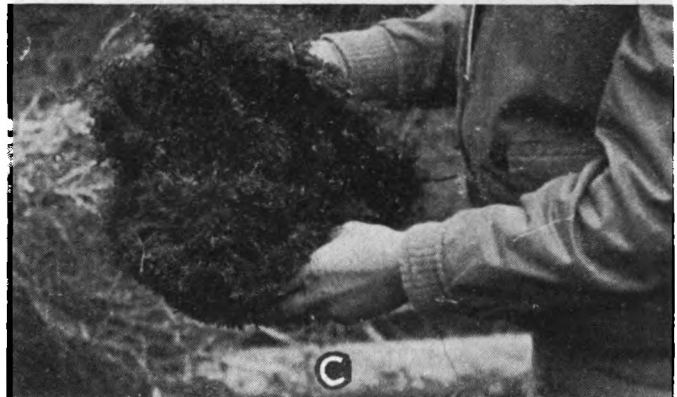
A, NATURAL CONDITIONS CONDUCIVE TO ICING. THE PICTURE WAS TAKEN IN OCTOBER 1942 AS WINTER BEGAN. B AND C, GROUND COVER OF MOSS AND VEGETAL DEBRIS THAT PREVENTS EVAPORATION IN SUMMER AND FREEZING IN WINTER.

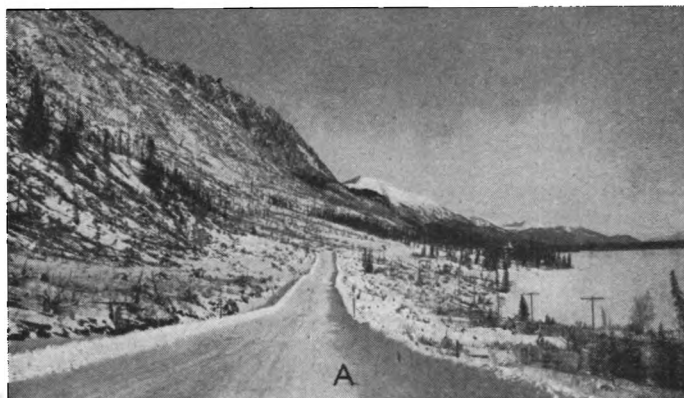
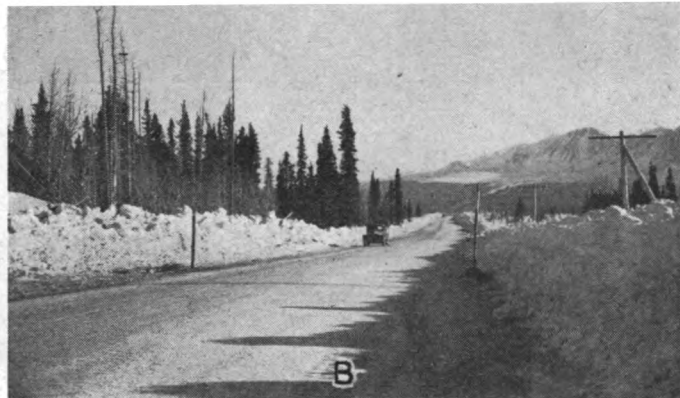
A, AT THIS LOCATION NEAR THE ALASKA BORDER THE NATURAL CONDITIONS ARE CONDUCTIVE TO ICING; B, DEEP SNOWS IN THE REGION NEAR KLUANE LAKE PREVENTED SERIOUS ICING.

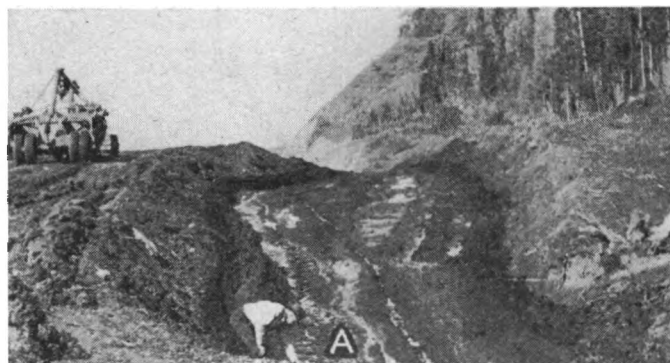
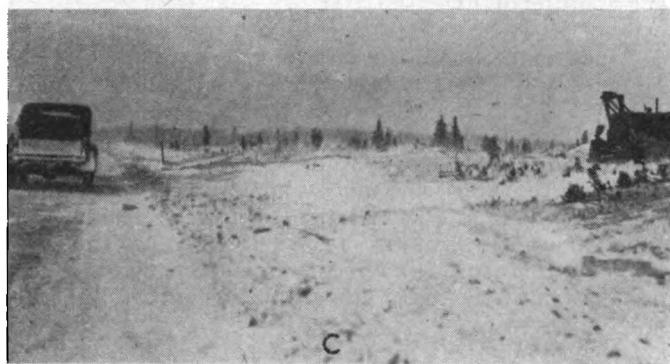
A, PERMAFROST EXPOSED BY GRADING IN ALASKA. B, WEST OF TANACROSS WHERE A "FROST DAM" FORMED AT THE ROADWAY. HYDROSTATIC PRESSURE HAS TIPPED THE TREES FROM VERTICAL POSITION. NOTE THE WATER ON THE SURFACE. C, AT THE SAME LOCATION AS B. HYDROSTATIC PRESSURE HAS RAISED THE THICK VEGETAL COVER AT THE RIGHT ABOUT 6 FEET.

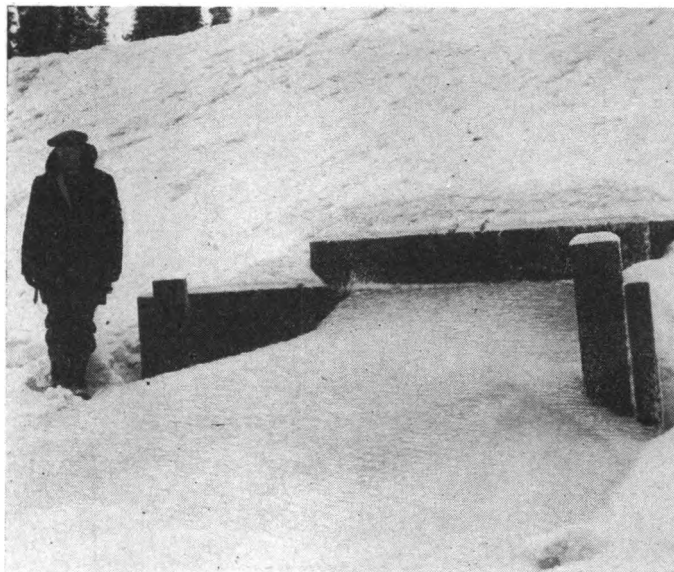
OUTLET OF A CULVERT THAT IS COMPLETELY FILLED WITH ICE.

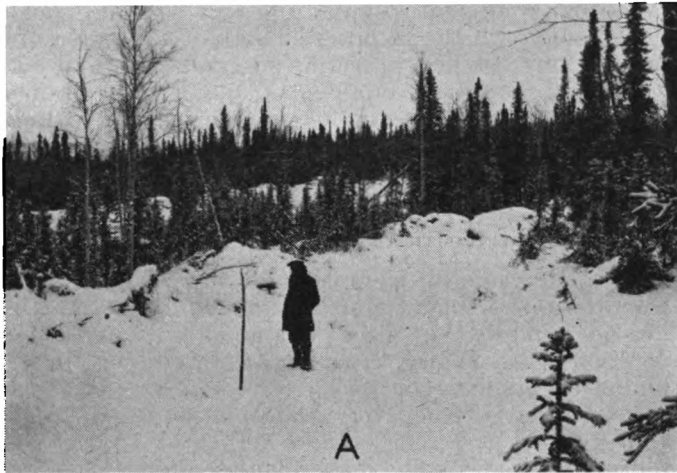
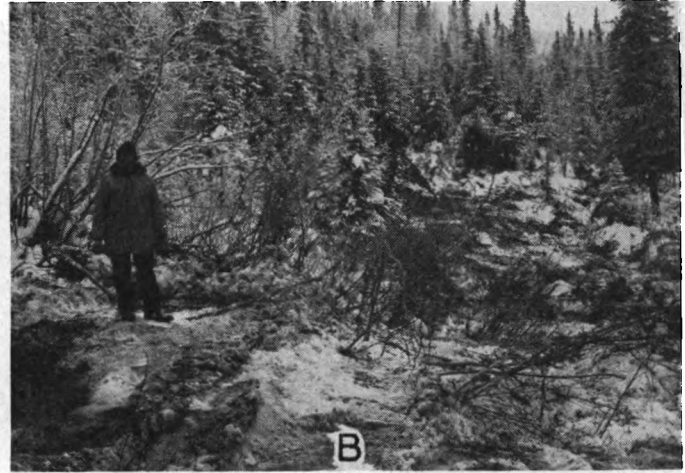
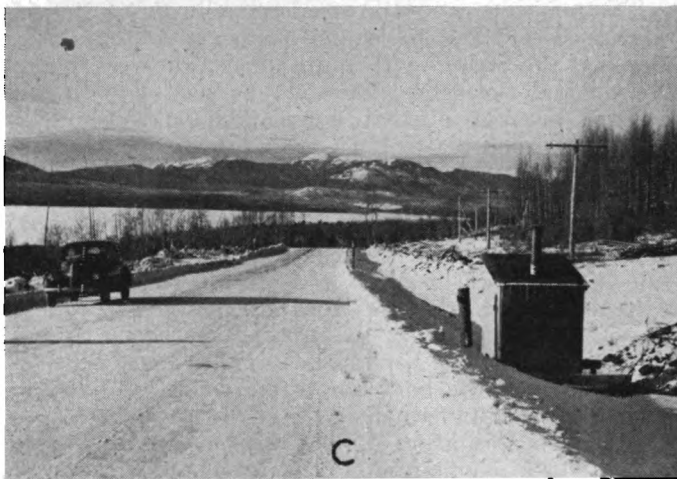
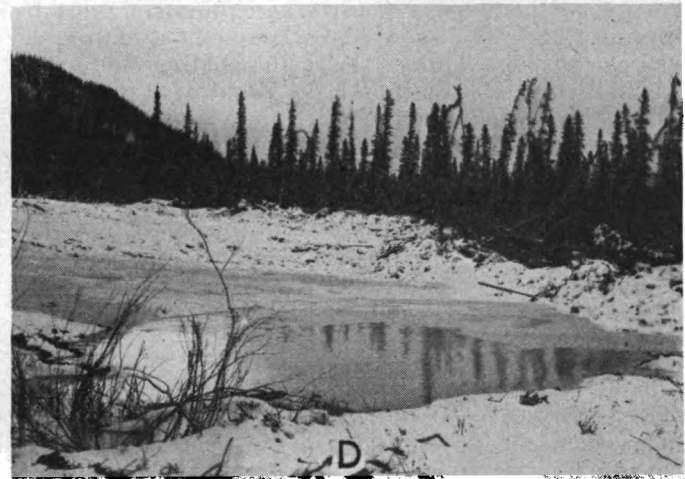
A, ICING STARTED AT ROADWAY EARLY IN THE WINTER. STRIPPING AN AREA ACROSS THE WATERCOURSE AT THIS POINT INDUCED ICING AND PROTECTED THE ROADWAY FOR THE REMAINDER OF THE WINTER. B, AN INDUCED-ICING AREA MADE WITH A BULLDOZER. C, A BUILDING PLACED OVER THE CULVERT INLET TO INCREASE HEATING EFFICIENCY. D, STORAGE OF ICE AND WATER AT AN INDUCED-ICING AREA.

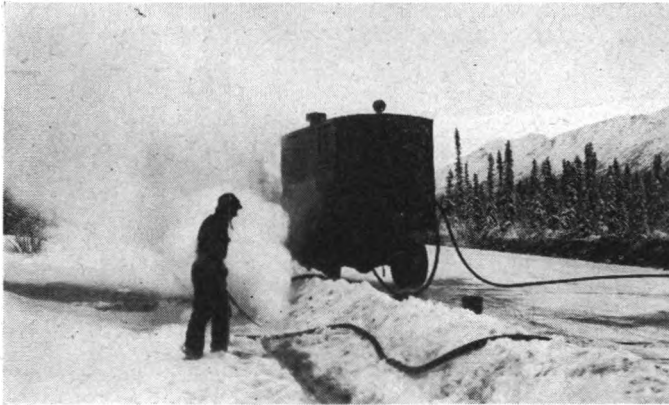
THE STEAM GENERATOR IN ACTION.
