VANGORDA PLATEAU DEVELOPMENT
AS-BUILT CONSTRUCTION REPORT FOR
LITTLE CREEK DAM

SRK REPORT 160636/1

MAY 1991

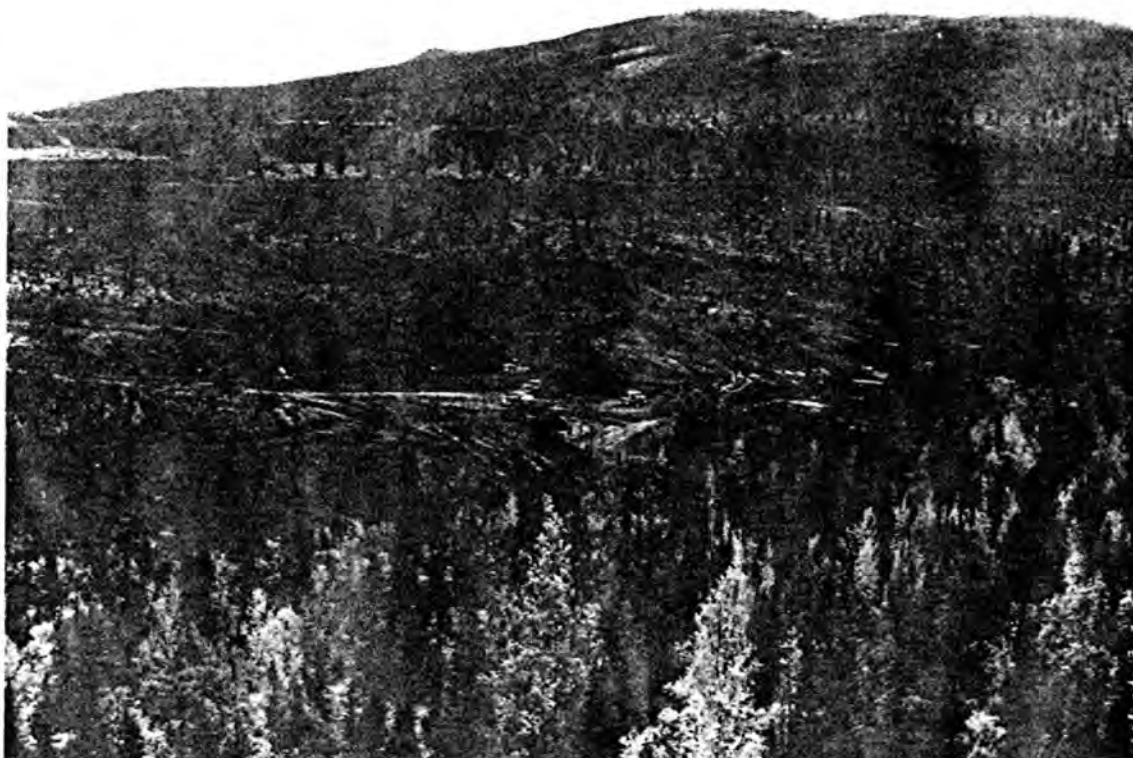
PLATE 1:

Sept. 12/90. View from the main haul road of the cleared footprint of the dam. Brownish soil in foreground of footprint is native sand and gravel; greyish soil in background of footprint is the native till. The flat embankment extending across the plate is the north limb of the starter dyke for the Vangorda waste dump.

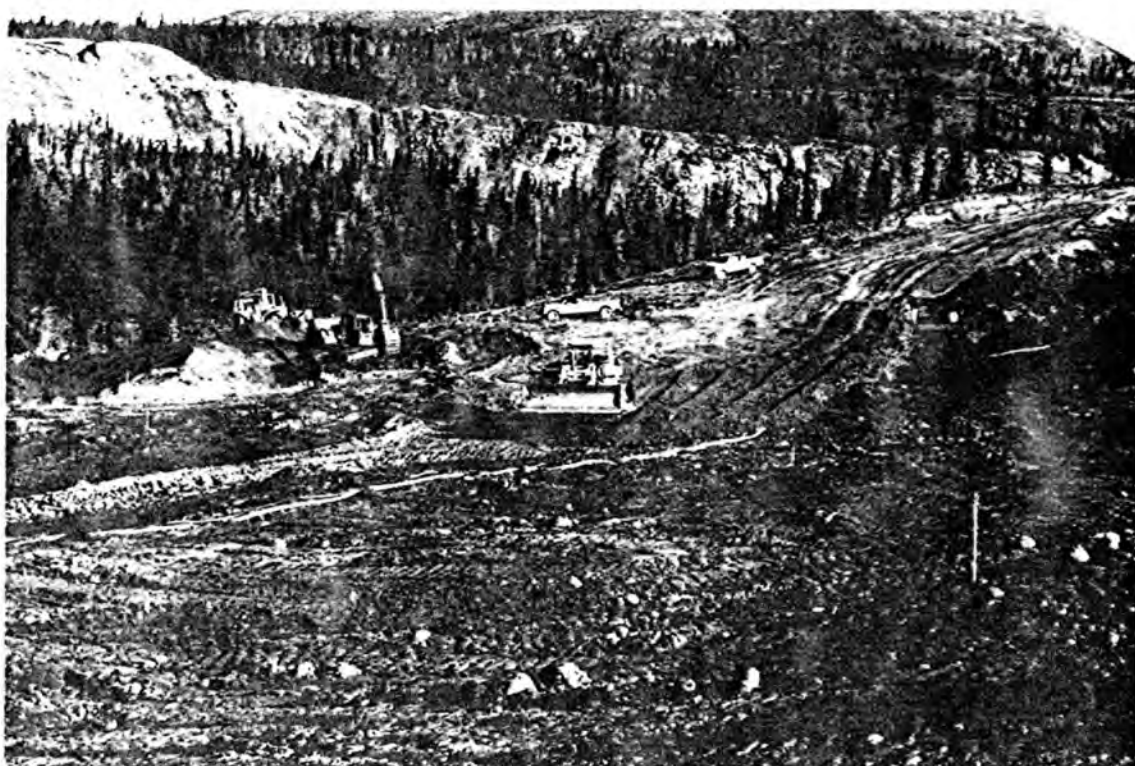
PLATE 2:

Sept. 13/90. Opposite view to Plate 1, from the south abutment of the dam. Excavation of the cutoff by the backhoe is underway and the area in valley bottom between the cutoff trench and the upstream toe of the dam is being covered with till from the stripping of Vangorda open pit.

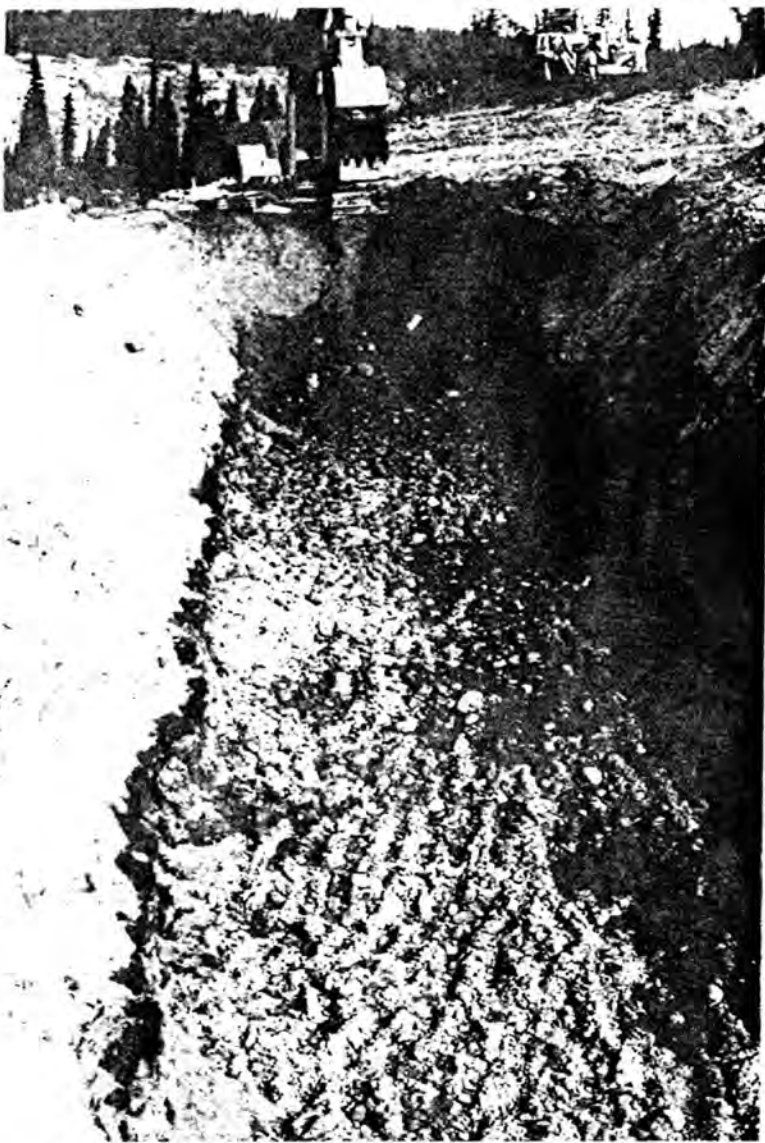
PLATE 3:

Sept. 13/90. Northward view of completed cutoff trench between Sta. 0+180 (in foreground) and Sta. 0+210. Brown sand and gravel overlies olive till which, in turn, overlies grey till. Groundwater is evident near the base of the sand and gravel.

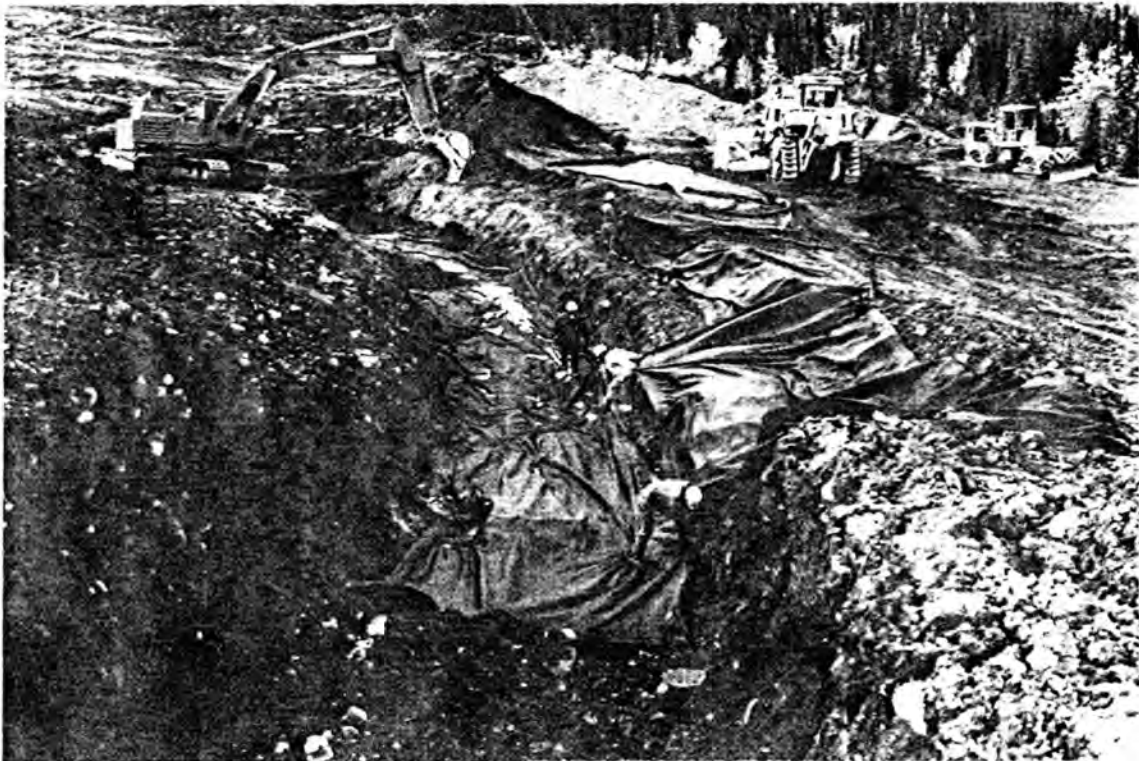
PLATE 4:

Sept. 14/90. Excavation of the cutoff trench between Sta. 0+180 and 0+235 is complete and filter fabric is being placed on the base and against the downstream face of the trench.

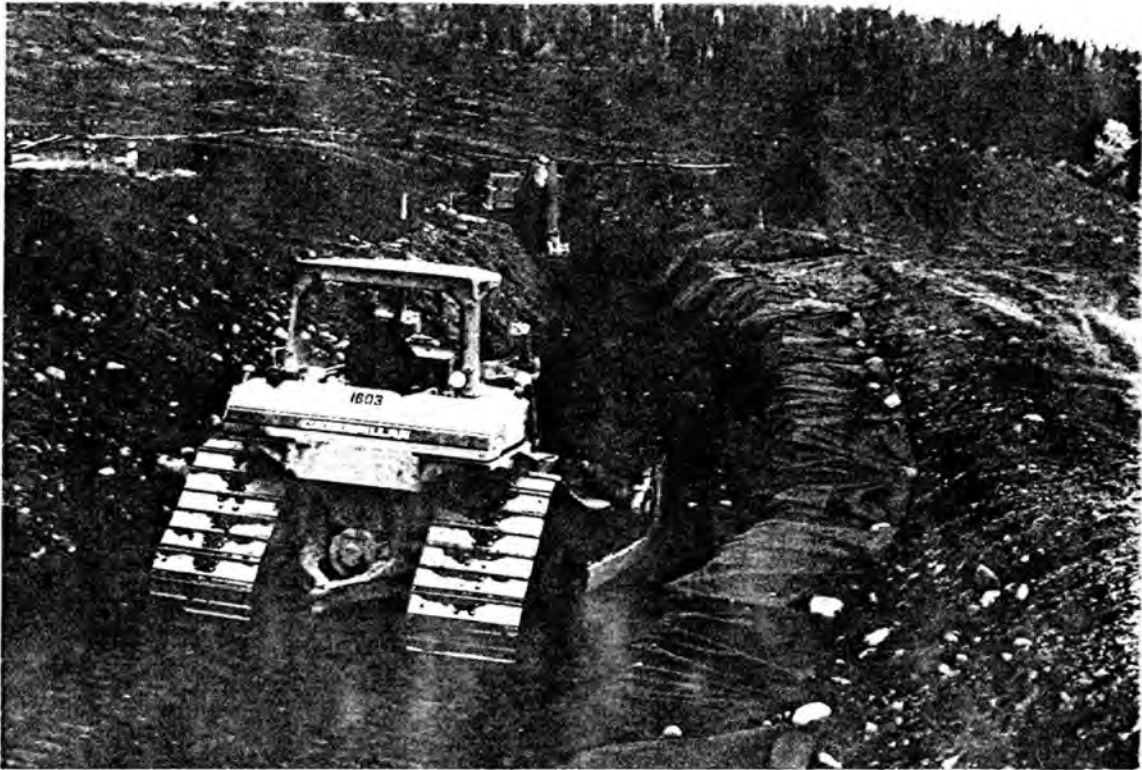
PLATE 5:

Sept. 14/90. The cutoff trench is then backfilled in thin lifts which are placed initially by the backhoe and then tracked down with a dozer in preparation for compaction.

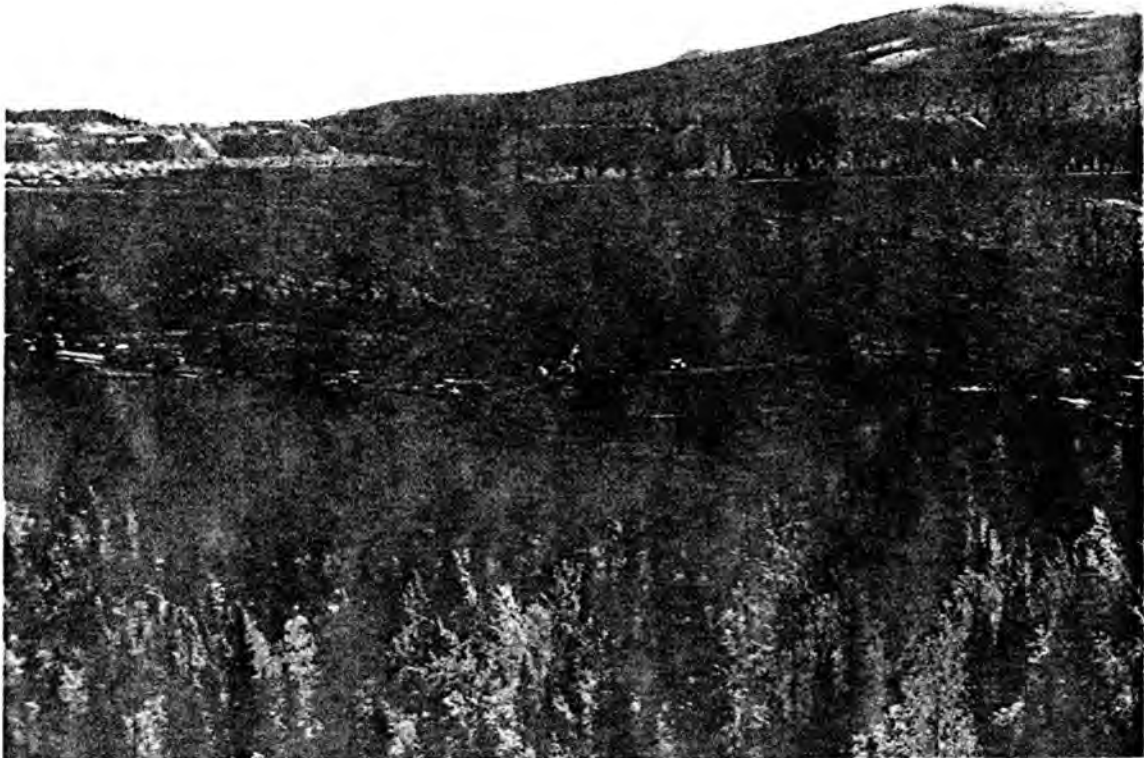
PLATE 7:

Sept. 15/90. View from the main haul road showing the scrapers hauling till. The brownish zone in the foreground of the footprint is the local sand and gravel which has been redistributed to develop part of the blanket drain and the downstream toe of the dam.

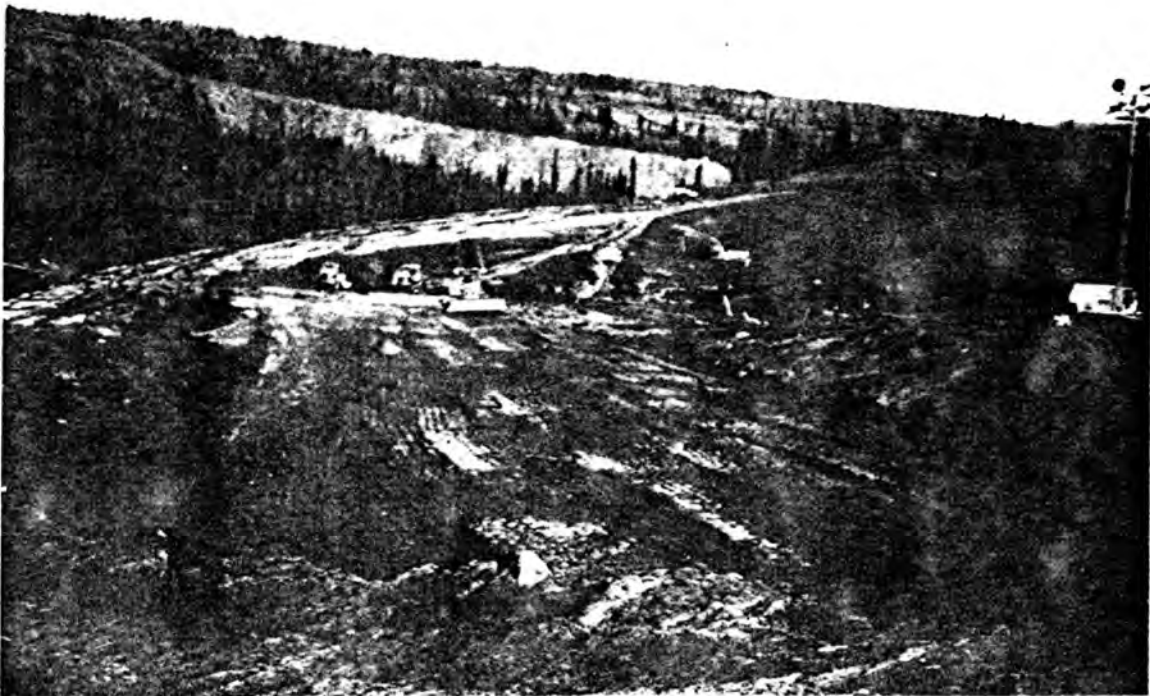
PLATE 10:

Sept. 30/90. Backfilling in thin compacted lifts of the area between Sta. 0+020 and 0+070 where the zone of permafrost was excavated.

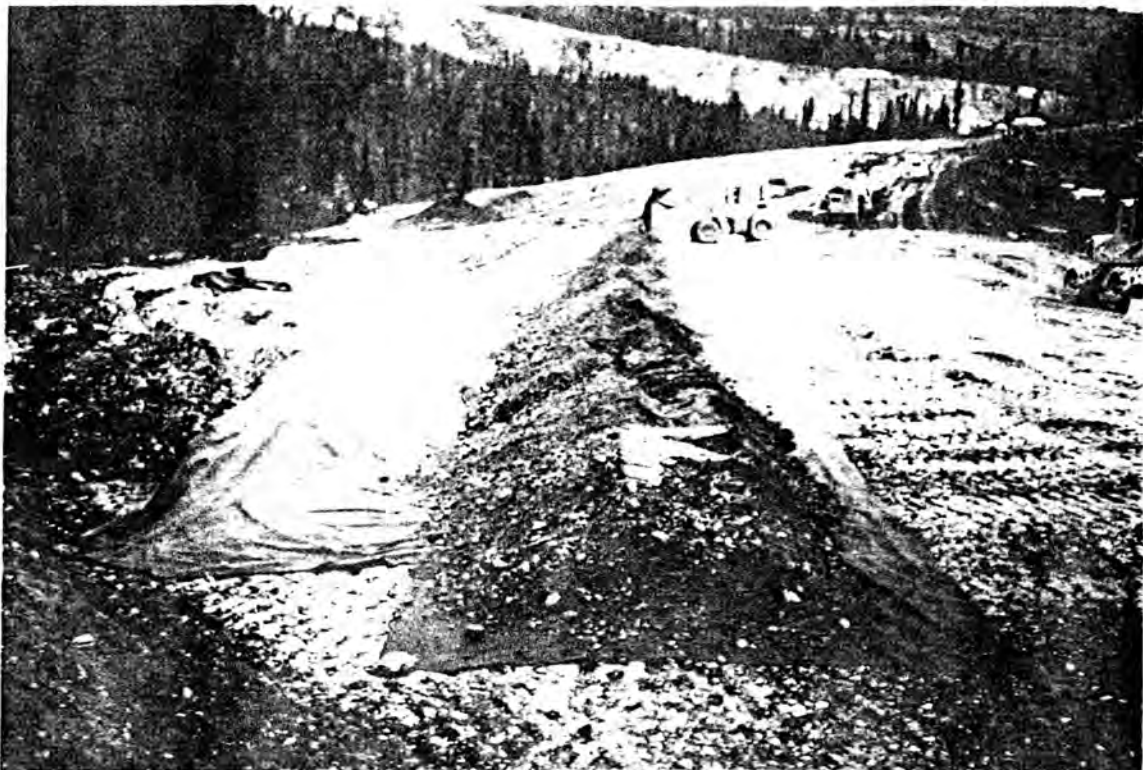
PLATE 11:

Oct. 1/90. View northwards from Sta. 0+040 at the construction of finger drain "L1."

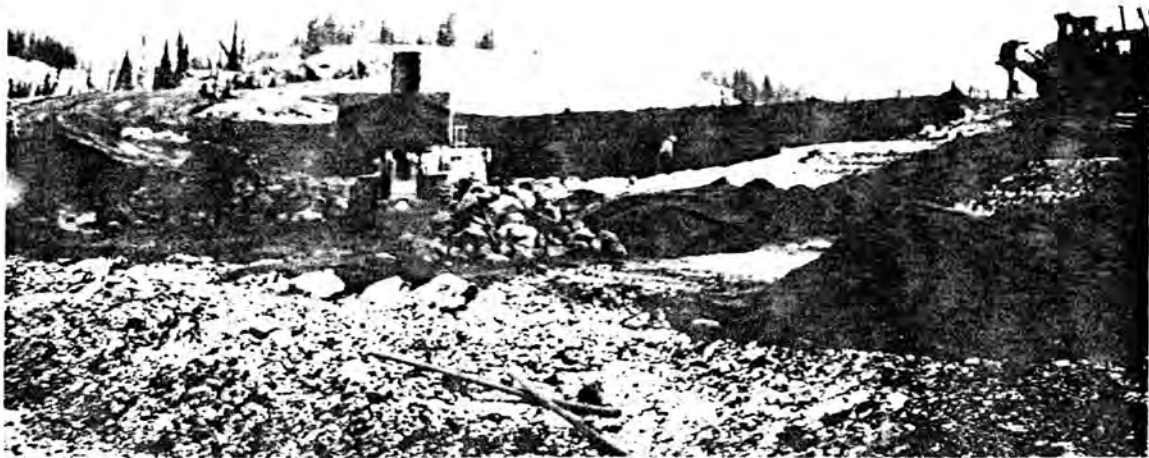
PLATE 12:

Oct. 3/90. Covering finger drains "T1" and "T2" with filter fabric and constructing the rock drain at the end of "T1."

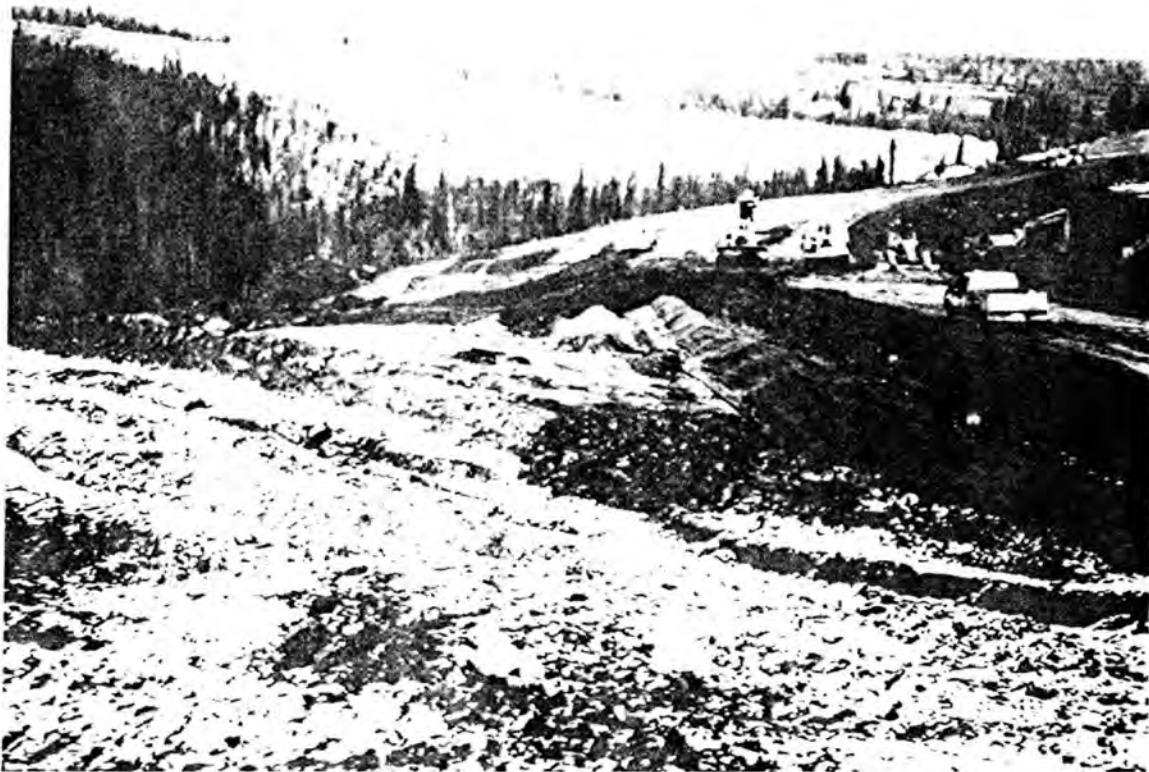
PLATE 13:

Oct. 3/90. Placement of till over top of the finger drains on the south side of the dam footprint.

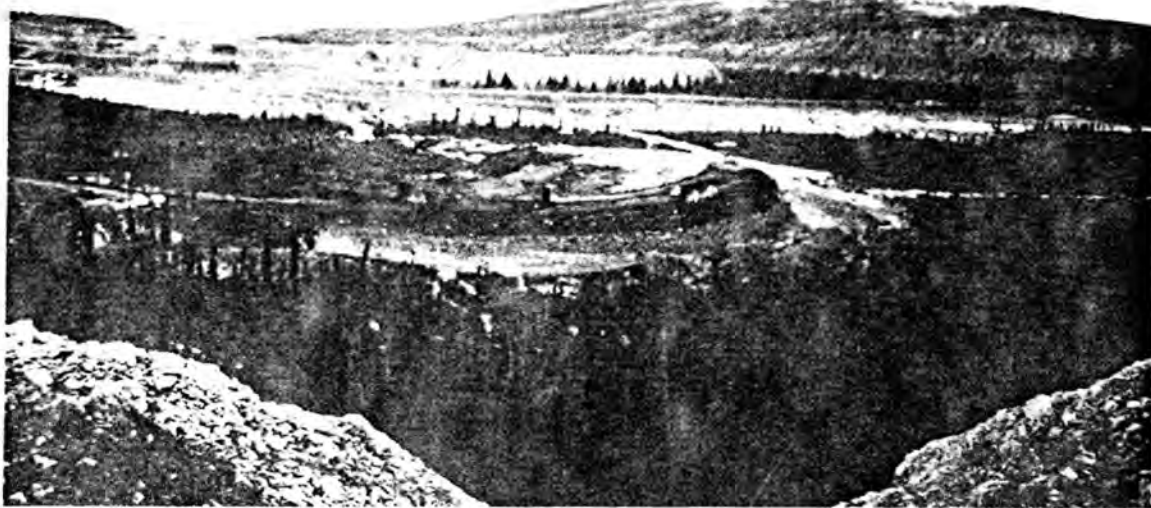
PLATE 14:

Oct. 8/90. View from the main haul road. Crest of the dam is at Elev. 1112.
